Ardmore Park Quarry – Modification 3
Engineering Assessment of
the Culverts and Bridges on
the Product Delivery Route

Bridge Designs Pty Ltd

B1833-R-01

Bungonia Culverts - Engineering Assessment

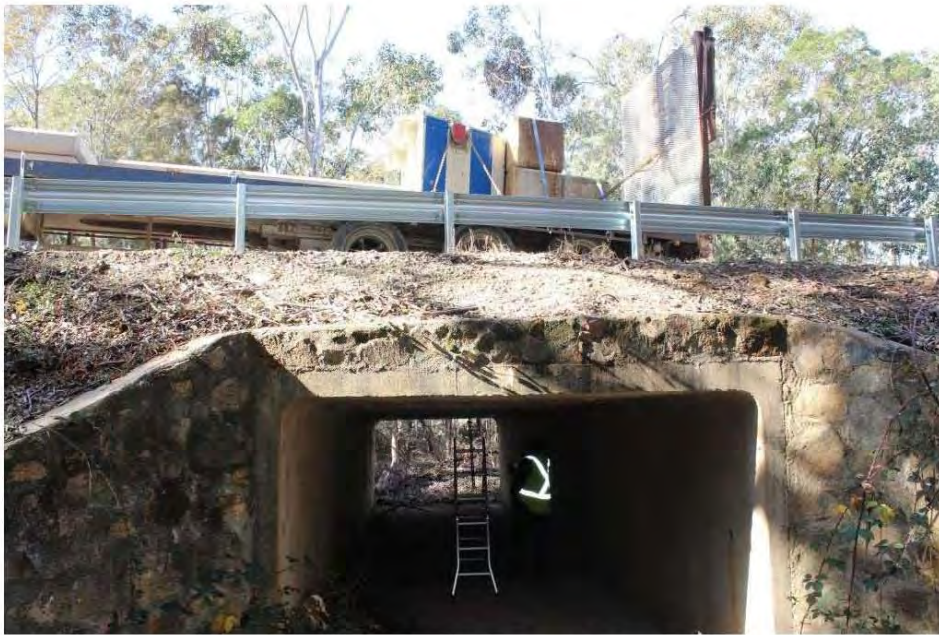
Figure 4.1: Test Setup at Culvert A

Deflections were measured at midspan using a dial gauge as shown in Figures 4.1 and 4.2. The dial gauge was secured to a ladder and positioned underneath the wheel path. The position of the dial gauge was kept the same for the three tests. Readings were taken before loading, under loading and after loading to determine the deflection and the return. The dial gauge was accurate to 0.01mm.

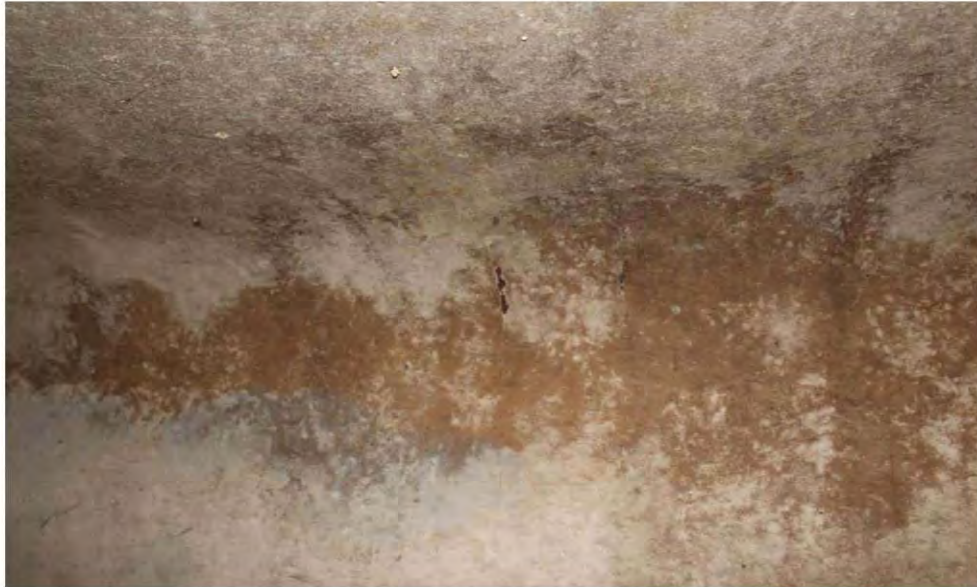
Element Description	Quantity	Condition State	Defect Description	Required Action			
				Monitor	Repair	Level 3 Inspection	Other
Precast Box Culvert	10	3	Exposed reinforcement in corners of most units, spalling and exposed reinforcement at joints	X

Exposed reinforcement at top corners

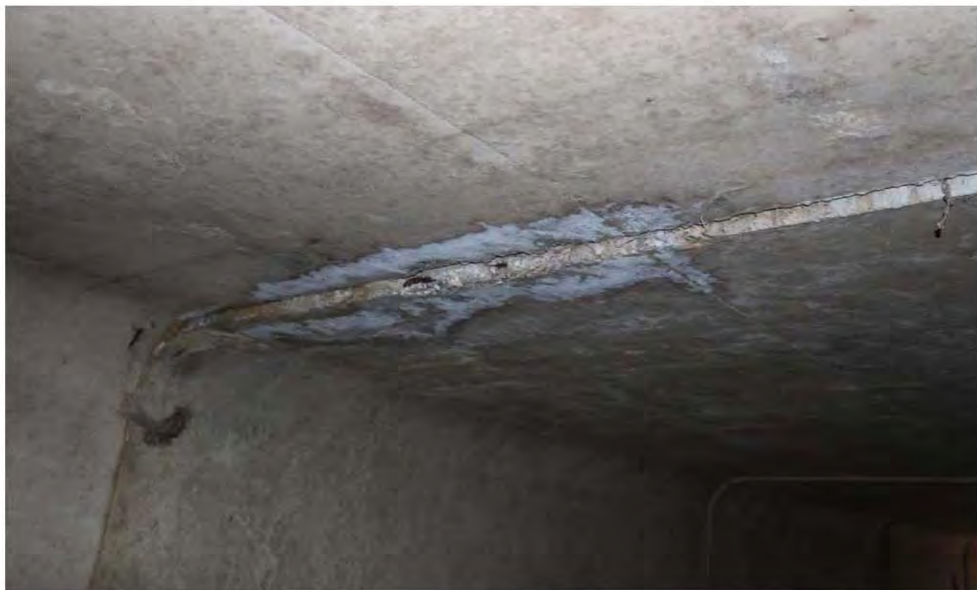
Exposed reinforcement and efflorescence in edge of culvert roof

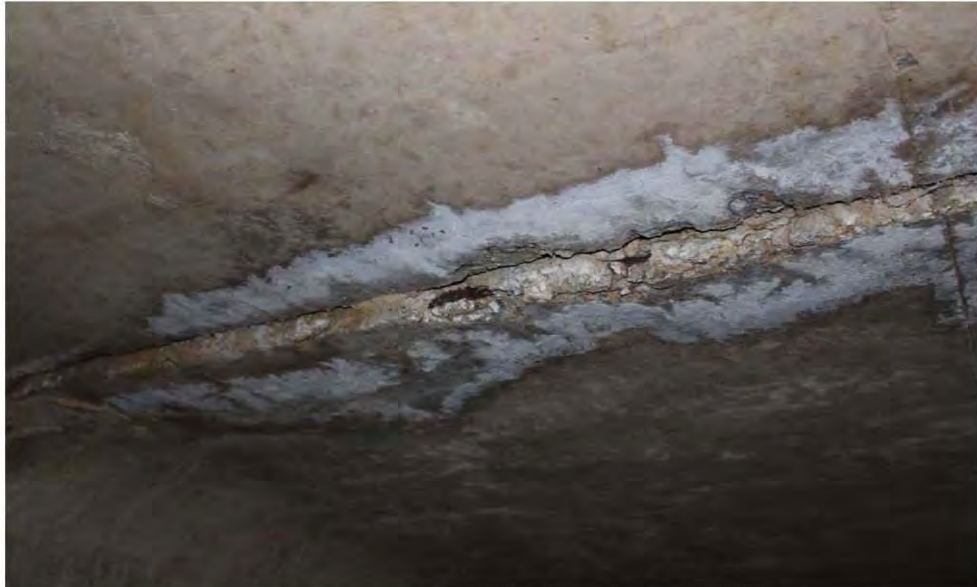
Exposed reinforcement and efflorescence in edge of culvert roof

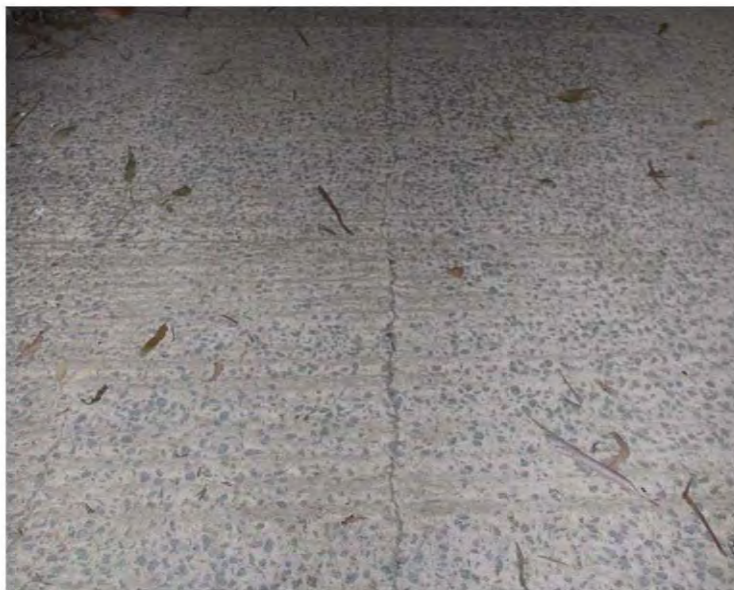
0.3mm crack in base slab

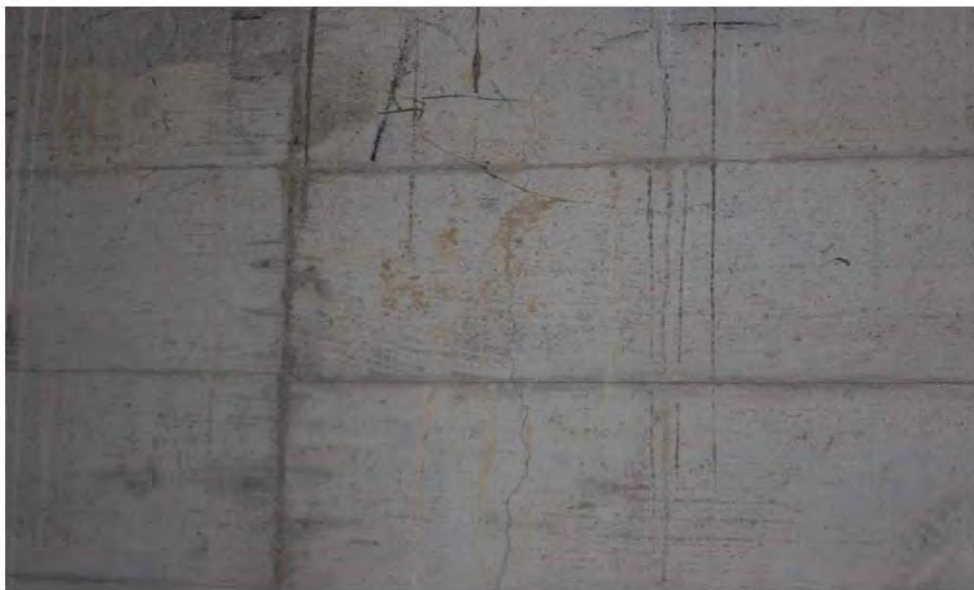
0.1mm vertical crack in Cell 3

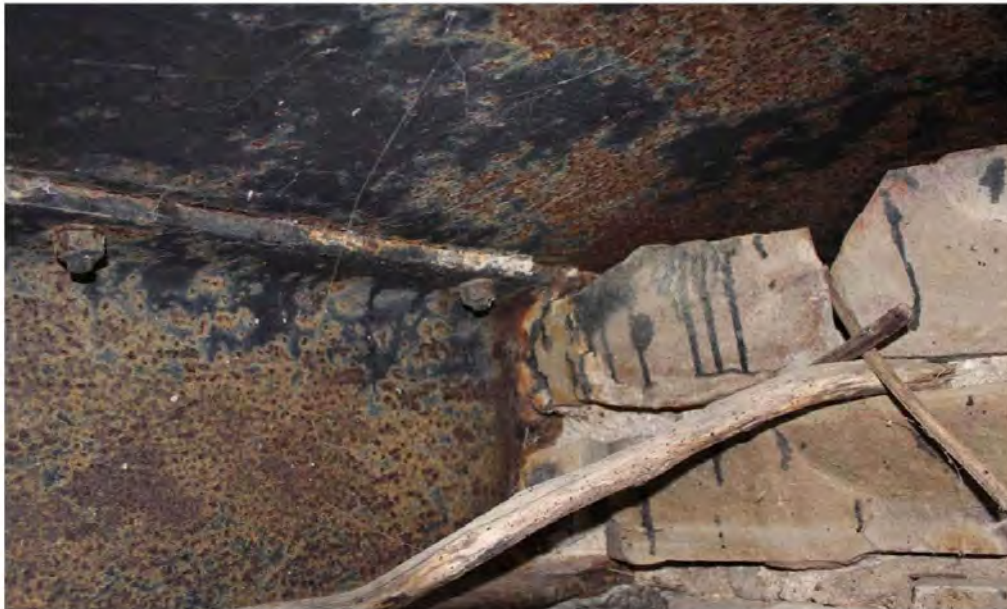
Corrosion of southern end of beam 4

Element Description	Quantity	Condition State	Defect Description	Required Action			
				Monitor	Repair	Level 3 Inspection	Other
Steel Girders	3m ²	3	Loss of paint coating and corrosion in some sections should be monitored.	X			
Steel Buckle Plate Decking	5m ²	3	Loss of paint coating and corrosion in some sections should be monitored.	X

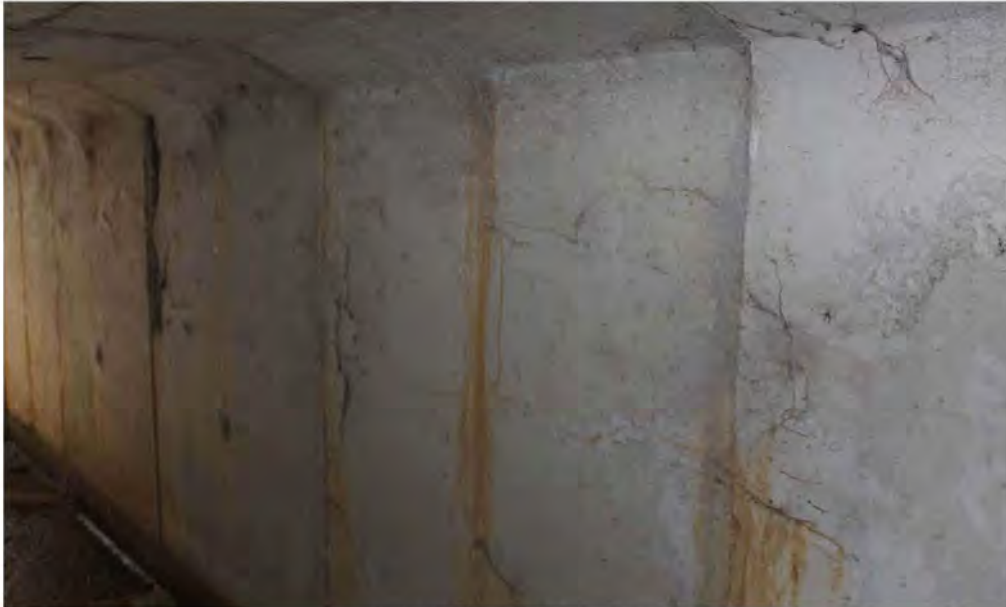
Cracking and spalling on sides of units

Element Description	Quantity	Condition State	Defect Description	Required Action			
				Monitor	Repair	Level 3 Inspection	Other
Precast Box Culvert	5m ²	4	Exposed and corroded reinforcement in walls and roof should be patched to prevent further deterioration		X		
Precast Box Culvert	10m ²	3	Vertical cracking and spalls in walls to be monitored.	X

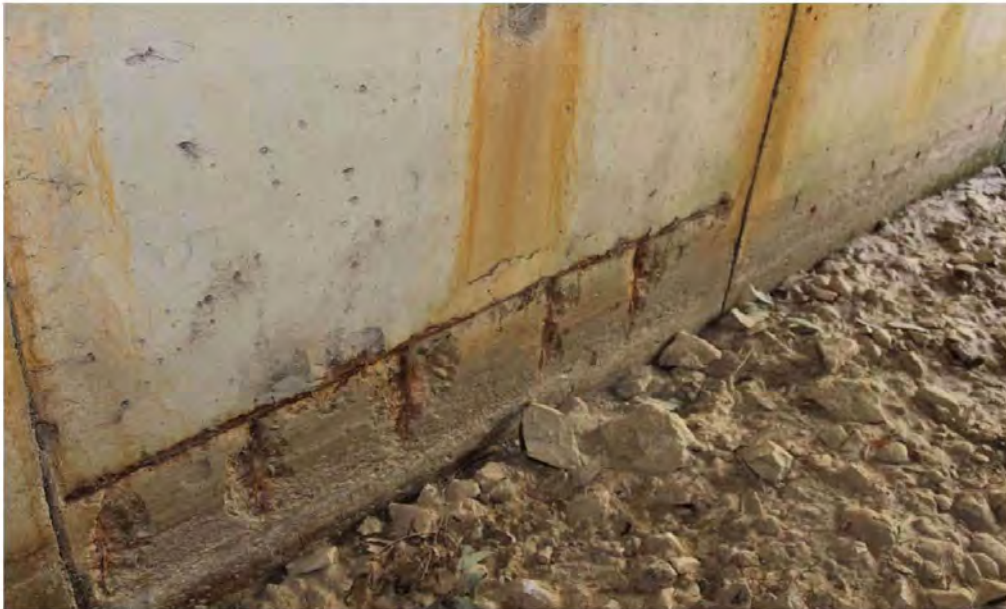
Exposed reinforcement (unit 3 north side)

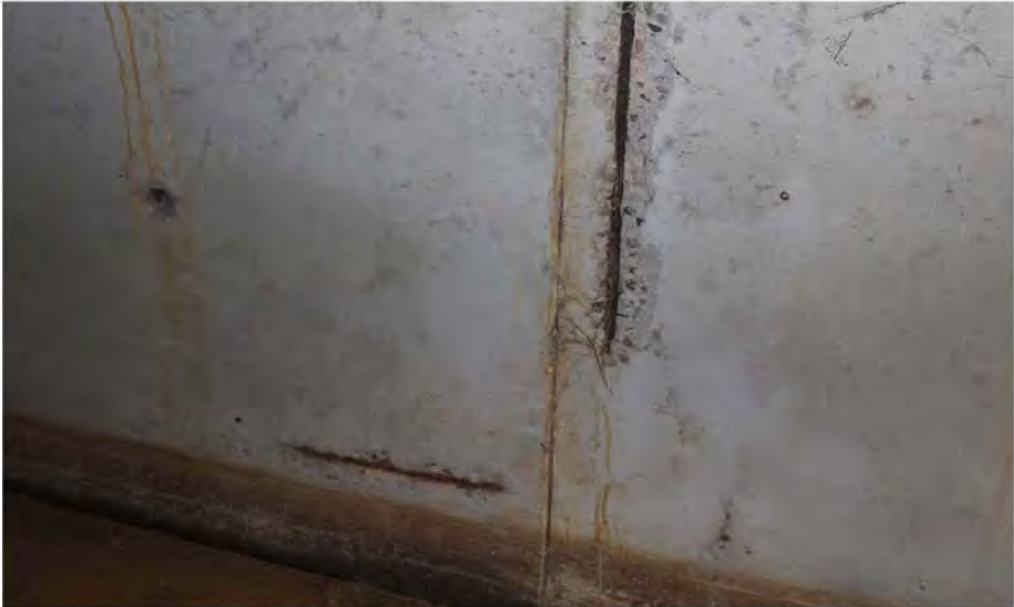
Exposed reinforcement (units 7 and 8 north side)

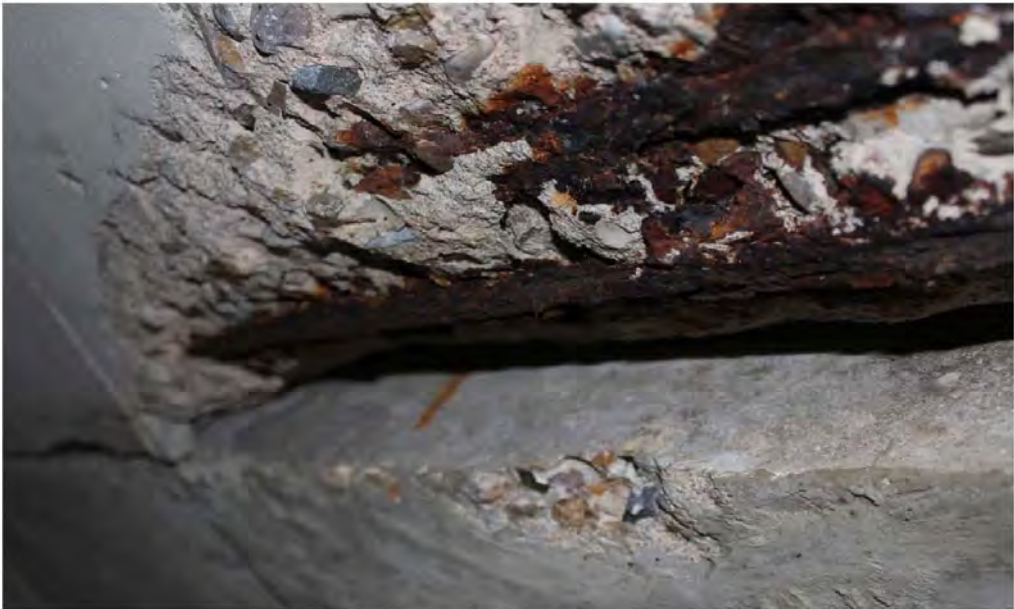
Spall and corroded reinforcement in top of unit 11

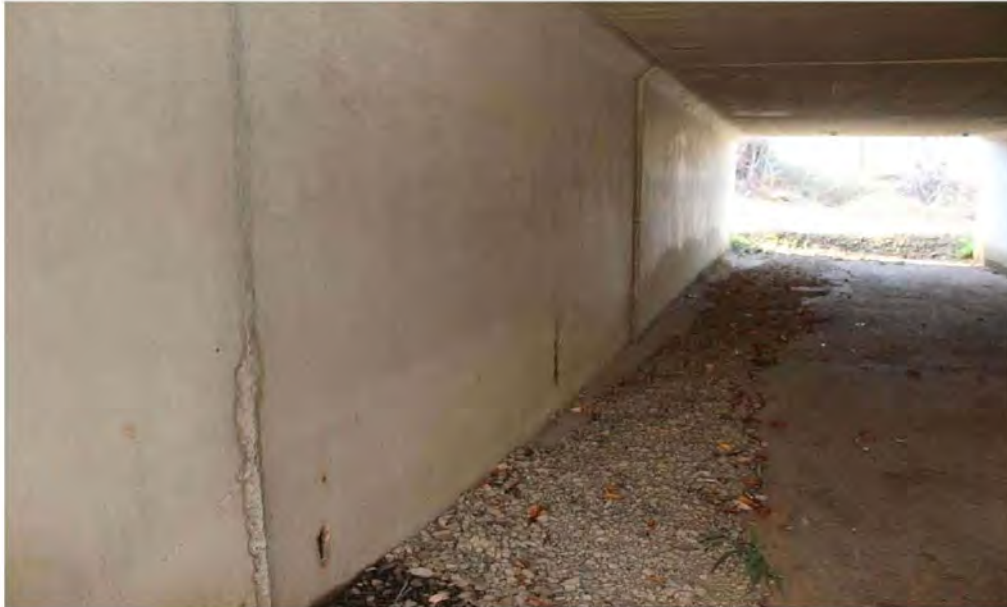
Exposed reinforcement in culvert wall

Element Description	Quantity	Condition State	Defect Description	Required Action			
				Monitor	Repair	Level 3 Inspection	Other
Concrete Box Culvert	10m ²	3	Spalled concrete in some walls and exposed reinforcement should be patched. Monitor cracking.	X	X

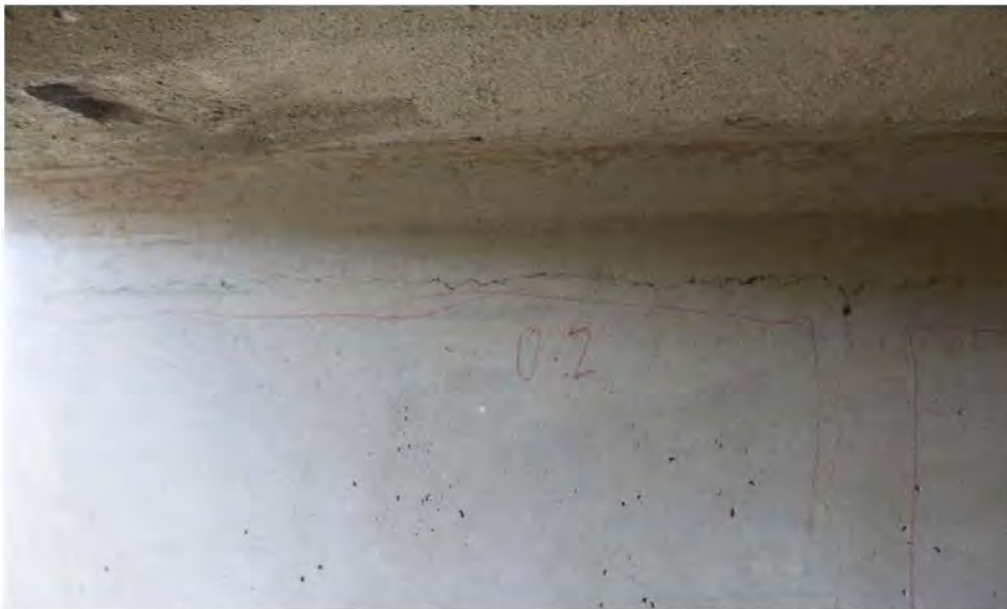
0.2mm horizontal cracking at top of wall and vertical cracking in middle of unit

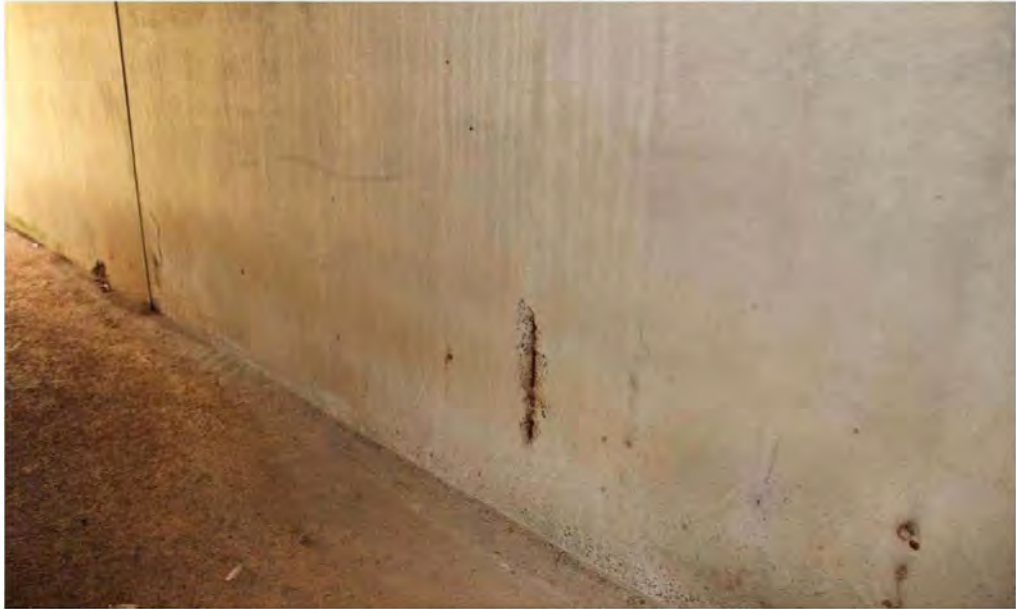
Exposed reinforcement in culvert wall

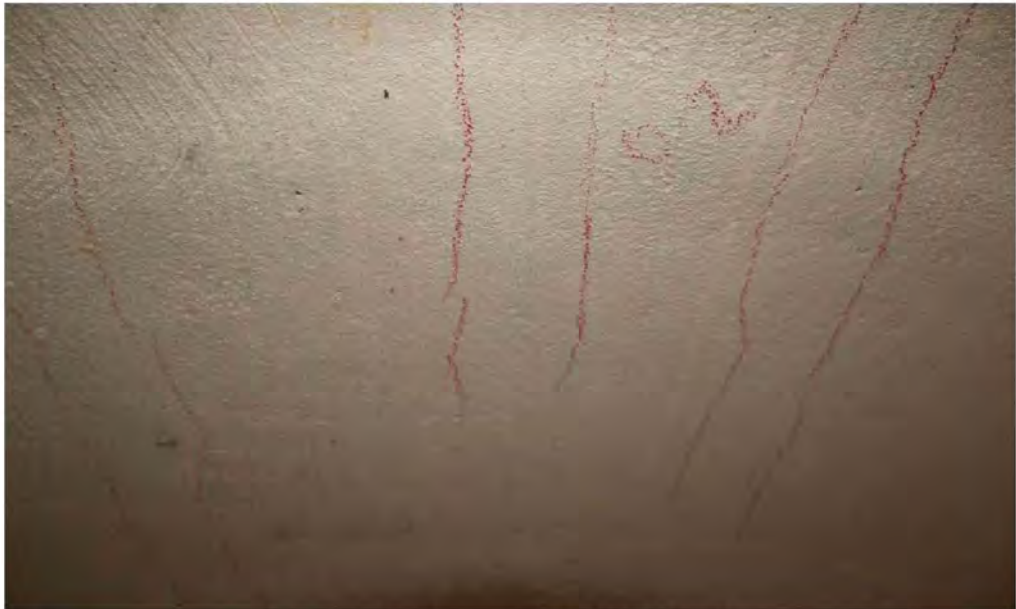
The roof slabs of Culverts A, B and F were uncracked before loading and remained uncracked under the 31.2t load. Culverts H, I and J had cracks in the roof unloaded and these cracks did not widen under the 31.2t load.

0.2mm transverse cracking in roof

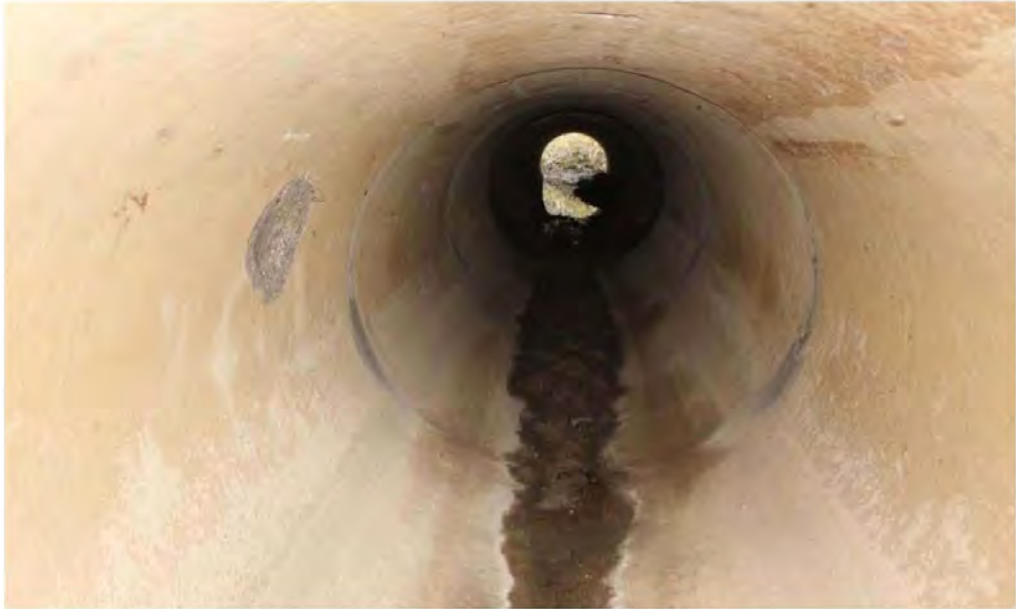
Cell 1 looking south (spall on left)

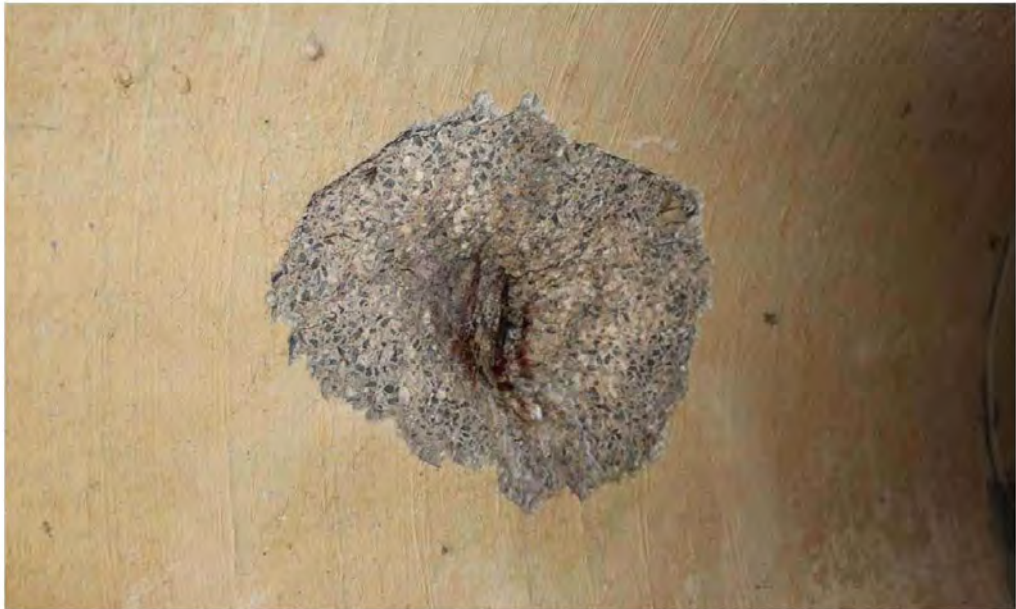
Spall in new section of cell 1

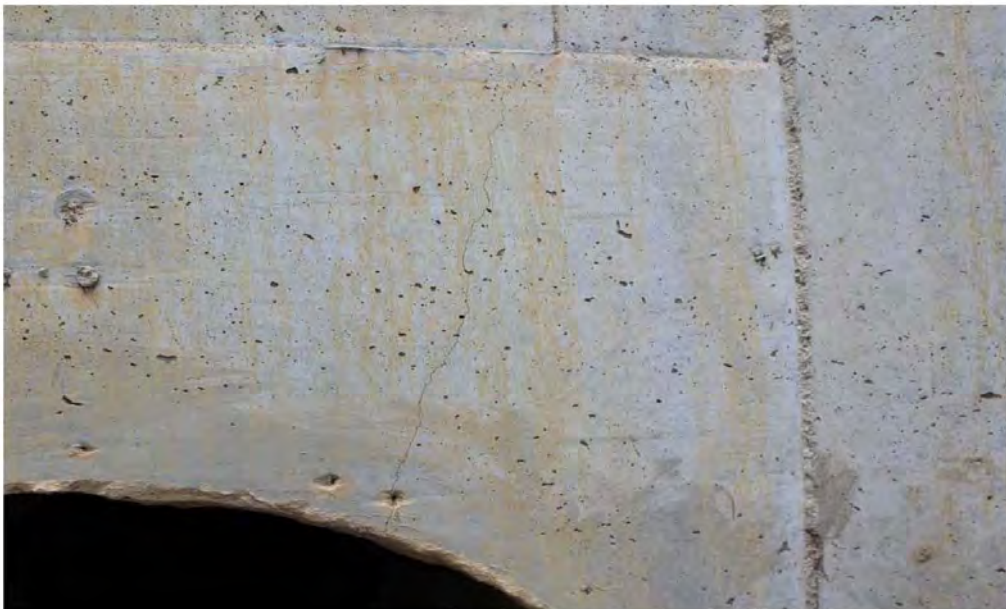
0.3mm crack in headwall at inlet

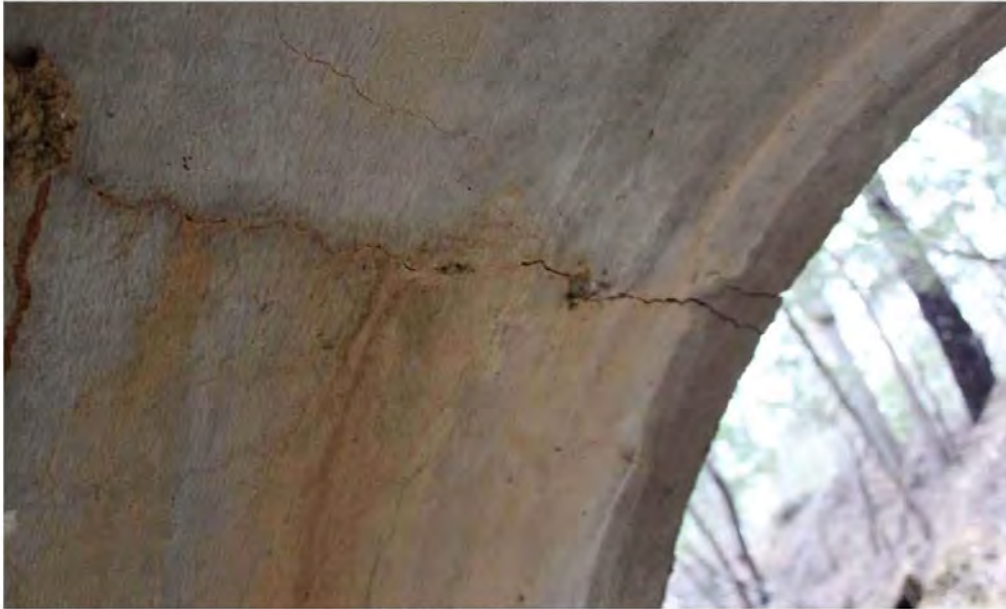
Cracking in side of unit 1 northern side

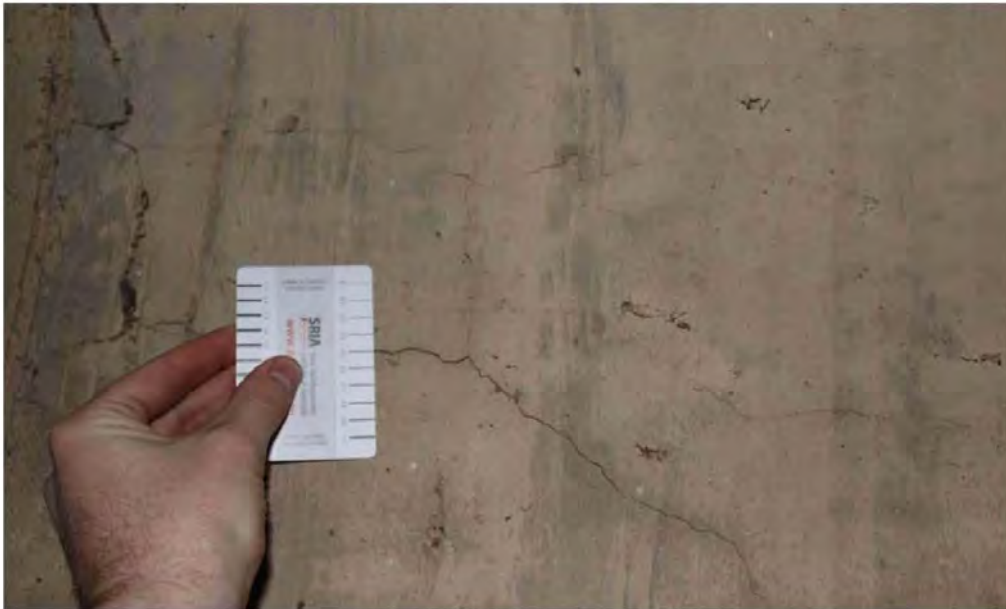
0.5mm cracking in pipe

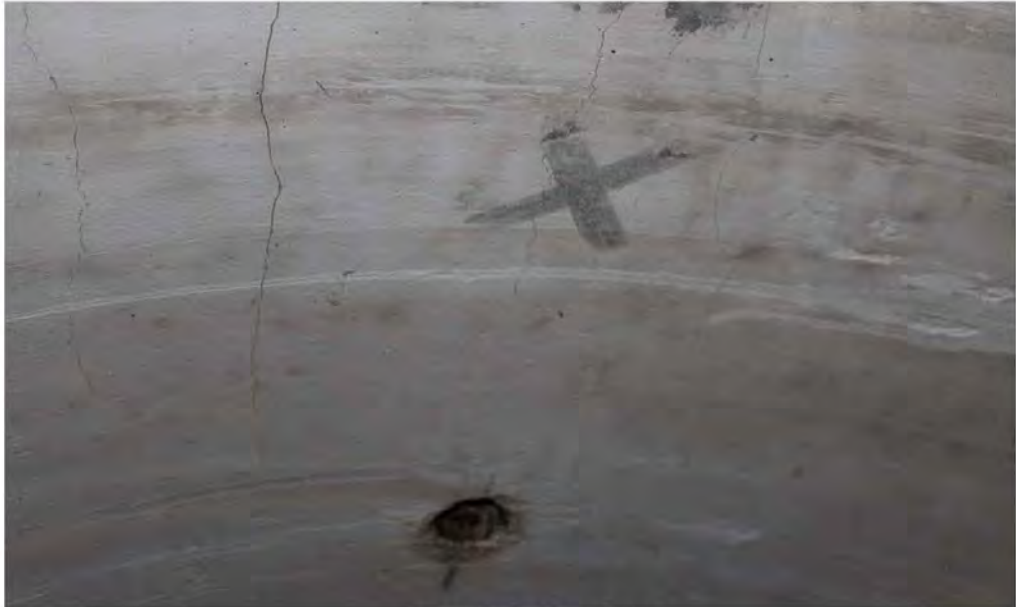
Cracking in top of pipe
