Ardmore Park Quarry – Modification 3

Road Safety Audit
Jerrara Road Upgrade

Rigore Engineering Services

April 2018

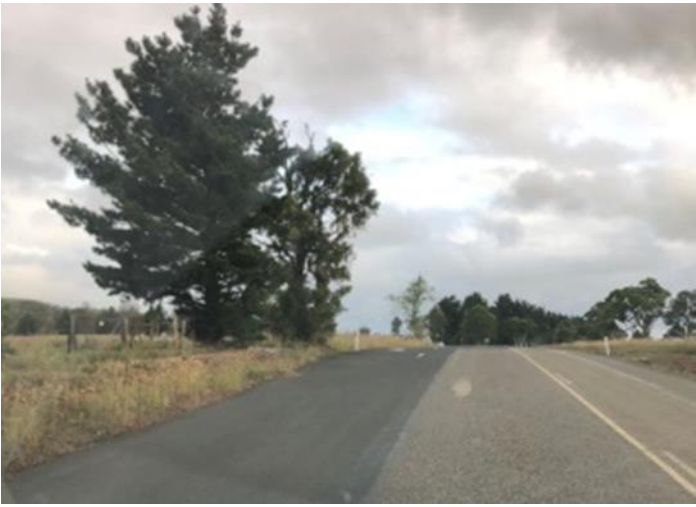
<p>Incorrect and misleading linemarking of the deceleration lane into the Quarry access.</p> <p>The current linemarking may encourage drivers to utilise the widened pavement in additional to the through lane. This could result in run off road and/or numerous intersection type crashes.</p>	Possible	Infrequent	Once every five to ten years	Low	Should be corrected at a suitable time, if cost is low.
2

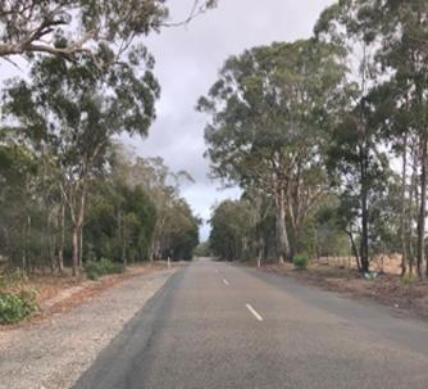
<p>Edgeline and raised reflective pavement markers (RRPM's) missing along this section.</p> <p>This limits a road user's ability to interpret the road alignment (particularly at night or in heavy fog) and could result in run-off road type crashes at high speed.</p>	Likely	Occasional	Once every one to five years	High	Should be corrected in the very near future, even if costs are high. Temporary mitigation measures should be considered until final correction action taken.

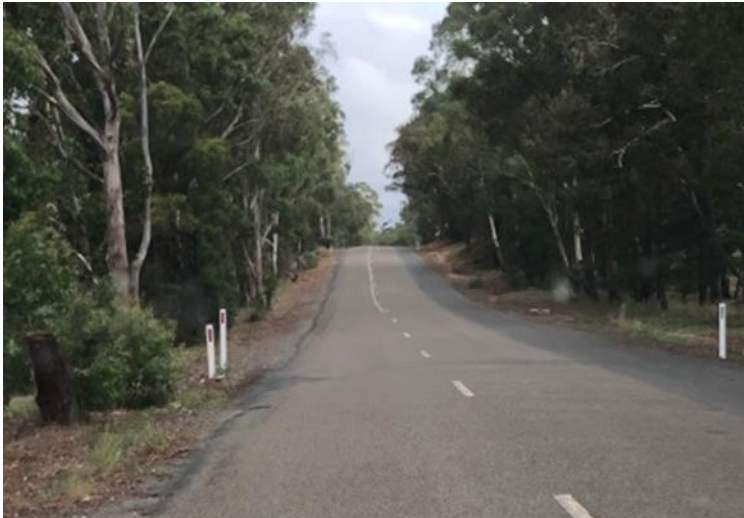
<p>There are lengths along this section with inconsistent and narrow lane widths. Some lanes are down to about 3.0m in places. The formation width allows for 2 x 3.5m lanes but the centreline has not been re-done, or done incorrectly after the shoulder widening has been completed.</p> <p>These narrow lanes increase the likelihood of sideswipe and head on accidents.</p>	Likely	Occasional	Once every one to five years	High	Should be corrected in the very near future, even if costs are high. Temporary mitigation measures should be considered until final correction action taken.
4	1.8km

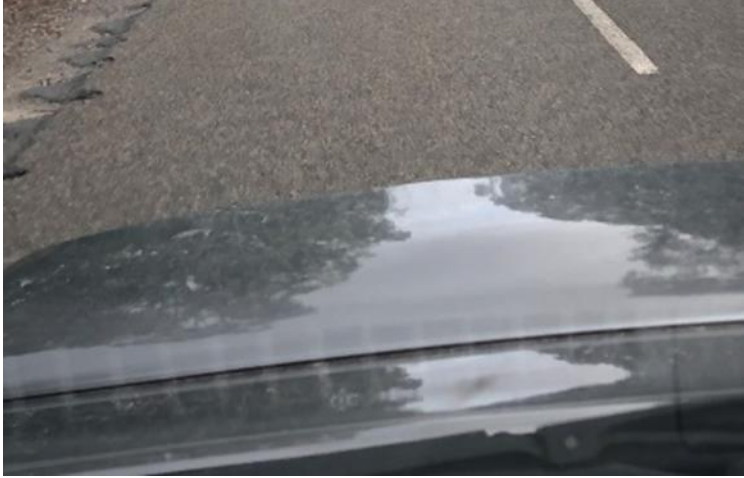
<p>There is an unprotected culvert structure with large vertical drop off on the Eastern side.</p> <p>This could result in a rollover and run-off road hit object type crash at high speed.</p>	Likely	Infrequent	Once every five to ten years	Medium	Should be corrected in the very near future, even if costs are moderate. A delay until the routine maintenance should be justified. Temporary mitigation measures should be considered until final correction action taken.

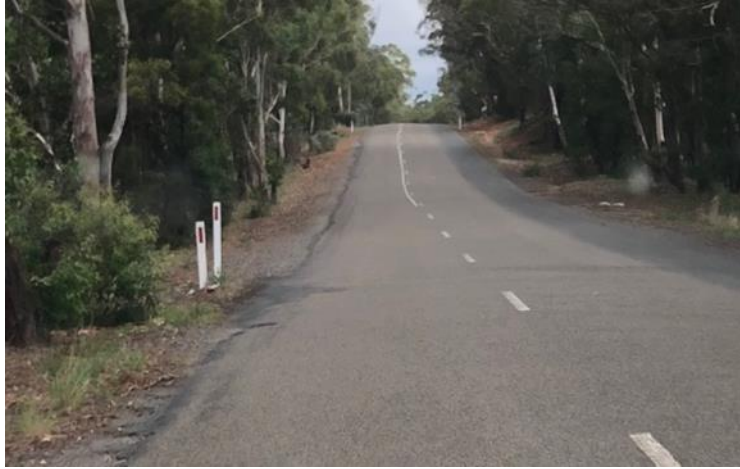
<p>Several curves and crests on this section have no additional warning signage or CAMS.</p> <p>This could result in run off road and hit object type crashes at these locations.</p>	Likely	Infrequent	Once every five to ten years	Medium	Should be corrected in the very near future, even if costs are moderate. A delay until the routine maintenance should be justified. Temporary mitigation measures should be considered until final correction action taken.
6	Numerous locations		<p>Blacked out linemarking still visible at night. In some cases the line types are different to the new linemarking.</p> <p>This is confusing for drivers at night and may lead to unsafe overtaking and encroachment into opposing traffic lanes.</p> <p>This could lead to head on and side swipe accidents.</p>	Likely	Infrequent	Once every five to ten years	Medium	Should be corrected in the very near future, even if costs are moderate. A delay until the routine maintenance should be justified. Temporary mitigation measures should be considered until final correction action taken.

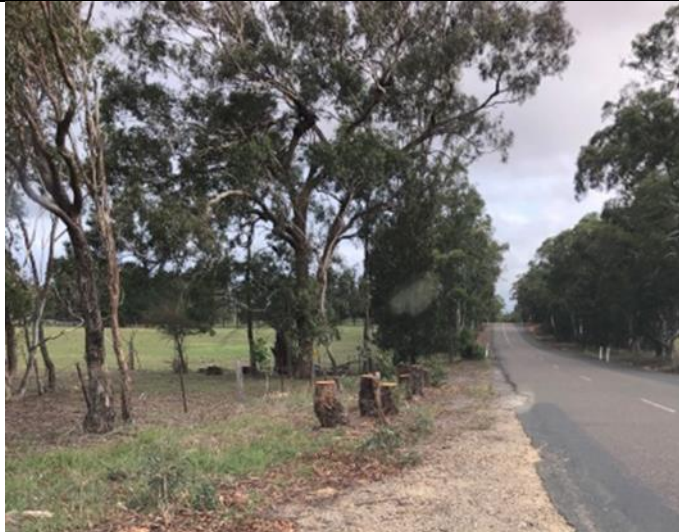
<p>Several trees along this length have been cut down but the stumps remain within the clearzone</p> <p>This could result in a run-off road hit object type crash at high speed.</p>	Likely	Infrequent	Once every five to ten years	Medium	<p>Should be corrected in the very near future, even if costs are moderate. A delay until the routine maintenance should be justified. Temporary mitigation measures should be considered until final correction action taken.</p>

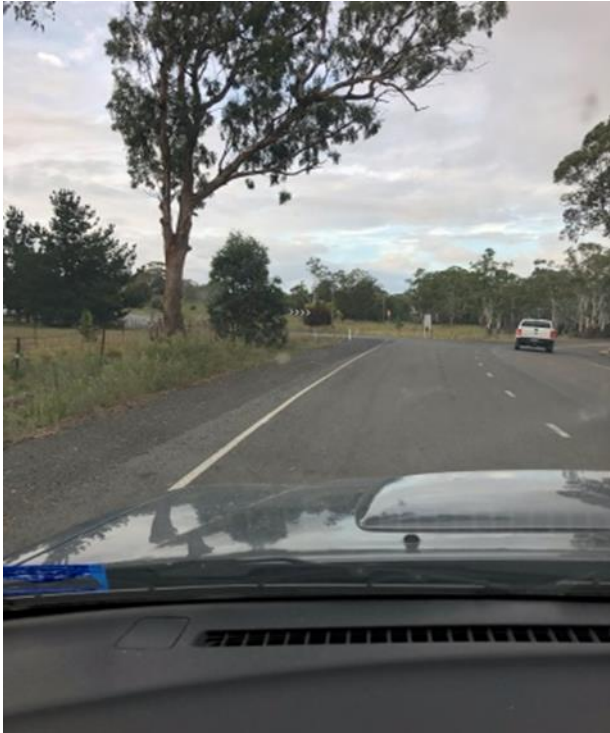
<p>Hazard board used for a curve advisory.</p> <p>This is misleading to drivers and may cause them to think they are coming up to T-Intersection. This could result in run off road and/or numerous intersection type crashes.</p>	Possible	Infrequent	Once every five to ten years	Low	Should be corrected at a suitable time, if cost is low.

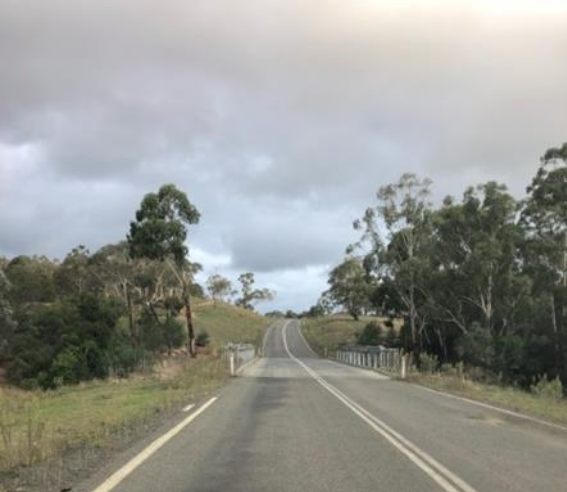
<p>No barrier on approach to bridge structure to protect steep drop off.</p> <p>This could result in run off road and hit object type crashes. It may also cause damage to the structural integrity of the bridge if struck.</p>	Likely	Infrequent	Once every five to ten years	Medium	Should be corrected in the very near future, even if costs are moderate. A delay until the routine maintenance should be justified. Temporary mitigation measures should be considered until final correction action taken.

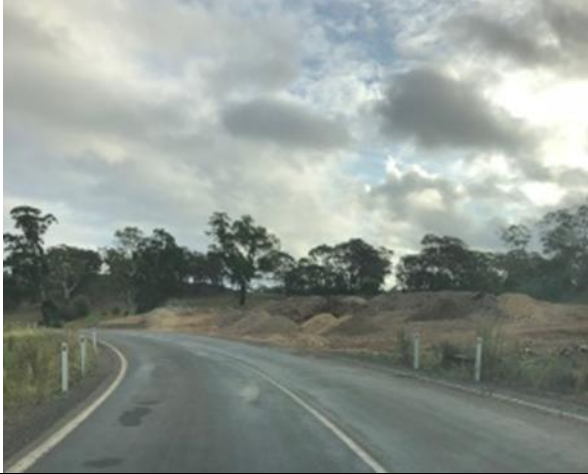
<p>This section does not have any RRPM's and guideposts are widely spaced.</p> <p>This limits a road user's ability to interpret the road alignment (particularly at night or in heavy fog) and could result in run-off road type crashes.</p>	Possible	Infrequent	Once every five to ten years	Low	Should be corrected at a suitable time, if cost is low.
13

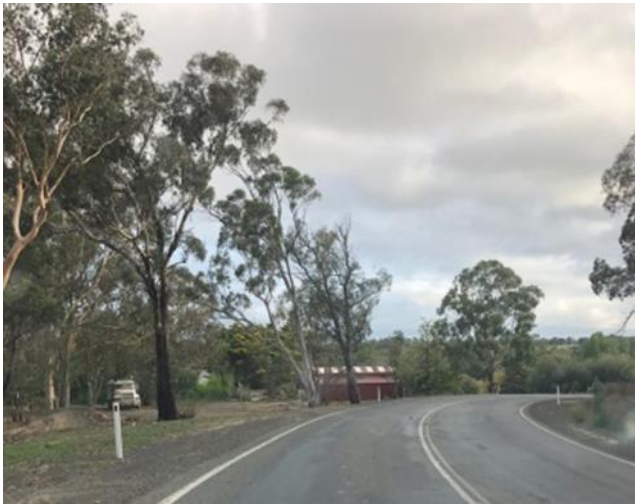
<p>Several curves on this section have no advance curve warning signage or chevron alignment markers (CAMS).</p> <p>This could result in run off road and hit object type crashes.</p>	Possible	Infrequent	Once every five to ten years	Low	Should be corrected at a suitable time, if cost is low.

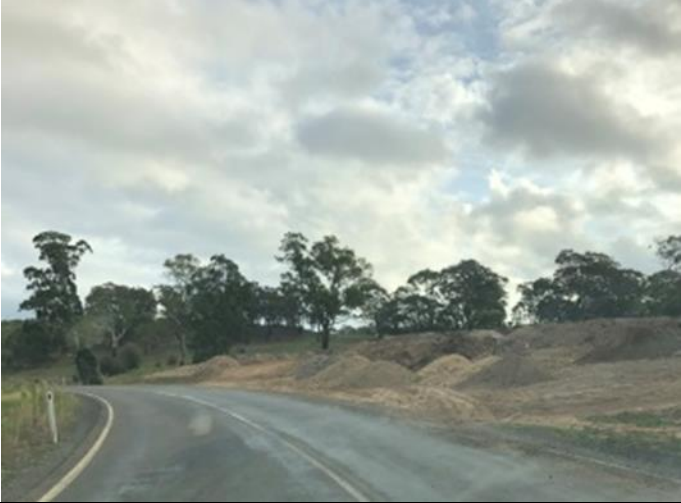
<p>No controlled access for the stockpile site.</p> <p>This allows unsafe movements in and out of the stockpile which may cause accidents with through traffic.</p>	Possible	Infrequent	Once every five to ten years	Low	Should be corrected at a suitable time, if cost is low.
15	4.5km

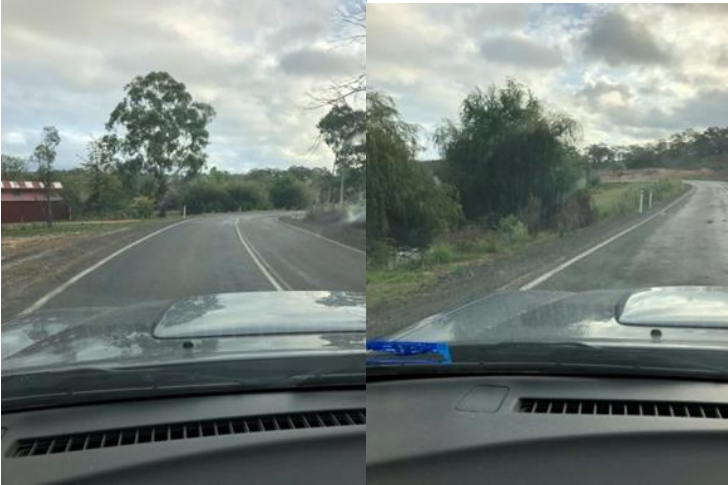
<p>Southbound vehicles have a tight right hand curve which tightens further into the curve. The curve has no curve advisory and chevron alignment markers (CAMS) signage or barrier protecting the high and steep embankment.</p> <p>This could result in roll over and run off road and hit object type crashes.</p>	Likely	Infrequent	Once every five to ten years	Medium	Should be corrected in the very near future, even if costs are moderate. A delay until the routine maintenance should be justified. Temporary mitigation measures should be considered until final correction action taken.

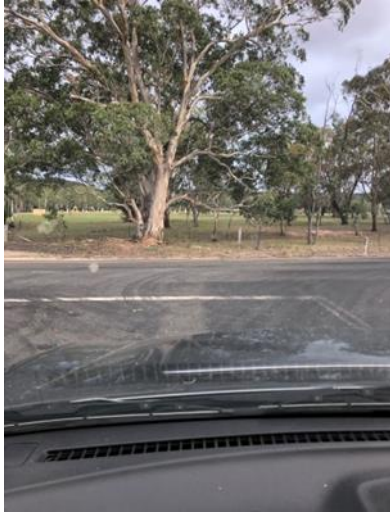
<p>Both intersections are lacking advance warning signage for the approaching T-Intersection.</p> <p>This could result in vehicles misjudging the intersections and encroaching into through lanes causing right angle type crashes. This is of particular concern for loaded heavy vehicles with reduced stopping ability on downgrades.</p>	Likely	Infrequent	Once every five to ten years	Medium	Should be corrected in the very near future, even if costs are moderate. A delay until the routine maintenance should be justified. Temporary mitigation measures should be considered until final correction action taken.
Section 3 - Mountain Ash Road Intersections (Bungonia Bypass Road and Jerrara Road)								
17

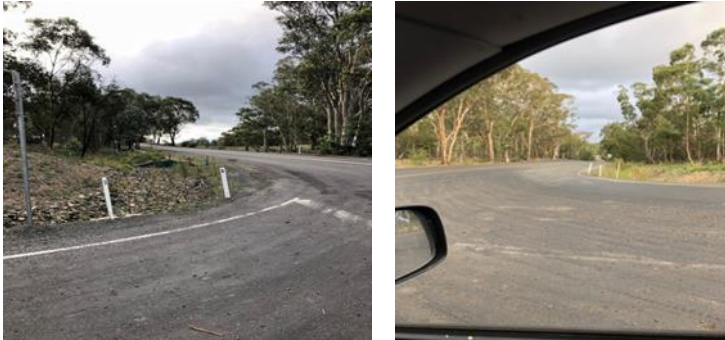
<p>Vegetation restricts sight distance at both intersections for vehicles entering Mountain Ash Road.</p> <p>This could result in vehicles pulling out in front of fast moving through traffic causing rear end and right angle type crashes.</p>	Likely	Occasional	Once every one to five years	High	Should be corrected in the very near future, even if costs are high. Temporary mitigation measures should be considered until final correction action taken.

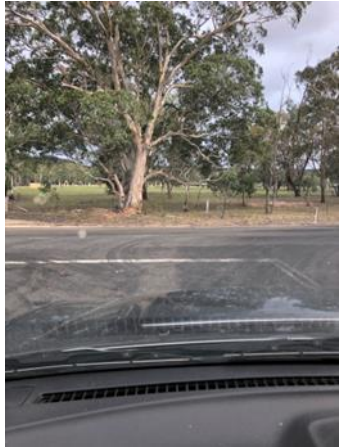
<p>Bungonia Bypass Road intersection is lacking hazard board.</p> <p>This may lead to cars misjudging the intersections and leading to right angle crashes.</p>	Possible	Infrequent	Once every five to ten years	Low	Should be corrected at a suitable time, if cost is low.
19

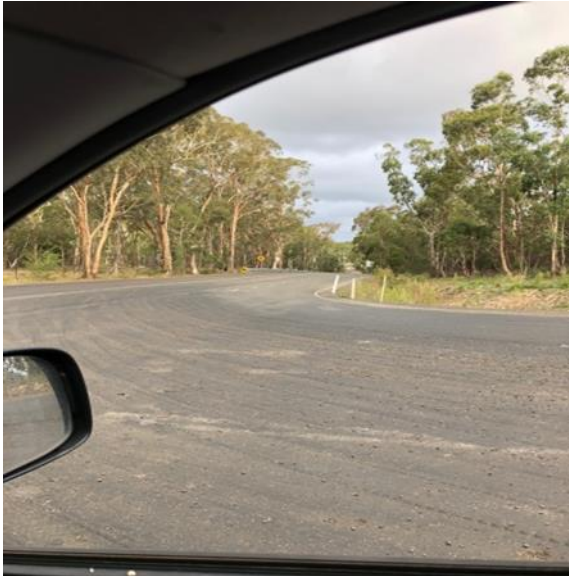
<p>The intersection linemarking is generally in poor conditions and turning lanes are missing painted turn arrows.</p> <p>This delineation assists in identifying the purpose of the additional lane. This may lead to through traffic incorrectly utilising this lane and could result in numerous crash types.</p>	Possible	Infrequent	Once every five to ten years	Low	Should be corrected at a suitable time, if cost is low.

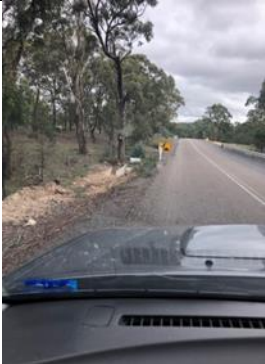
<p>Several curves and crests on this section have no advisory warning signage or chevron alignment markers (CAMS).</p> <p>This could result in run off road and hit object type crashes.</p>	Likely	Occasional	Once every one to five years	High	Should be corrected in the very near future, even if costs are high. Temporary mitigation measures should be considered until final correction action taken.
21

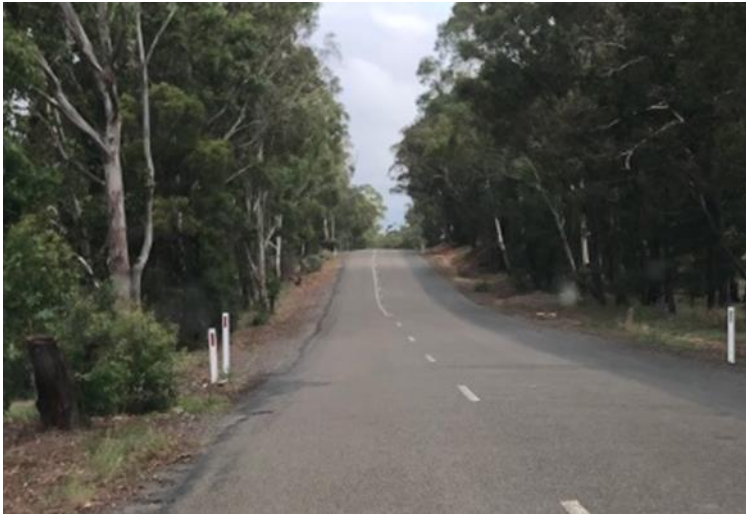
<p>There are lengths along this section with inconsistent and narrow lane widths. Some lanes are down to about 3.0m in places. The formation width allows for 2 x 3.5m lanes but the centreline has not be re-done, or done incorrectly after the shoulder widening has been completed.</p> <p>These narrow lanes increase the likelihood of sideswipe and head on accidents.</p>	Likely	Infrequent	Once every five to ten years	Medium	Should be corrected in the very near future, even if costs are moderate. A delay until the routine maintenance should be justified. Temporary mitigation measures should be considered until final correction action taken.

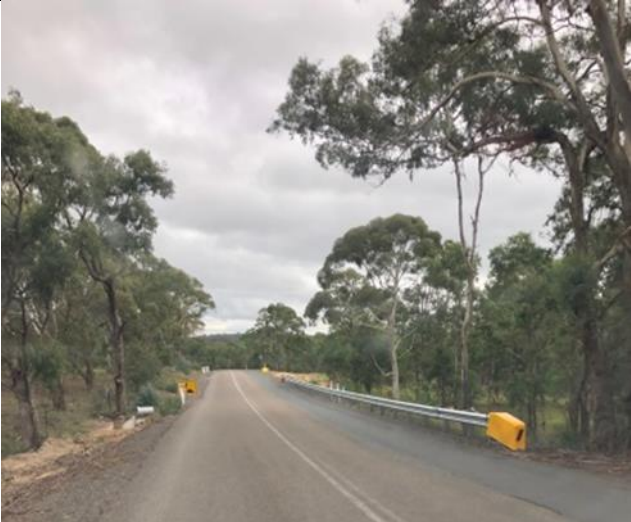
<p>Edgeline and raised reflective pavement markers (RRPM's) missing along this section.</p> <p>This limits a road user's ability to interpret the road alignment (particularly at night or in heavy fog) and could result in run-off road type crashes at high speed.</p>	Likely	Infrequent	Once every five to ten years	Medium	Should be corrected in the very near future, even if costs are moderate. A delay until the routine maintenance should be justified. Temporary mitigation measures should be considered until final correction action taken.

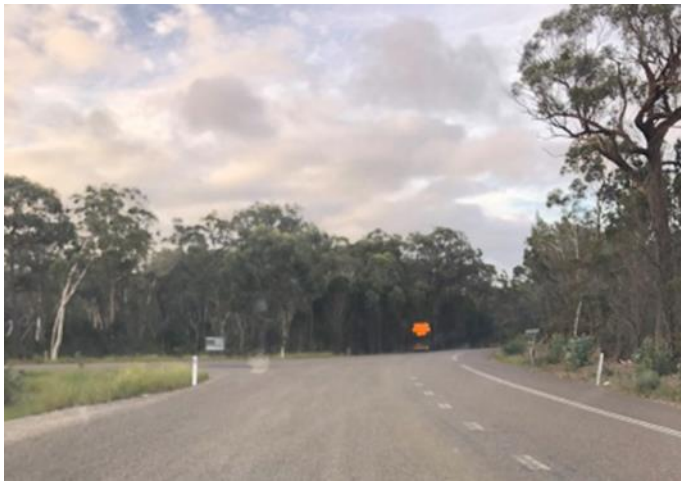
<p>Fisher Road intersection has a large uncontrolled area located adjacent to the turning lane.</p> <p>This area is not defined and could be used as a parking/pullover area.</p> <p>There may be a conflict between turning vehicles and vehicles using this area to pull over.</p>	Possible	Infrequent	Once every five to ten years	Low	Should be corrected at a suitable time, if cost is low.
Section 5 - Jerrara Road Work zone								
27	4.0km	This area was too dangerous to safely pull over to take photograph.	<p>There is a length on a back of the curve where:</p> <ul style="list-style-type: none"> - Embankments are steep (non-traversable/recoverable) - no curve advisory or chevron alignment markers (CAMS) - narrow lanes. <p>This could result in rollover and run-off road hit object type crashes.</p>	Very Likely	Infrequent	Once every five to ten years	High	Should be corrected in the very near future, even if costs are high. Temporary mitigation measures should be considered until final correction action taken.

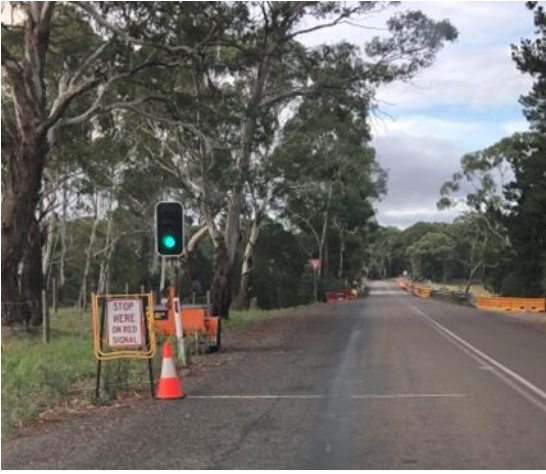
<p>In some locations the signage conflicts the traffic control. In one location the temporary signals and stop sign were present but a Give-Way sign was also located further into the work zone.</p> <p>This could lead to vehicles entering controlled areas of the work zone when not permitted causes head on type accidents or endangering workers.</p>	Likely	Infrequent	Once every five to ten years	Medium	Should be corrected in the very near future, even if costs are moderate. A delay until the routine maintenance should be justified. Temporary mitigation measures should be considered until final correction action taken.
32	9.5km

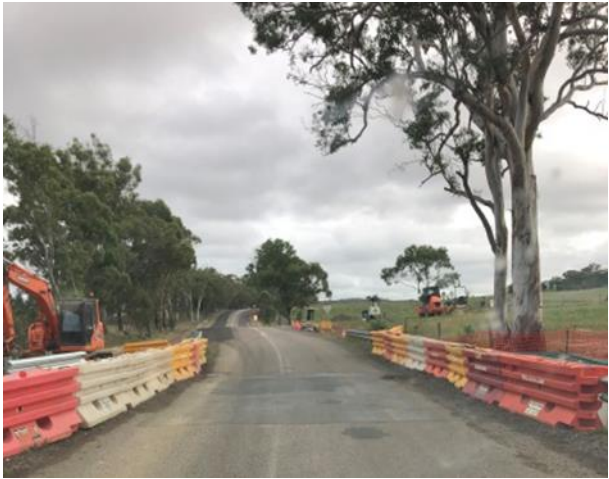
<p>Drainage structure currently under construction without any traffic control. The road width in this locations is about 4-5m which does not allow vehicles to pass. This is inconsistent with other areas of a similar work which are controlled under stop/go or temporary signals. This issues was excentuated at night.</p> <p>This could cause head on type accidents.</p>	Very Likely	Occasional	Once every one to five years	Intolerable	Must be corrected immediately

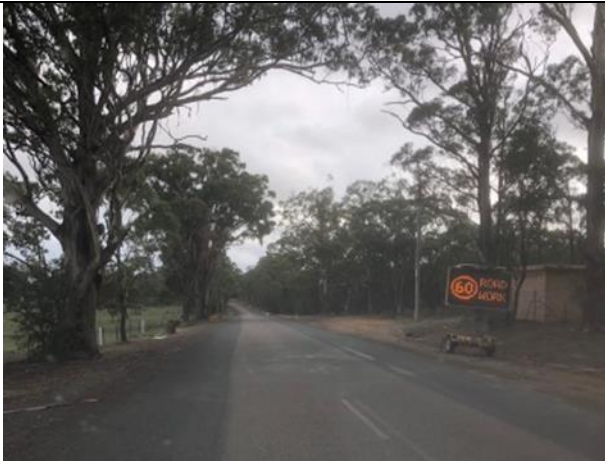
<p>Centreline scrubbed out and not clearly visible.</p> <p>This could lead to vehicles encroaching into oncoming lanes or overtaking in unsuitable locations.</p>	Likely	Rare	Less than once every ten years	Low	Should be corrected at a suitable time, if cost is low.
34

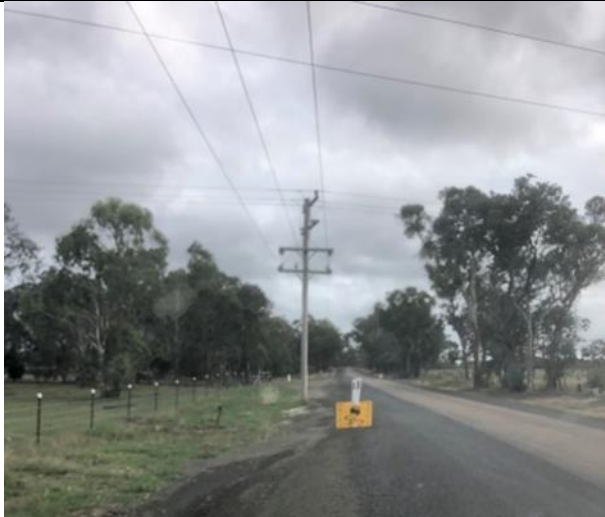
<p>Power poles located within the clearzone, approximately 2.0m from edgeline.</p> <p>This could cause run off road hit object type crashes.</p>	Likely	Infrequent	Once every five to ten years	Medium	Should be corrected in the very near future, even if costs are moderate. A delay until the routine maintenance should be justified. Temporary mitigation measures should be considered until final correction action taken.

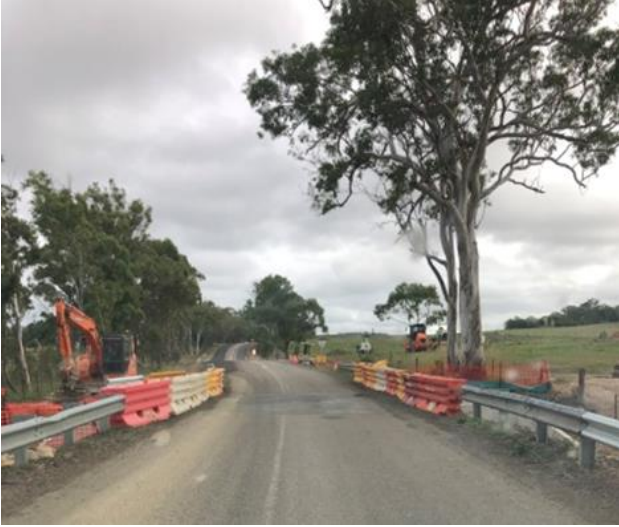
<p>Temporary water filled barriers not filled with water.</p> <p>This barrier doesn't not serve any protection for workers and can allow serious injury if vehicle were to hit the barrier while workers are present.</p>	Very Likely	Infrequent	Once every five to ten years	High	Should be corrected in the very near future, even if costs are high. Temporary mitigation measures should be considered until final correction action taken.
36			<p>Reduced sight distance on approach to some temporary traffic signals.</p> <p>This could cause rear end accidents and vehicles entering the work zone under red light conditions.</p>	Very Likely	Infrequent	Once every five to ten years	High	Should be corrected in the very near future, even if costs are high. Temporary mitigation measures should be considered until final correction action taken.

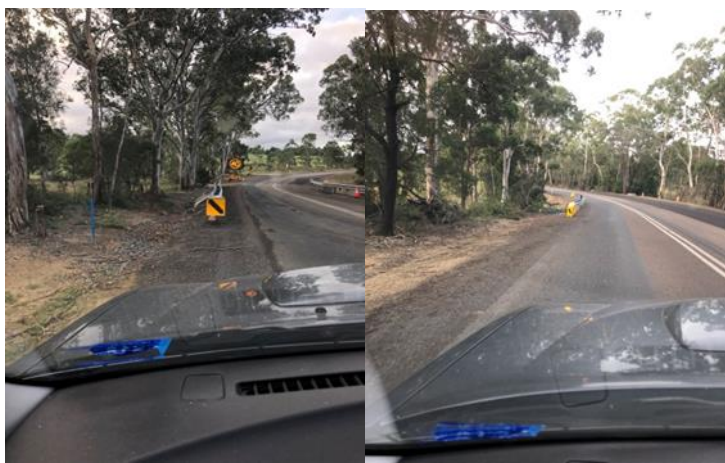
<p>Several lengths of new barrier are not long enough to protect the entire hazard and required run out angles.</p> <p>This could result in run off road and hit object type crashes.</p>	Possible	Occasional	Once every one to five years	Medium	Should be corrected in the very near future, even if costs are moderate. A delay until the routine maintenance should be justified. Temporary mitigation measures should be considered until final correction action taken.

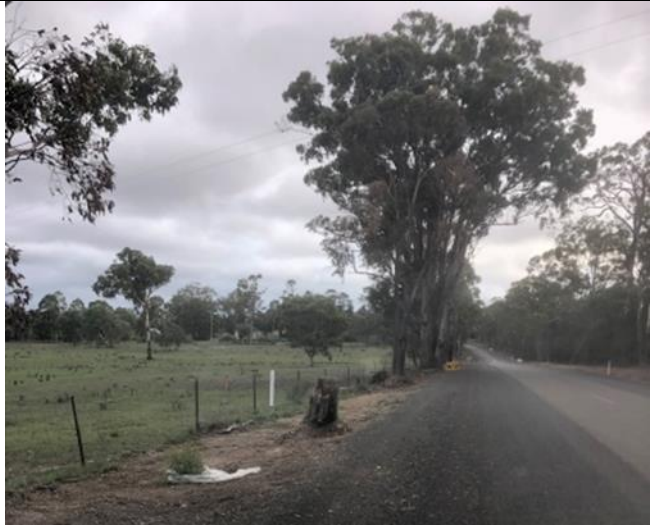
<p>Several trees along this length have been cut down but the stumps remain within the clearzone</p> <p>This could result in a run-off road hit object type crash at high speed.</p>	Likely	Infrequent	Once every five to ten years	Medium	<p>Should be corrected in the very near future, even if costs are moderate. A delay until the routine maintenance should be justified. Temporary mitigation measures should be considered until final correction action taken.</p>
