Ardmore Park Quarry – Modification 3

## Post Construction Phase Road Safety Audit of the Product Delivery Route

## ROAD SAFETY AUDIT OF EXISTING ROAD

### ARDMORE PARK QUARRY

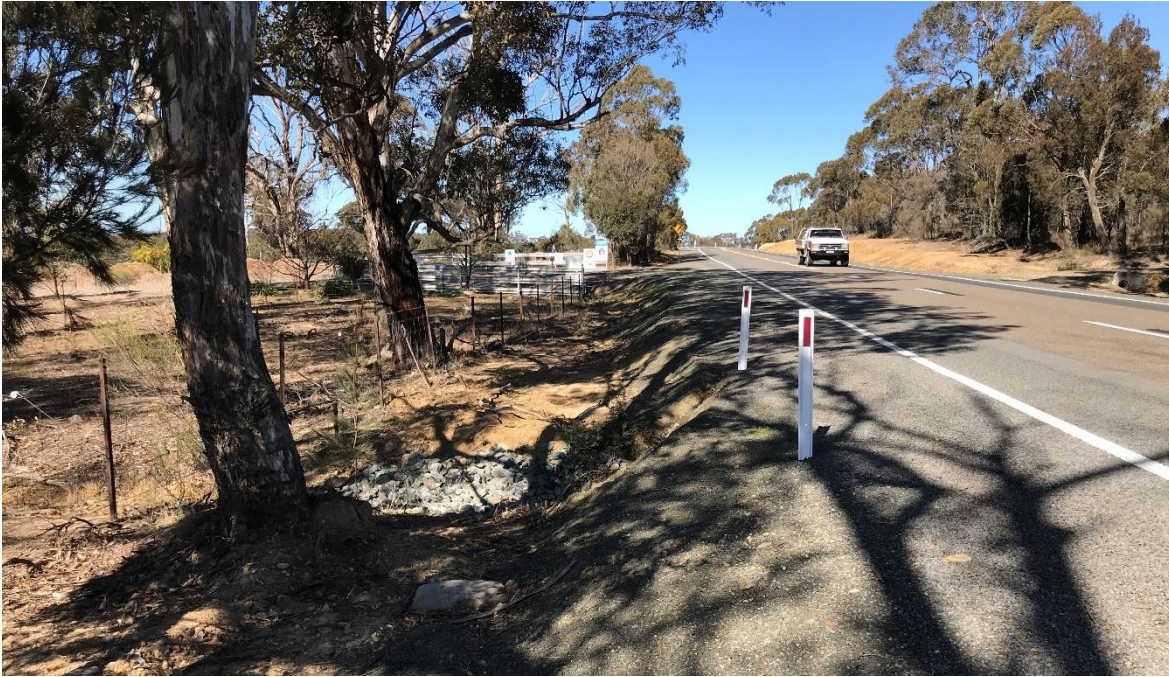
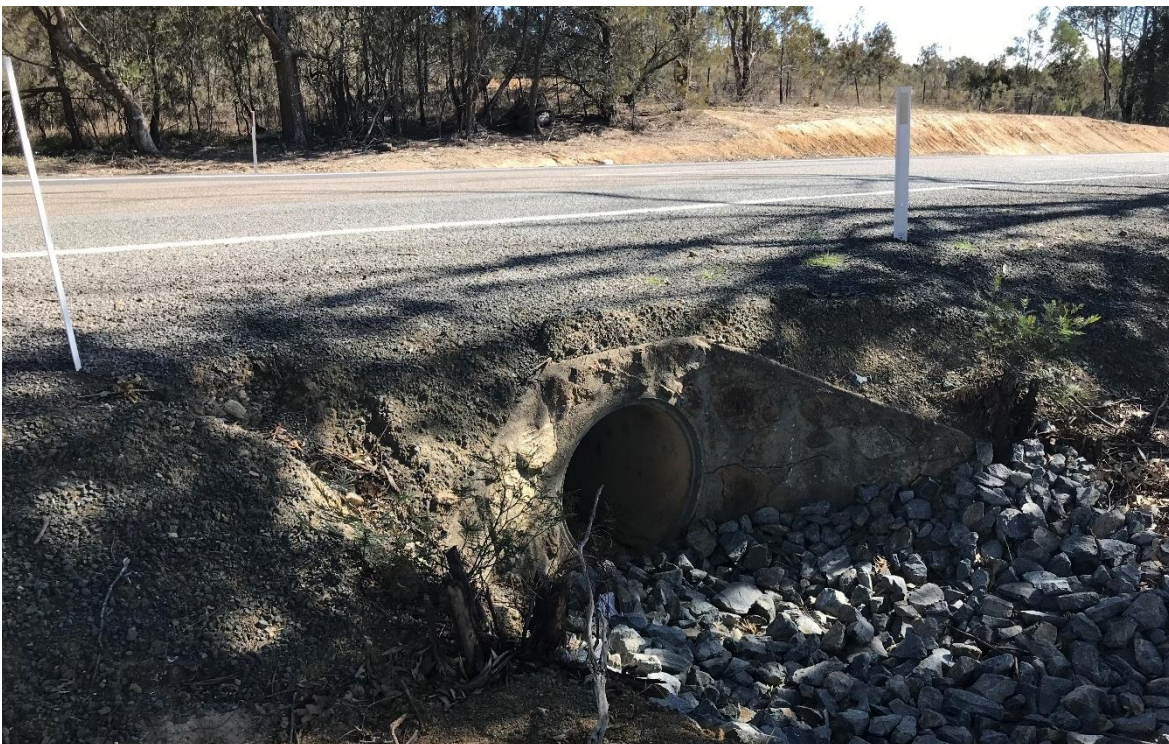
Item 1

Item	Location on road	Issue	Risk Ranking	Response by Audit Manager
1	CH.1500	Steep unprotected batter and headwall on southbound approach to driveway (Gate 157/159) Combination of drop off around culvert and driveway approach increases risk with vehicles pulling towards the shoulder on approach to the driveway, particularly in night conditions.	Medium	
2	CH.3980, CH.4140 and CH.4250	Sections of guardrail protecting electrical poles in the clear zone (southbound) are approximately 8-12m in length, which is below the minimum standard length. The guardrail will not provide adequate protection in the event of a run-off road accident.	Medium	
3	CH.4710 to CH.4830	Chevron alignment markers are located on southbound approach to the curve (northern side of the driveway Gate 481) Markers should be extended further past the driveway to complete the curve.	Low	
4	CH.10550	Chevron alignment markers are located on northbound approach to the curve. Markers should be extended further to complete the curve.	Low

Steep unprotected batter/headwall on southbound approach to driveway (Gate 157/159)

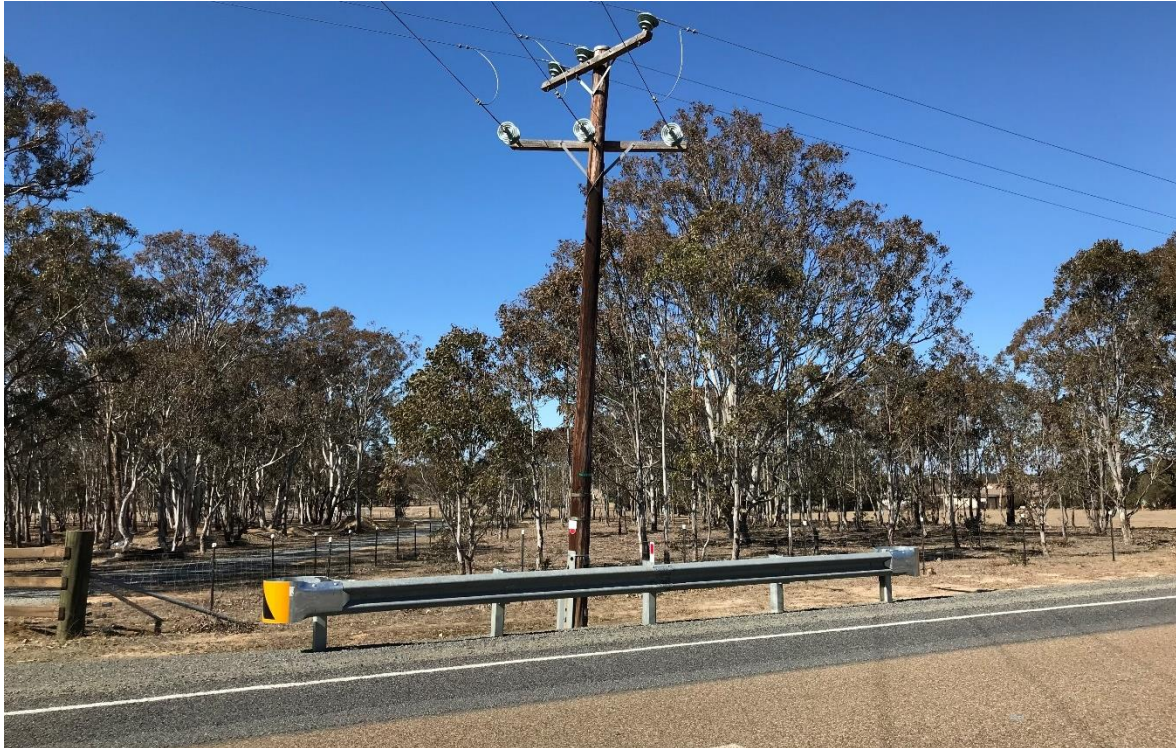
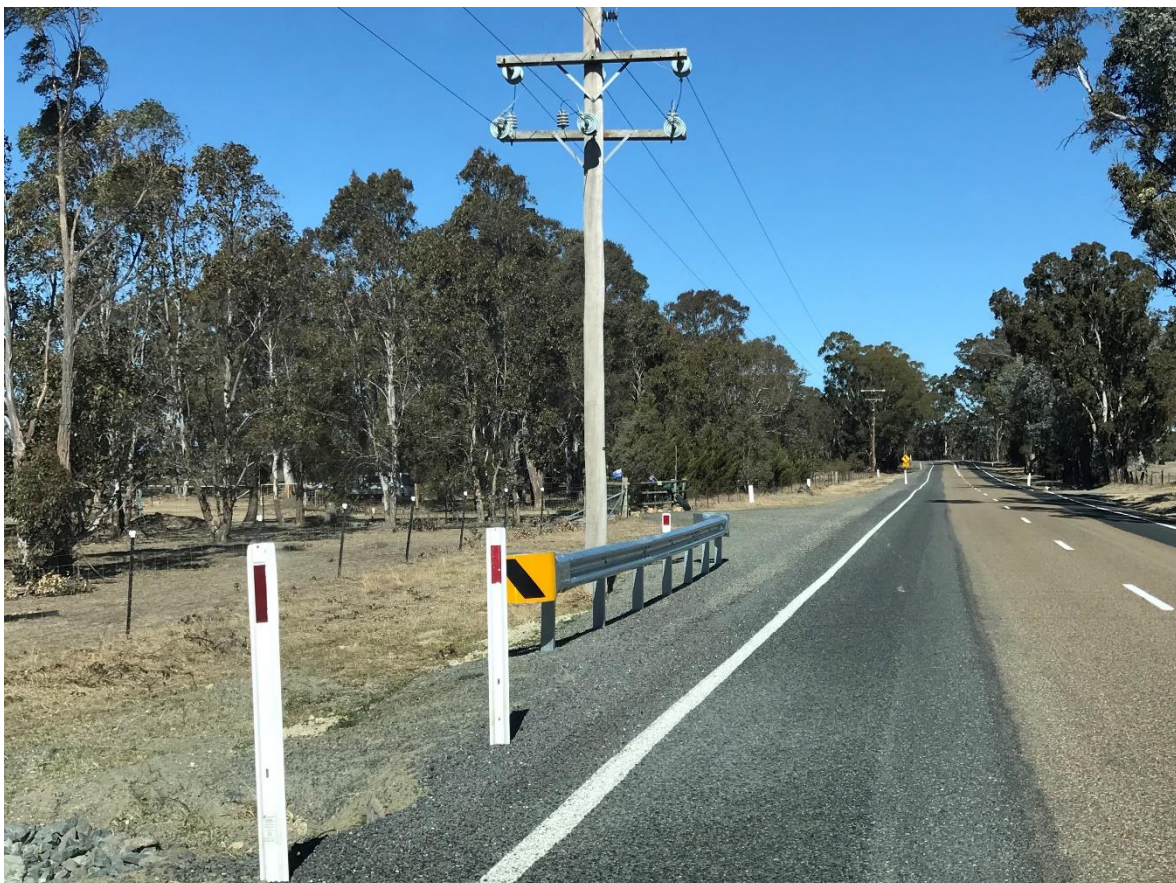
Item 2

- Guardrail has been used in 3 locations to protect roadside poles in the clear zone. The length of guardrail provided is less than the minimum length required to provide effective protection from the roadside hazard.

Sections of guardrail protecting electrical poles in the clear zone

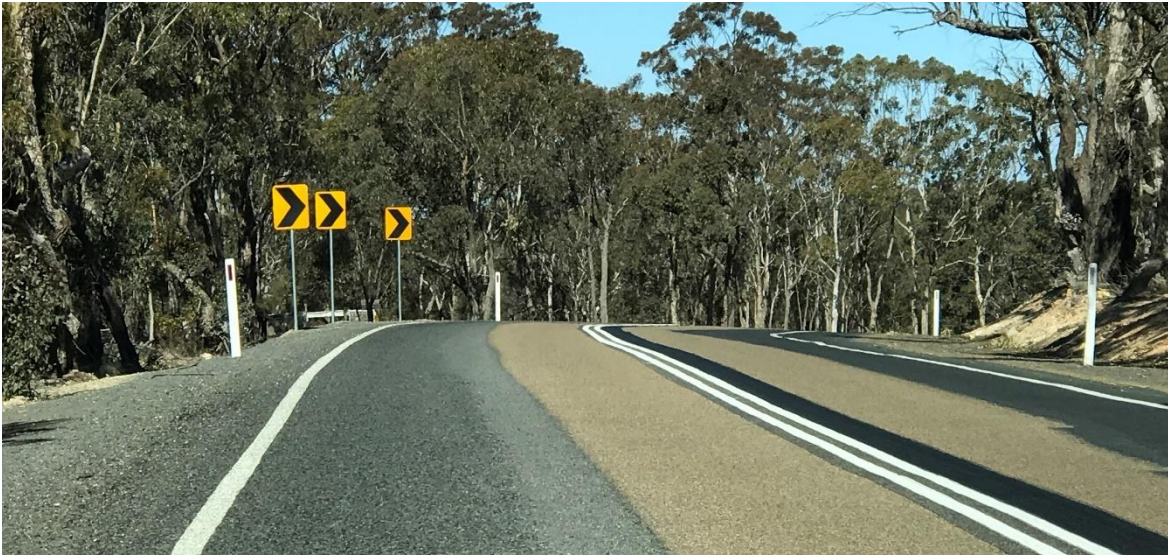
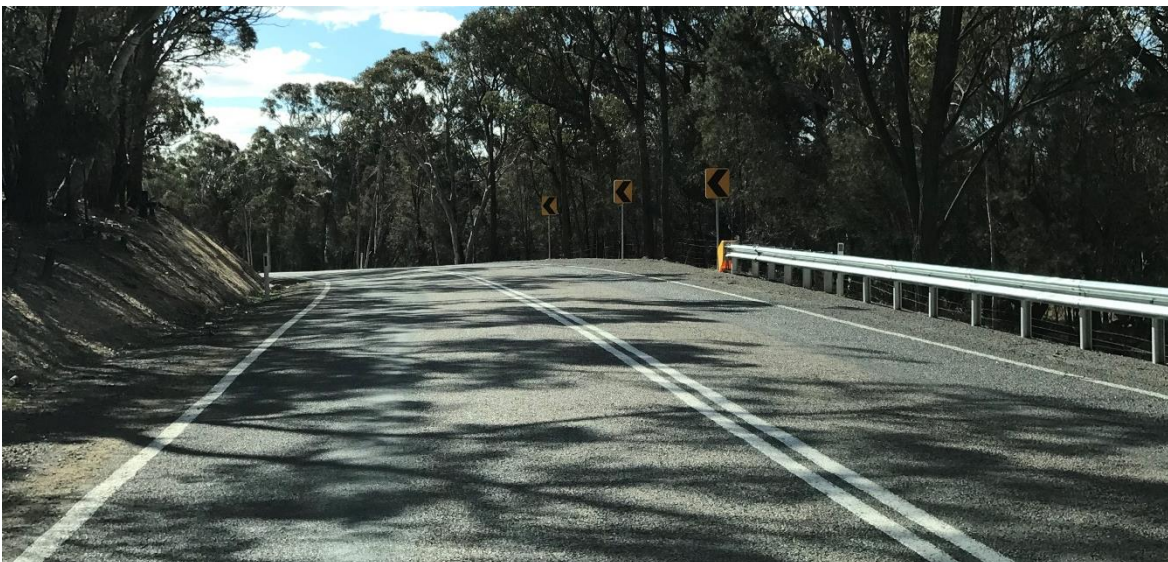
Items 3 and 4

Chevron alignment markers should be extended further to complete the curve.

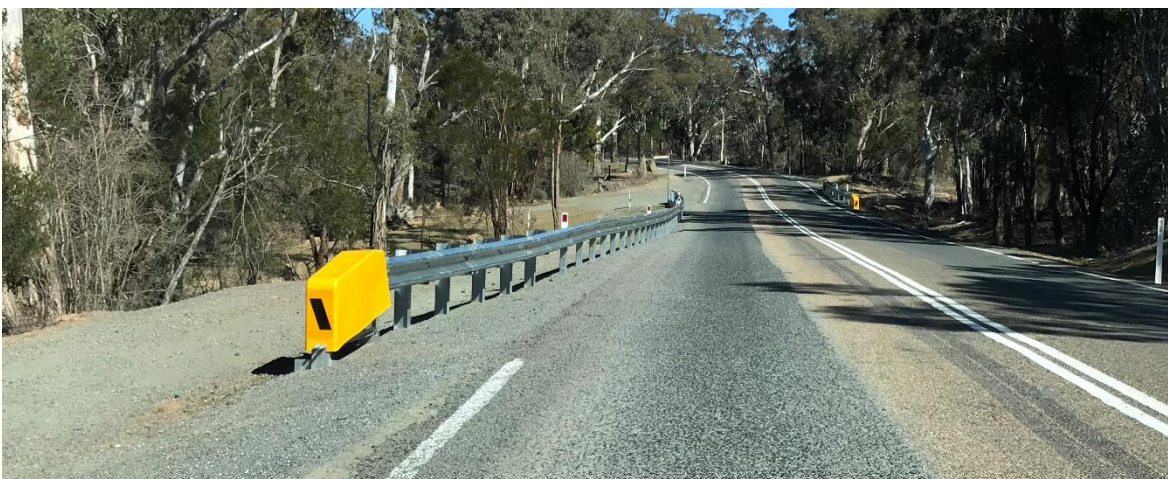
Item 5

5	CH.13660	Edgeline missing on southbound carriageway of Water Course Crossing	Low	
6	CH.14200 to CH.14640	Vehicle skid marks were observed on the southbound approach of Jerrara Road at the intersection with Mountain Ash Road. The approach is on a downhill grade with reverse curves. a. T-intersection warning signage (W2-3) is provided approximately 250m before the intersection at CH.14370. Consider replacing existing W2-3 signage with W2-12 (Reduce Speed, T-intersection 250m Ahead) b. Consider providing chevron alignment markers on curve in road alignment approximate CH.14460 to CH.14520.	Medium

Edgeline missing on southbound carriageway of Water Course Crossing

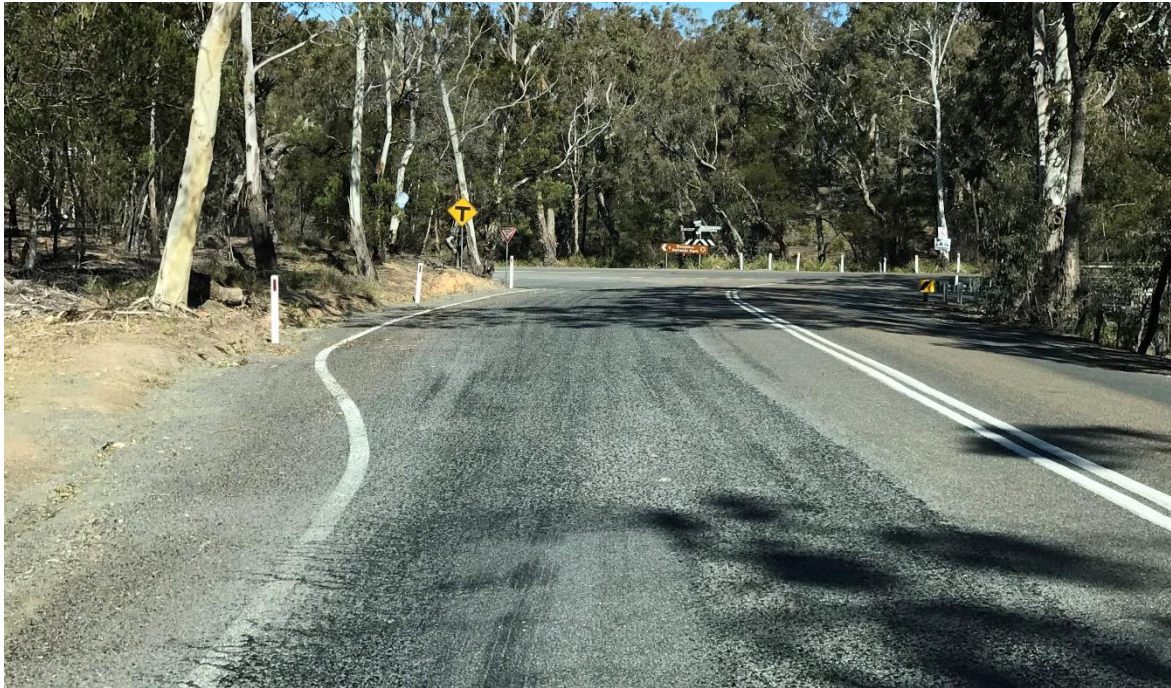
**Item 6**

Vehicle skid marks were observed on the southbound approach of the intersection

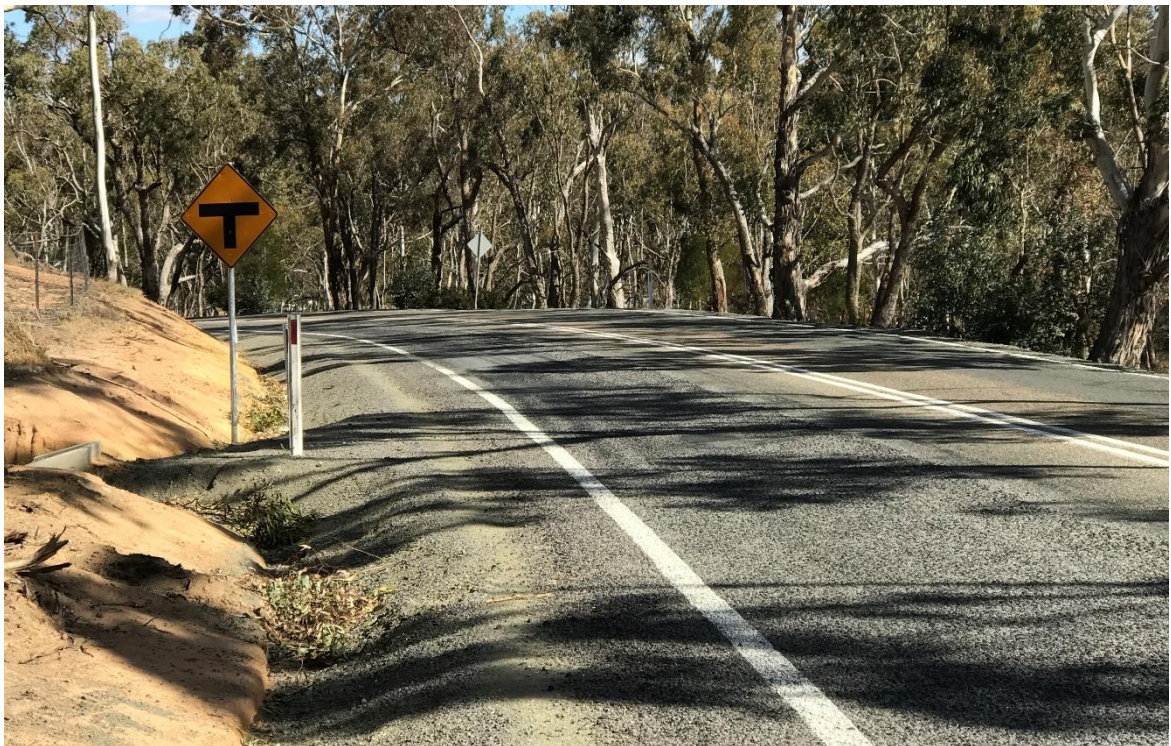
Consider providing chevron alignment markers on curve in road alignment and replacing existing warning signage

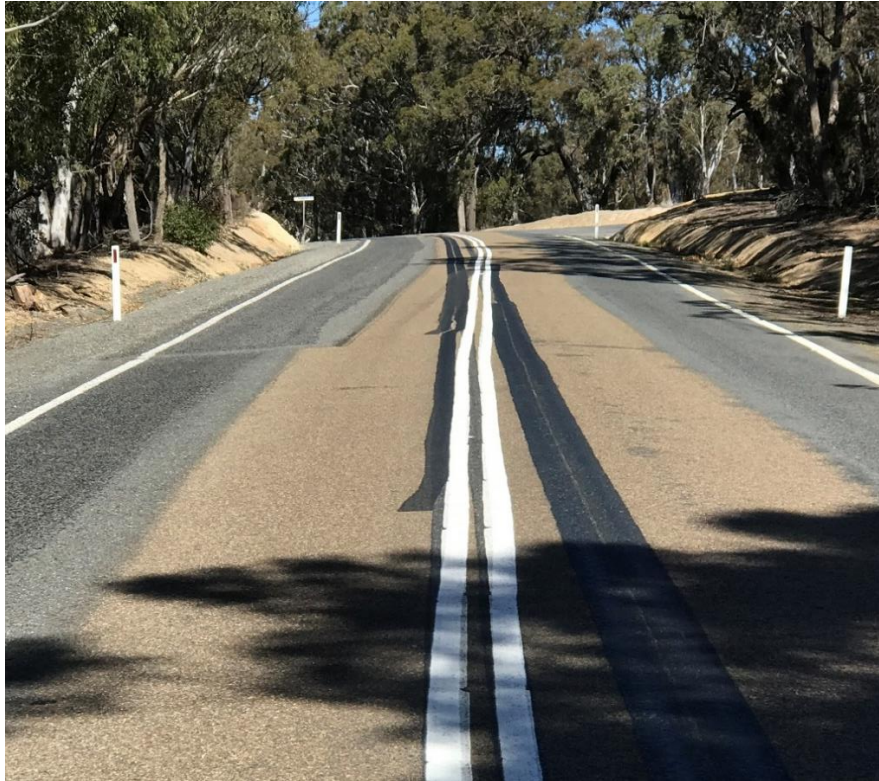
**Item 8**

Blacking out of redundant centerline markings is not effective and confusing when crossing over new centerline markings

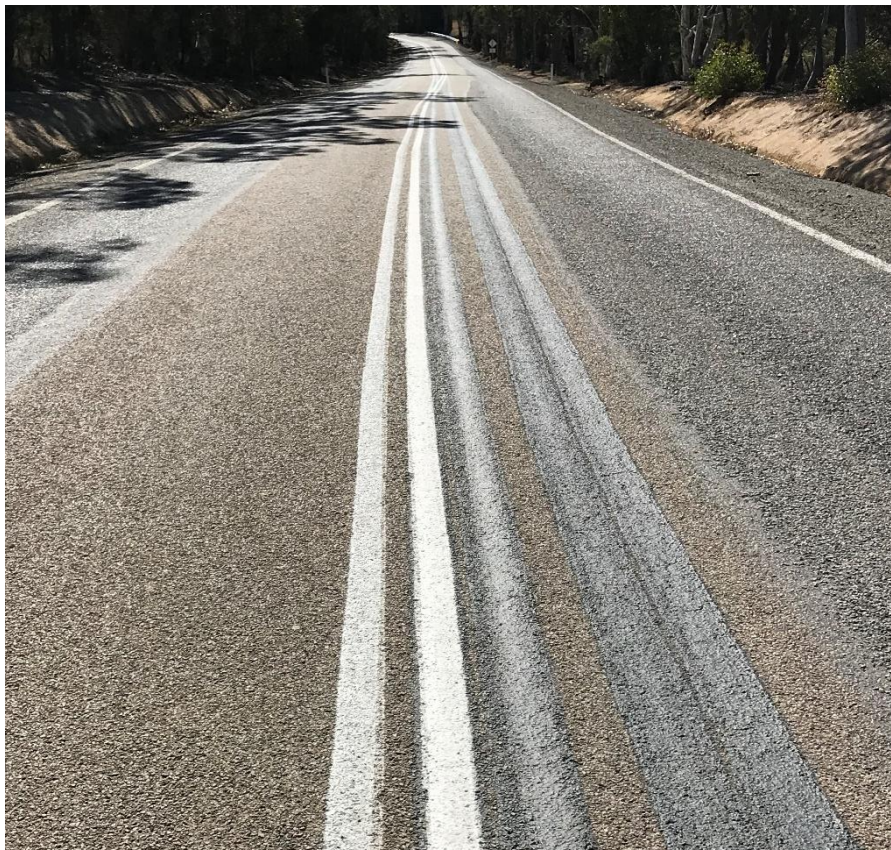
Blacking out of redundant centerline markings is not effective with sunlight reflection

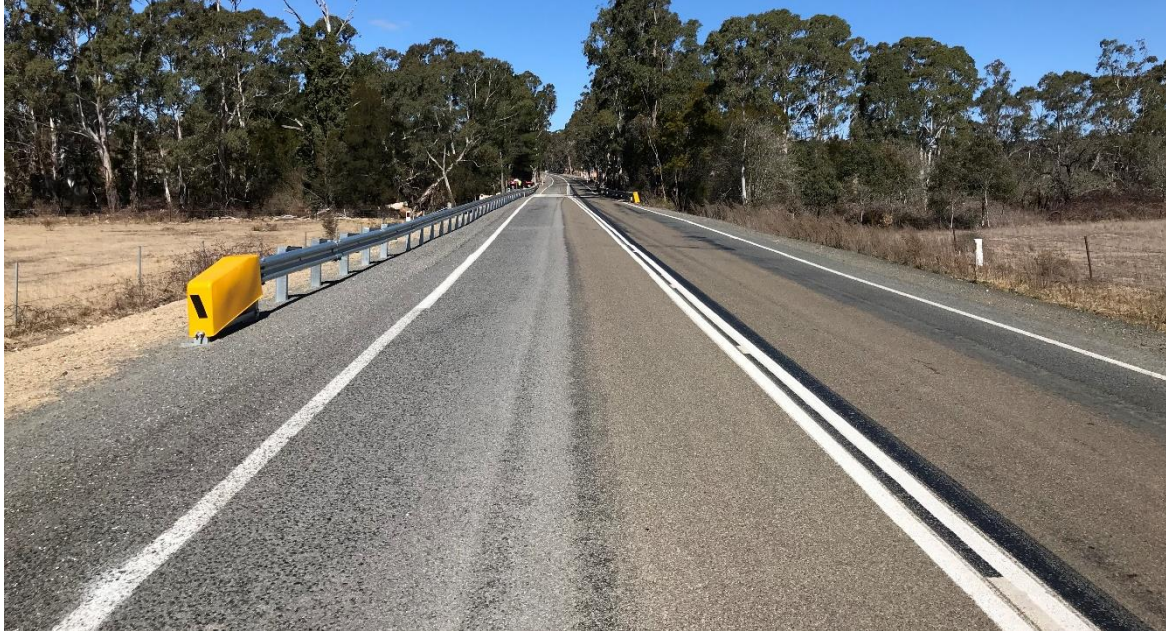
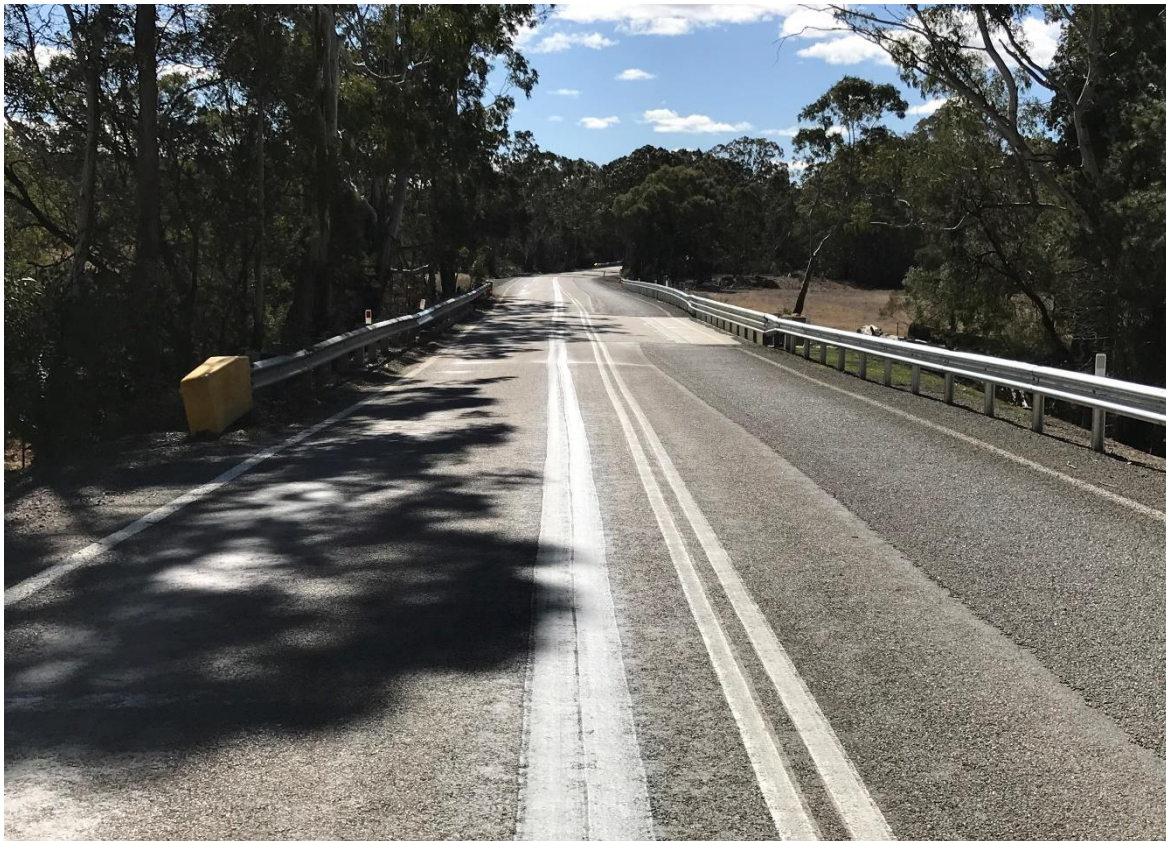
**Item 9**

Water Course Crossings are generally located on near straight road alignments with good lengths of guardrail and edgelines on all approaches.

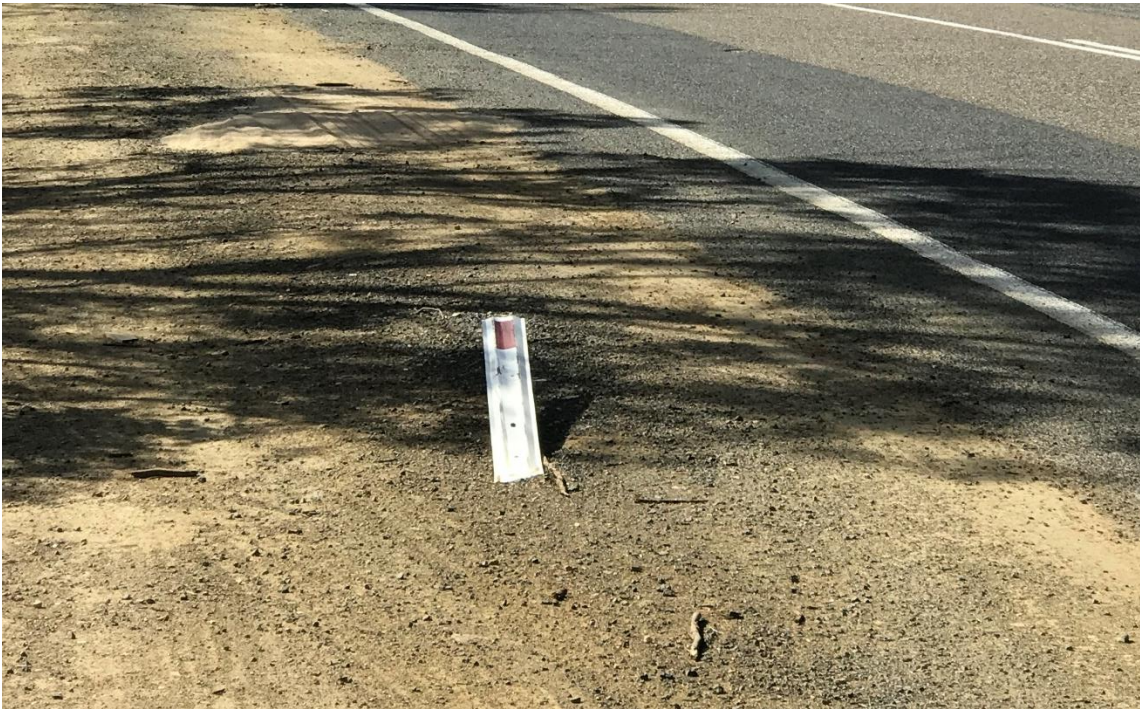
**Item 10**

A number of reflectorised guideposts were observed to be damaged or flattened

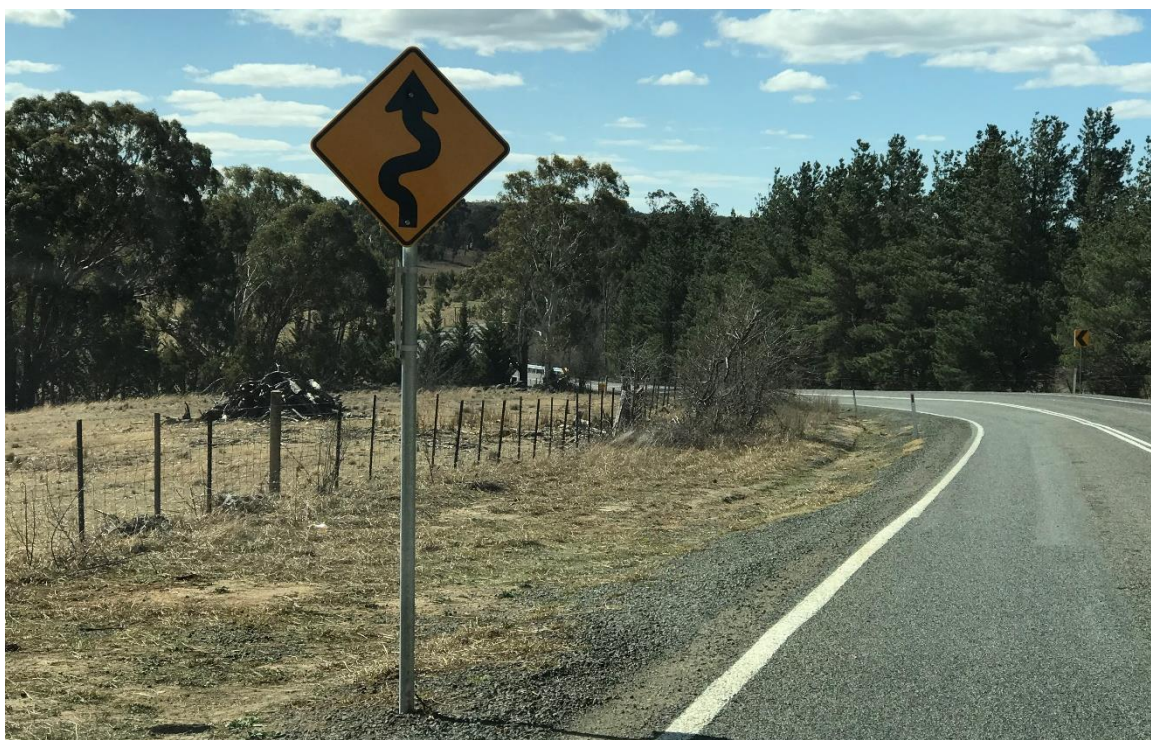
Item 8

7	Various locations	Supplementary Speed Advisory signs below warning signs have been twisted and are not visible to approaching vehicles	Low	
8	Intersections	Give Way (TB) and Stop Line (TF) markings at intersections are worn. Ensure regular maintenance program is in place to replace worn linemarking.	Low

Supplementary Speed Advisory signs below warning signs have been twisted and are not visible to approaching vehicles
