Annual Environmental Review

Ardmore Park Quarry Project

For the period 21st August 2018 – 20th August 2019

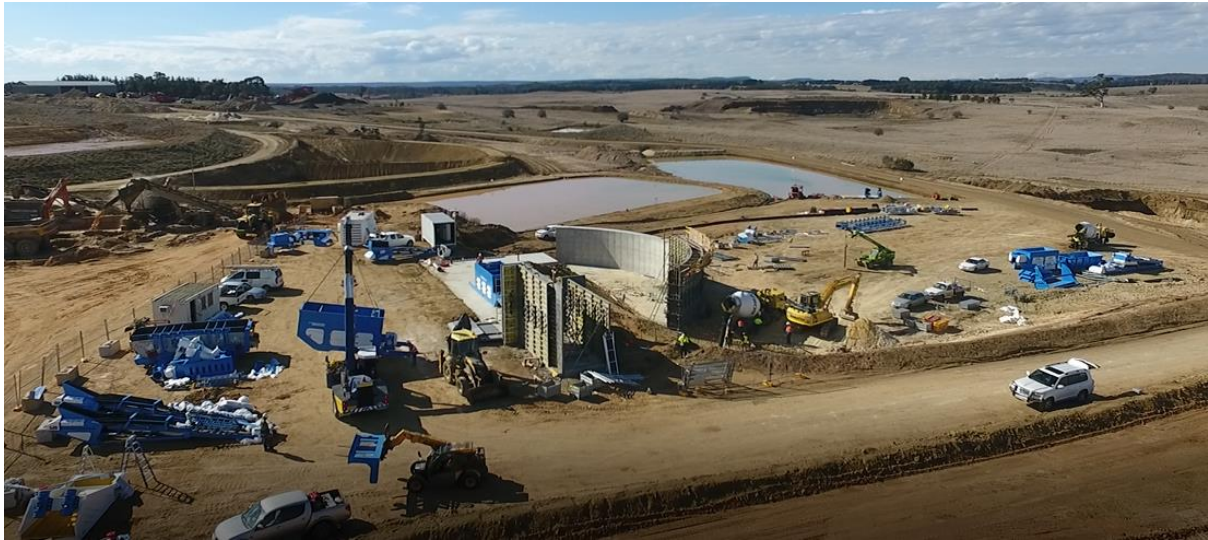
Figure 4 - Early stages of site preparation and plant installation

The 2018 reporting year saw the commissioning of the sand wash plant on site. The model installed was an M4500 manufactured by CDE. The plant was delivered to site in August of 2018 and was fully operational by the conclusion of the calendar year.

Figures 4 and 5 show two, progressive stages of construction of the sand plant in September of 2018.

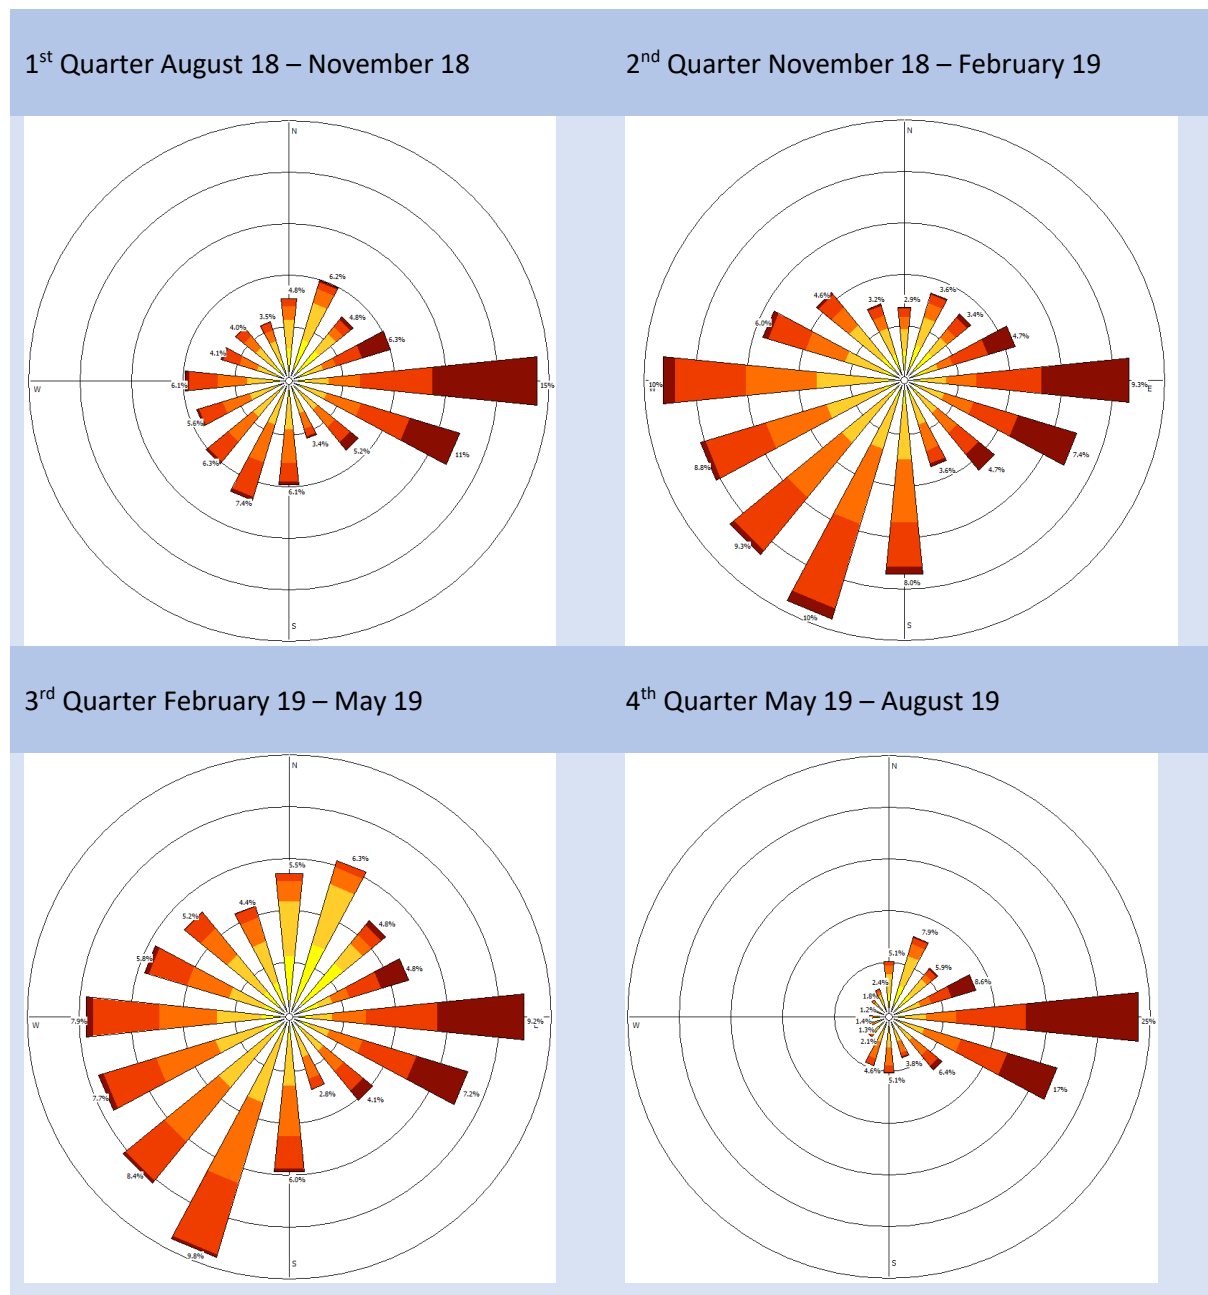
Figure 9: Quarterly wind roses

Wind conditions at Bungonia during the reporting year were varied. Strong winds are more frequent during winter months and reached speeds of 90-100km/hr. Dominant winds were westerlies, particularly in winter, however significant variation in wind direction occurred in summer and autumn.

A key to the colour bands (describing windspeed) in each wind rose is presented in Table 7.

Colour	Windspeed
Dark Red	>25km/hr
Red	15 < 25 km/hr
Orange	10 < 15 km/hr
Yellow-Orange	5 < 10 km/hr
Yellow	2 < 5 km/hr
Light Yellow	0.5 < 2 km/hr
White	< 0.5 km/hr

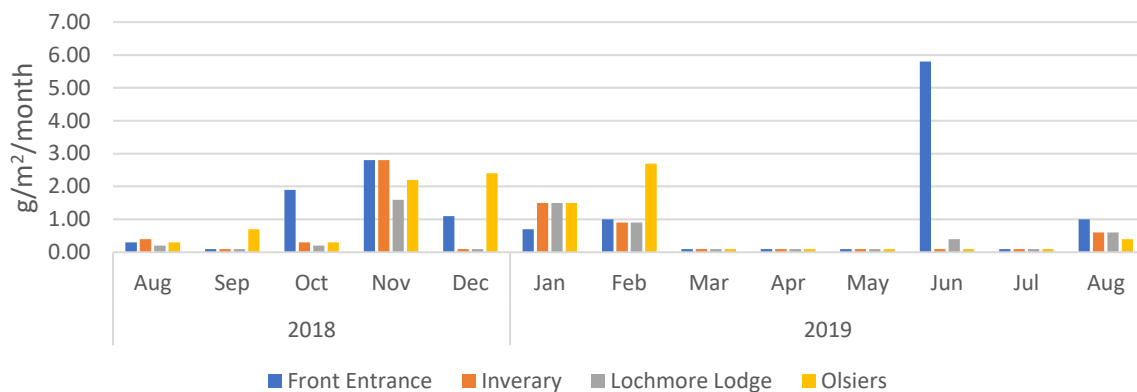
Figure 10 – Ash

The monthly deposited dust measured by each monitor as measured by the ash and insoluble solids fraction of each sample is presented in Figures 10 and 11.

The short-term criteria for the project was exceeded by monitor 4 (Front Entrance) in the month of June 2019. Given this result was highly anomalous to both other monitors in June and to the results of preceding and following months in monitor 4, this result was not considered indicative of a failure to comply with the project’s monitoring criteria and was discounted as an outlier.

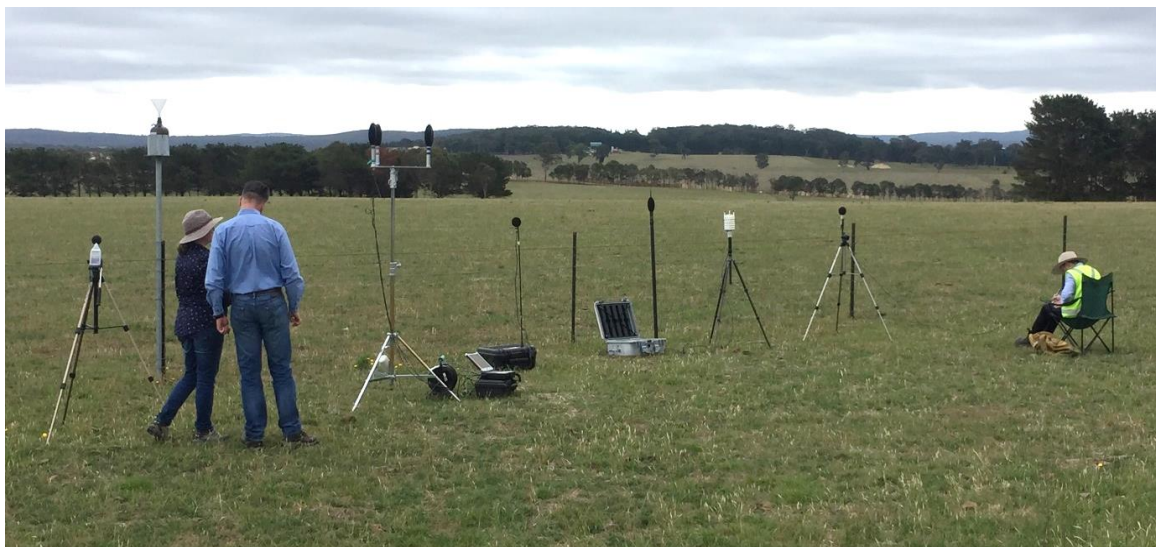
Figure 12 – Attended noise survey on 5th December 2018

No exceedance of the performance criteria was recorded on the quarry site or at surrounding sensitive receivers during monitoring. Results demonstrated comfortable compliance with the noise performance criteria of the quarry. This led the EPA to conclude the PRP without recommending any changes to operating plant or procedures on site. During the reporting year, the EPA updated EPL 13213, removing the requirement to conduct further noise monitoring as part of the PRP. This notwithstanding, Multiquip will continue to conduct attended noise surveys on an ongoing basis to assessment compliance.

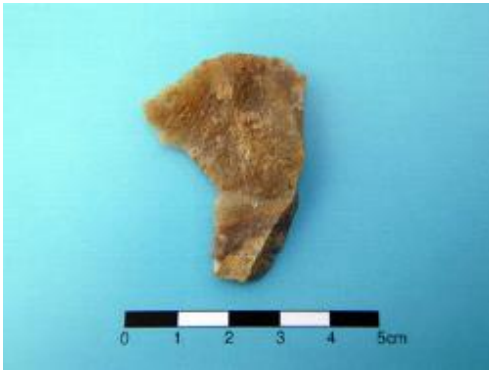
Figure 14: Quartzite flake artefact

The five artefacts recovered were all single piece stone fragments varying in size from 1cm across to 5cm. A photo of one typical recovered artefact is shown in Figure 14.

None of the recovered artefacts were considered archaeologically significant, nor did the density of finds discovered differ from what typical background scatter of the local area (OzArk Environmental and Heritage Management, 2018). None of the sites assessed demonstrated archaeological stratigraphy or hearths. Consequently, OzArk concluded that “the findings are assessed to have a very low scientific significance due to their inability to meaningfully add to our understanding of past Aboriginal occupation and use of the area” (OzArk Environmental and Heritage Management, 2018).
