**Ardmore Park Quarry**

# Annual Environmental Review

**21<sup>st</sup> August 2019 - 31<sup>st</sup> December 2020**

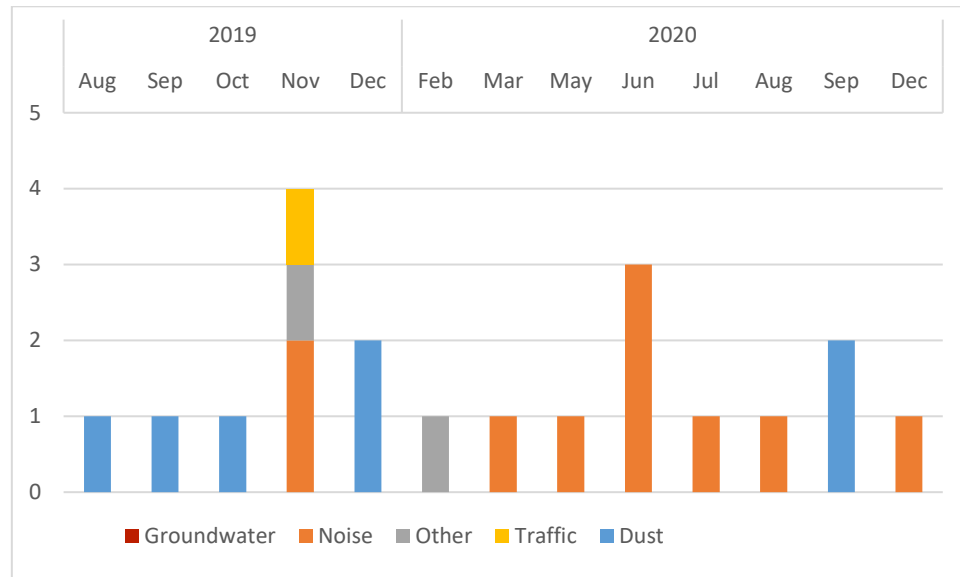
Figure 8: Complaints received during reporting year

Twenty complaints were received by Multiquip during the reporting year. Seven of these complaints related to dust emissions, ten related to noise, one for traffic and two related to issues that were not definitively related to quarry operations. Complaints are recorded in an electronic register, with details of the complainant, date, time, method of delivery, the Multiquip contact who received the complaint, the subject of the complaint, information on corrective actions and additional comments are noted.
