# Visual Impact Assessment

CEAL Limited trading as Multiquip Quarries

5152 Oallen Ford Road, Bungonia NSW 2580

March 2021

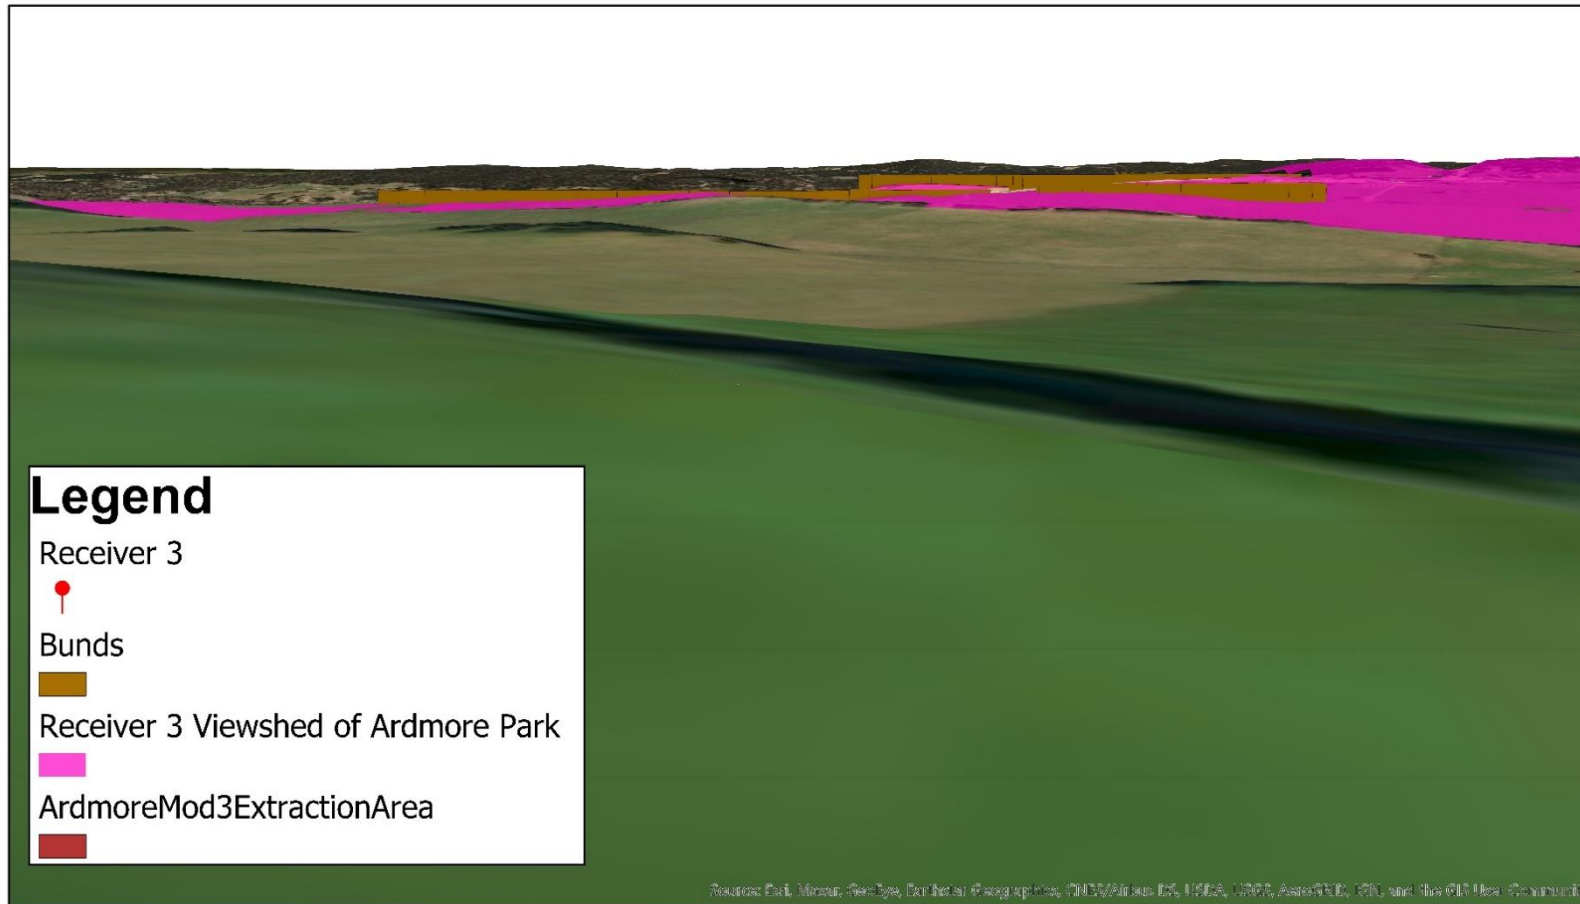
Figure 3: Three-dimensional modelling of proposed eastern visual amenity bund

Three-dimensional modelling of the proposed bunding from Receiver 3's vantage point has been undertaken to assess the adequacy of the specifications for proposed visual amenity bunding. At the time of writing, it is understood that the construction of this bunding has commenced. The outcome of three-dimensional modelling has found that Receiver 3 would still experience a minor degree of visibility to the extraction area if the visual amenity bunding was lower than 3m in height.

- Construction of visual amenity bunding on the eastern side of the quarry extraction area between 3.5 to 4.5m high;
- Planting additional vegetation at Receiver 4 to screen distant view of the waste dewatering area; and
- Establishment of vegetation to serve as a visibility screening at the Quarry premises on the western side of the waste dewatering area.

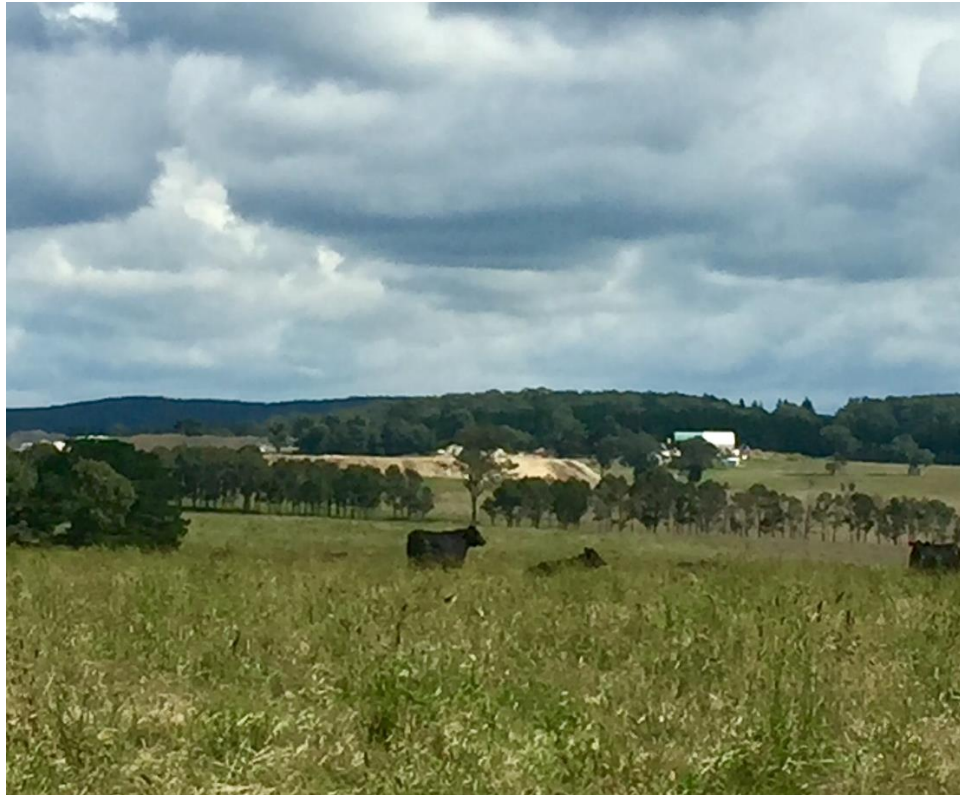
Figure 5: Photograph of view from Receiver 3 (facing west)

Figure 1 demonstrates points of visibility at Receiver 3. Receiver 3 has a medium to distant view of the extraction area when facing west (additional photograph of line of sight provided in Figure 5). The viewshed analysis presented in Figure 2 indicates that a section of the eastern portion of the Quarry is visible to Receiver 4. This area is currently utilised for materials storage and dewatering, part of which can be observed at Receiver 3 when facing north east (Refer to Figure 6 for photograph).

Receiver 3 is deemed to be affected by a **low-moderate** level of visual impact. Receiver 3 has a long-range view of the Quarry when looking directly west from their property. Receiver 3 is oriented in a position that observers from this location are likely to experience moderate visibility of the quarry due to the elevation of the property in relation to the quarry. The existing topography between the receiver and the site consists of rolling ridges, covered mostly by grassland. The construction of vegetated visual amenity bunding between approximately 3.5 to 4.5m in height is deemed appropriate to mitigate the level of visual impact. It is expected that during the construction of visual amenity bunding, Receiver 3 will experience a short-term impact on visual amenity, however, following the establishment of vegetated visual amenity bunding, the degree of visibility the quarry will be adequately mitigated.

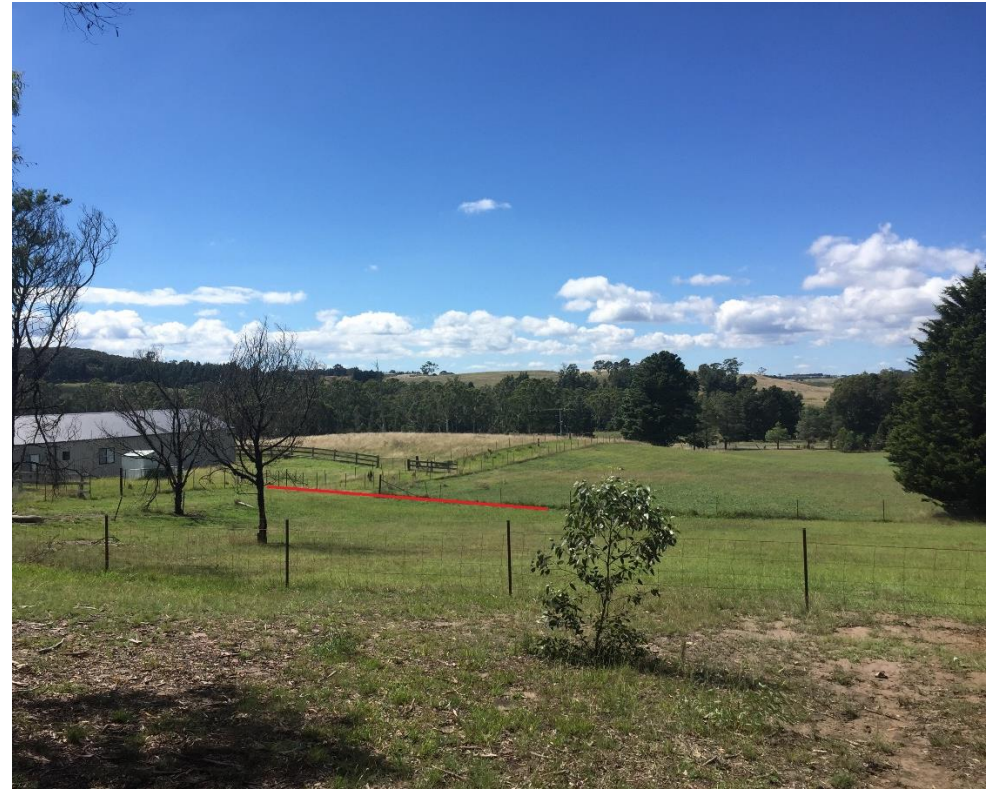
Figure 6: Photograph of view from Receiver 4 (facing north east)

The viewpoint at Receiver 4 is deemed to experience a **moderate** level of visual impact. This receiver has a long-range view to the designated dewatering area of the Quarry where materials are stockpiled on an ongoing basis. The reddish clay waste is stockpiled at an elevated location in relation to the receiver. Due to the colour contrast between the waste material and surrounding vegetation, observers will tend to notice the presence of the Quarry at Receiver 4. The horizon upon which the quarry is located is largely vegetated, however a small gap in vegetation exists providing a clear line of sight from the viewpoint of Receiver 4. The level of visibility of the Quarry is expected to be adequately mitigated with

<b>Captured by:</b>	TN	<b>Report reference:</b> 2021MUL – Visual Impact Assessment	<b>Key:</b>	Red line: denotes recommended location of visual amenity vegetation at Receiver 4.
<b>Date:</b>	24/03/21	<b>Image source:</b> 4Pillars Environmental Consulting

the planting of visual amenity screening vegetation. It is recommended that vegetation be planted at Receiver 4's premises, at the location denoted by the red line in Figure 6. Further to this, vegetation should be planted adjacent and as close to the waste dewatering area as practicality allows. Vegetation should be a mix of densely growing shrub and trees which grow to approximately 15m at maturity. It is recommended that the planting of vegetation starts at the western corner of the dewatering area (Coordinates: -34.898627, 149.947677), extending due north in a linear arrangement for a minimum of approximately 75m.
