Ardmore Park Quarry – Modification 3
Engineering Assessment of
the Culverts and Bridges on
the Product Delivery Route

Bridge Designs Pty Ltd

B1833-R-01

Bungonia Culverts - Engineering Assessment

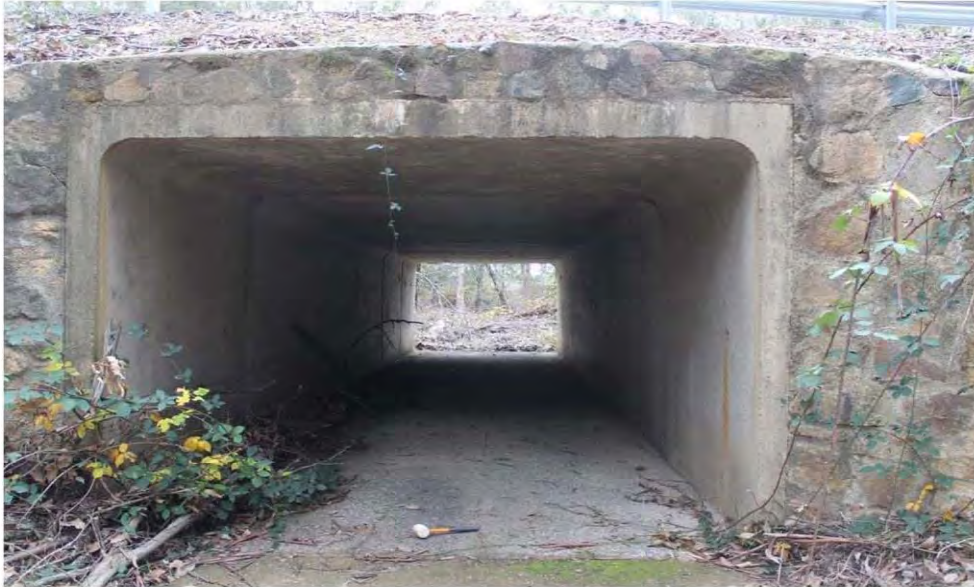
View of culvert from western side

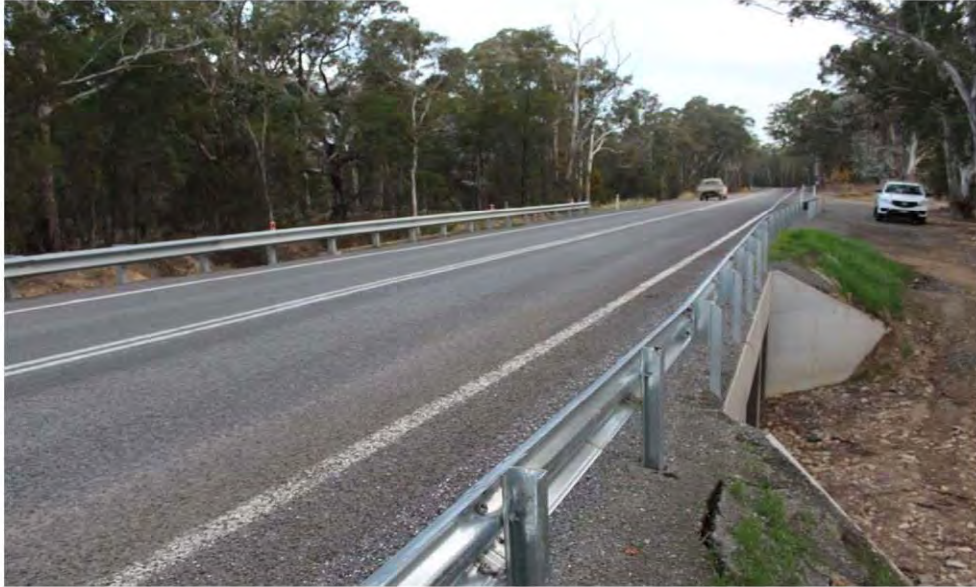
Culvert from road level (facing south)

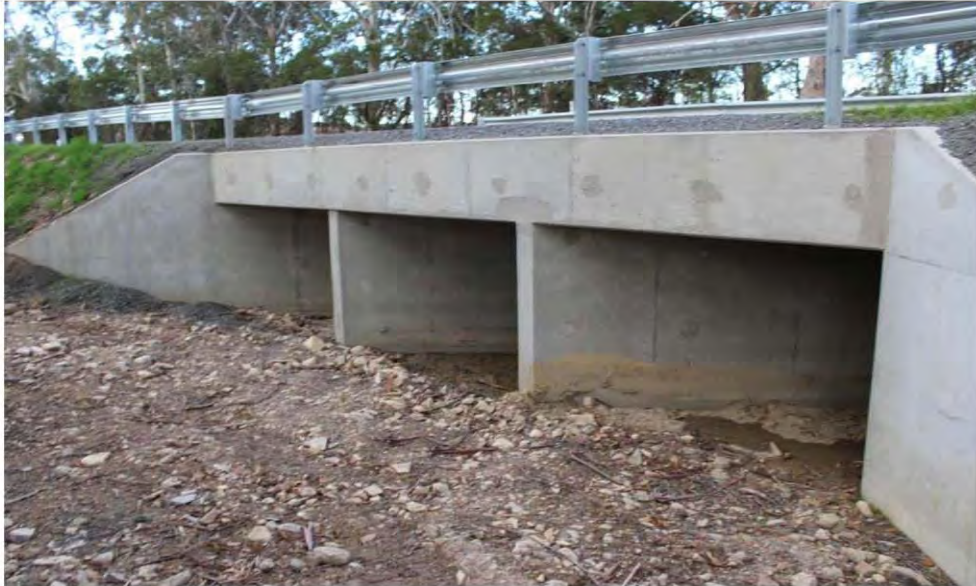
Culverts from western side (recent extension)

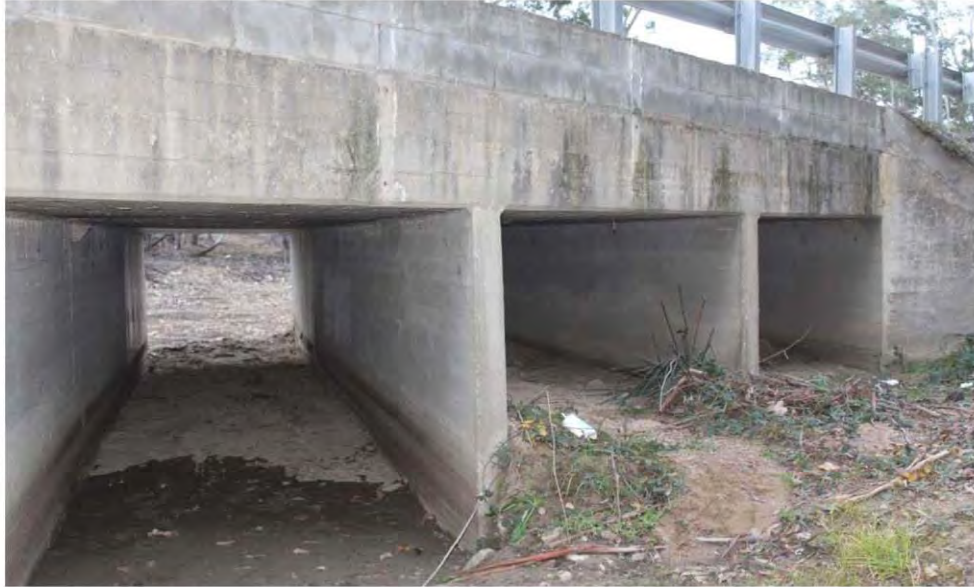
Culverts from eastern side (original)

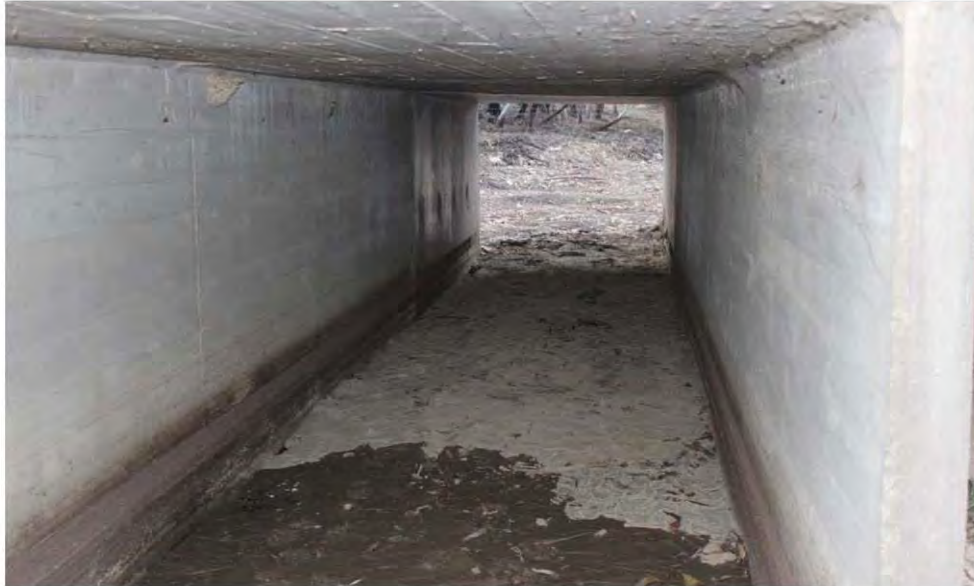
Cell 3 from east

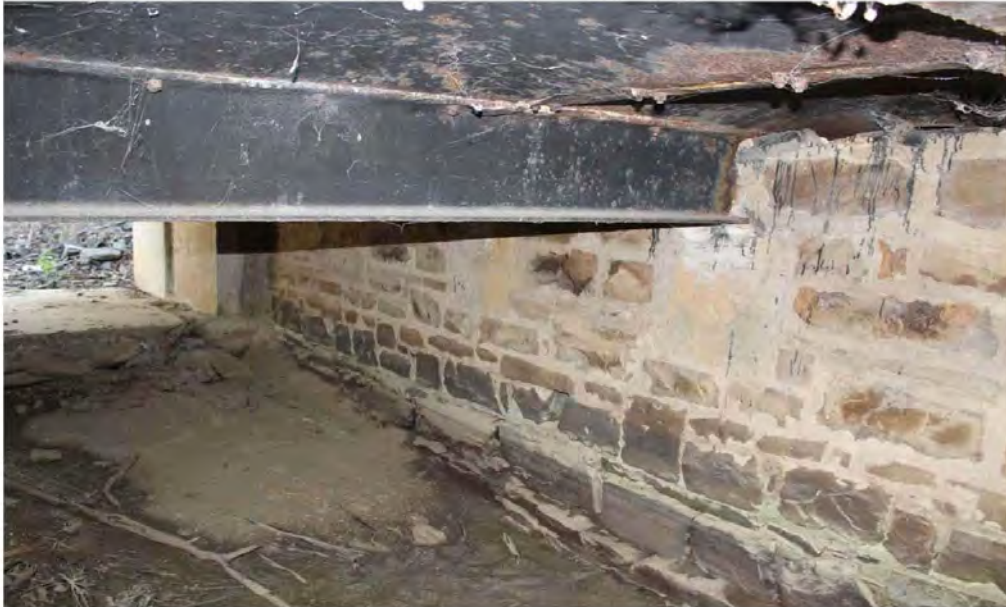
Southern abutment and beam 4

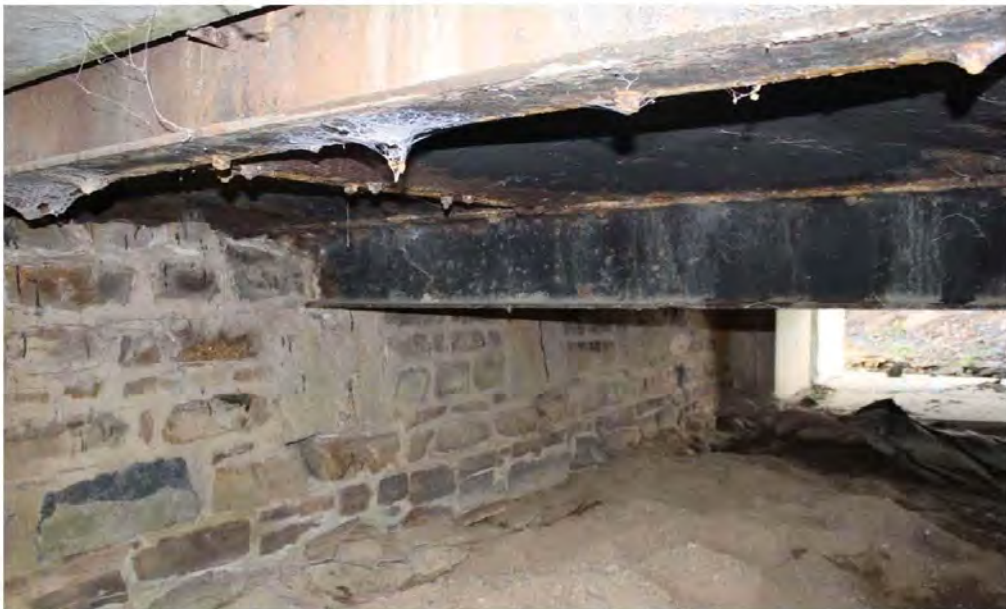
Southern abutment and beams 1 and 2

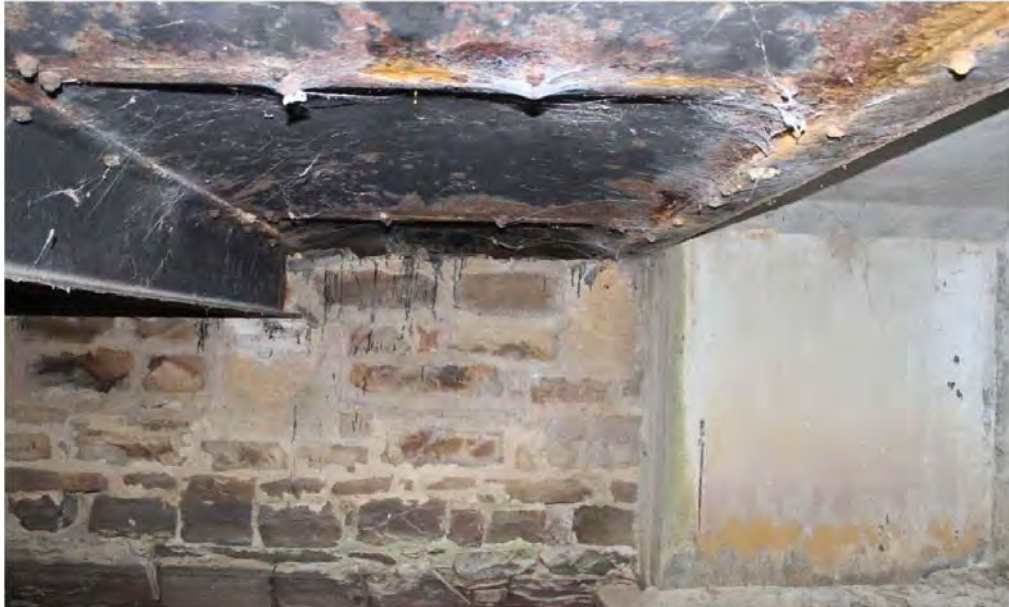
Beams 1 and 2, steel decking and eastern culvert

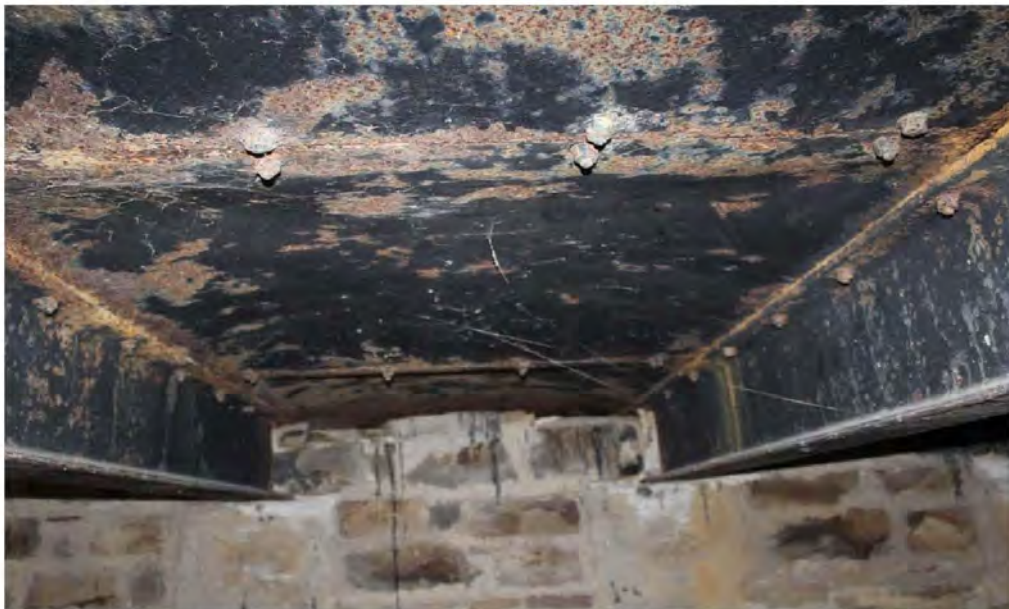
Beams 2 and 3 and steel decking

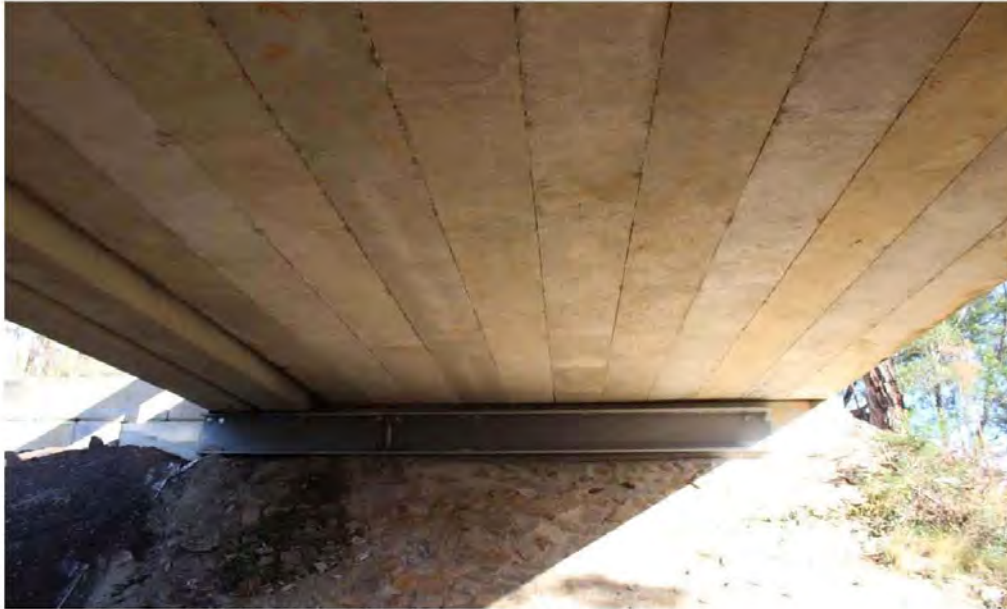
Abutment A and girders

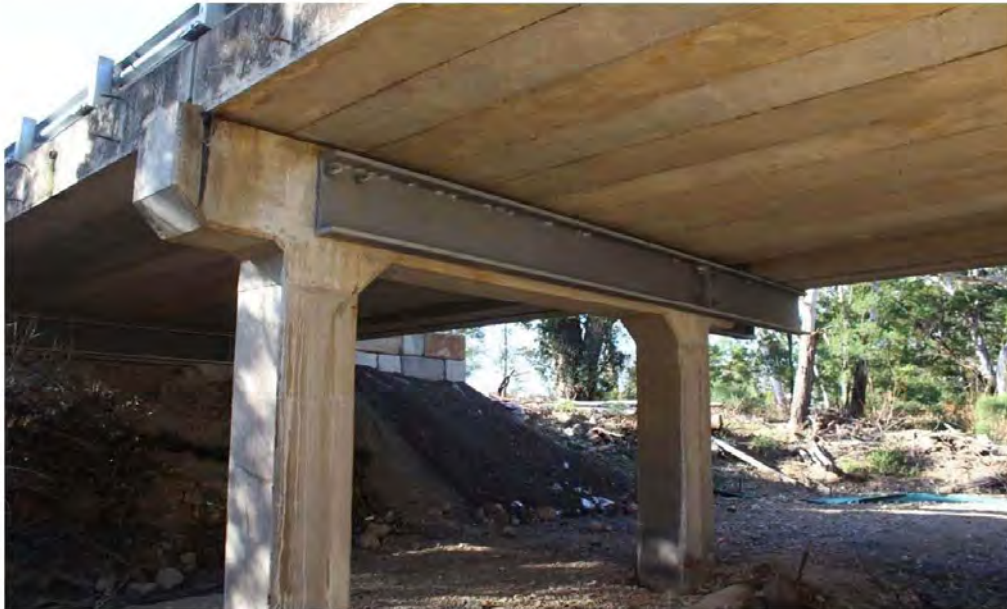
Pier from south west

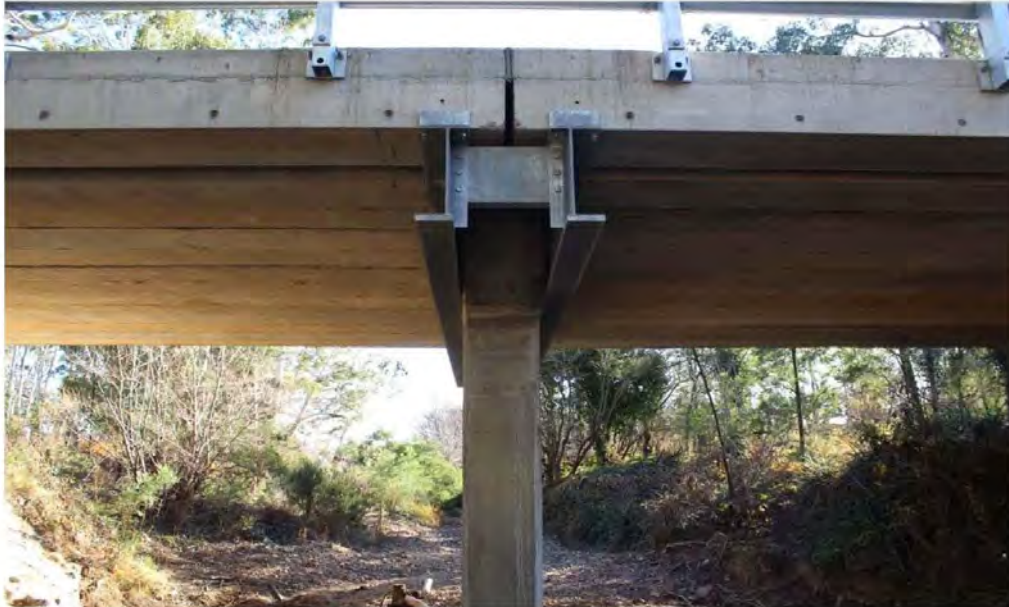
View of pier from east

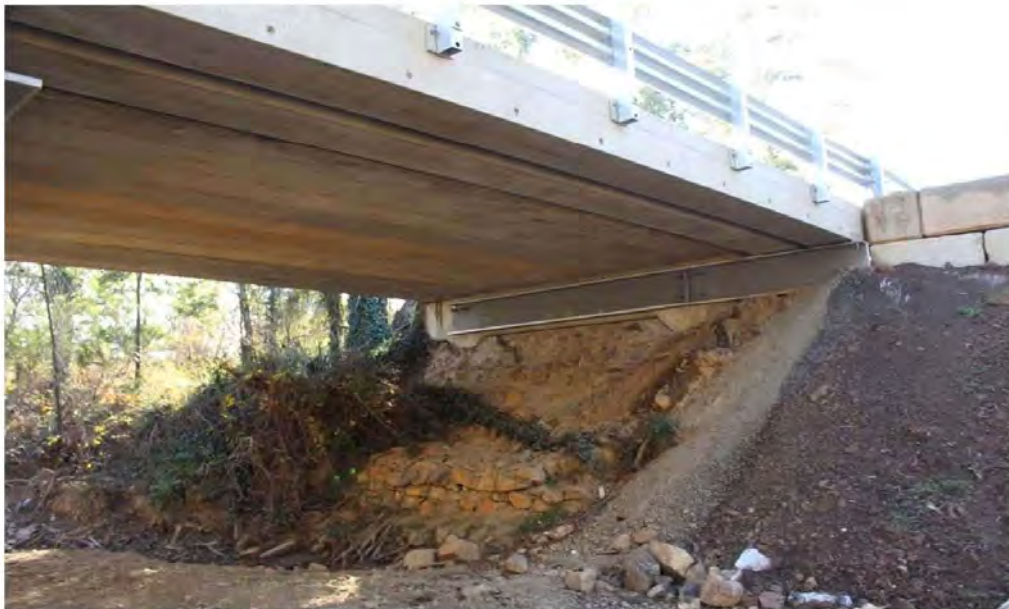
Abutment B and girders

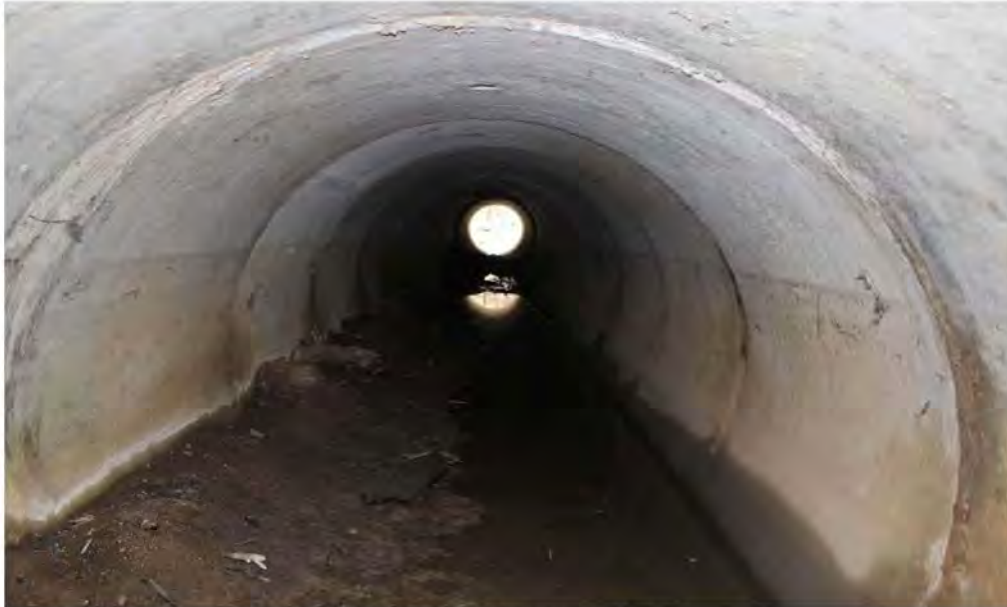
Inside culvert looking north

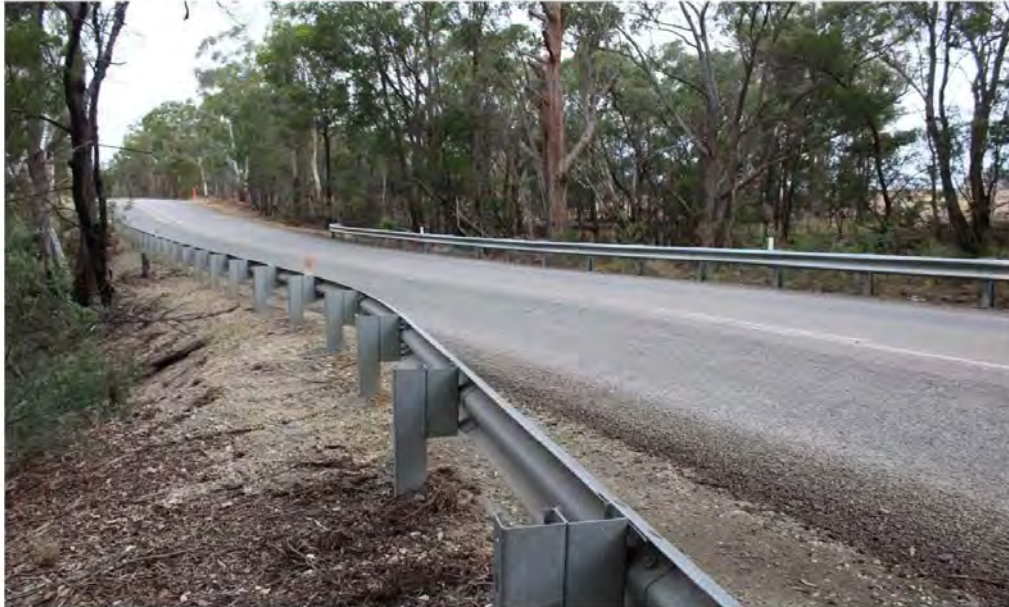
Road level looking south

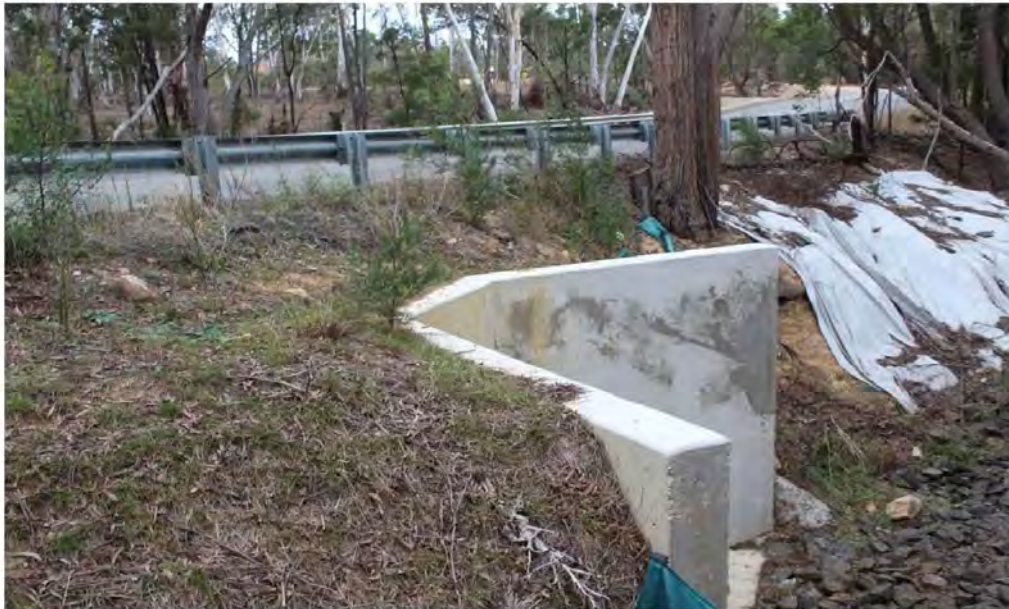
Pipe inlet (western side)

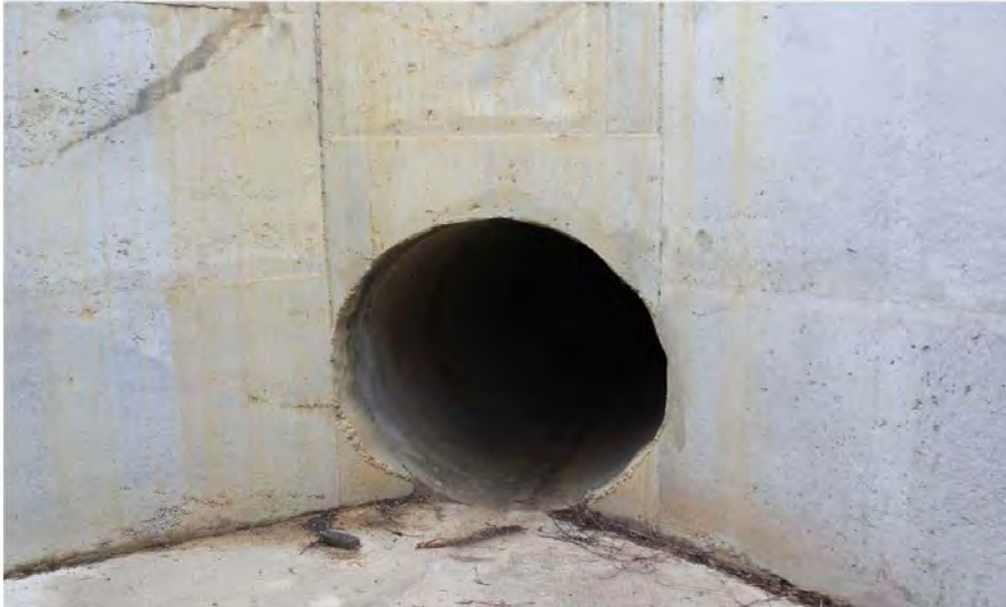
Pipe inlet (western side)

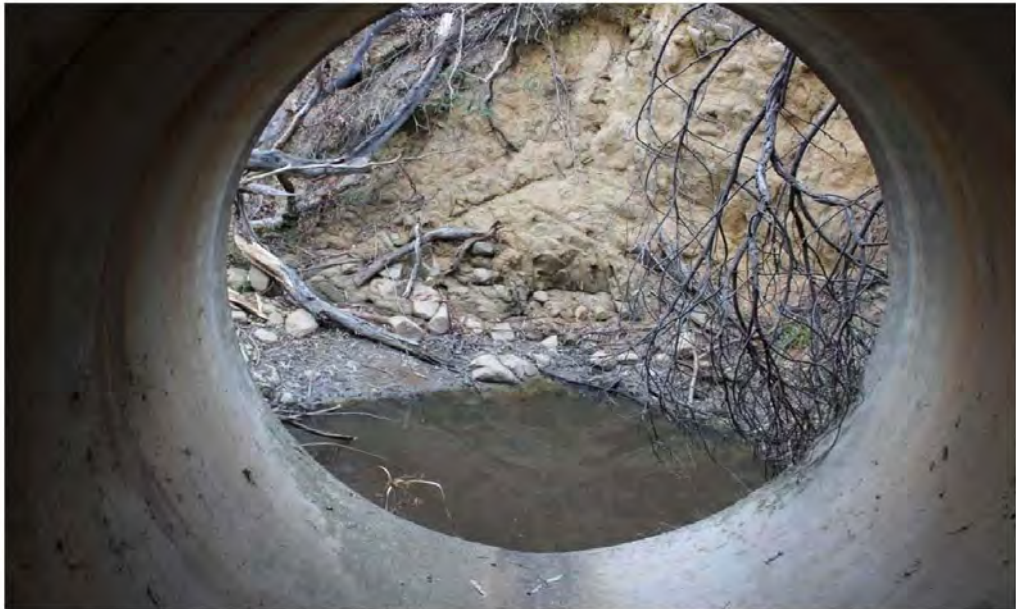
Pipe outlet (eastern side)
