ANNUAL ENVIRONMENTAL MANAGEMENT REVIEW

AUGUST 2017-2018

ARDMORE PARK QUARRY

5152 OALLEN FORD ROAD, BUNGONIA

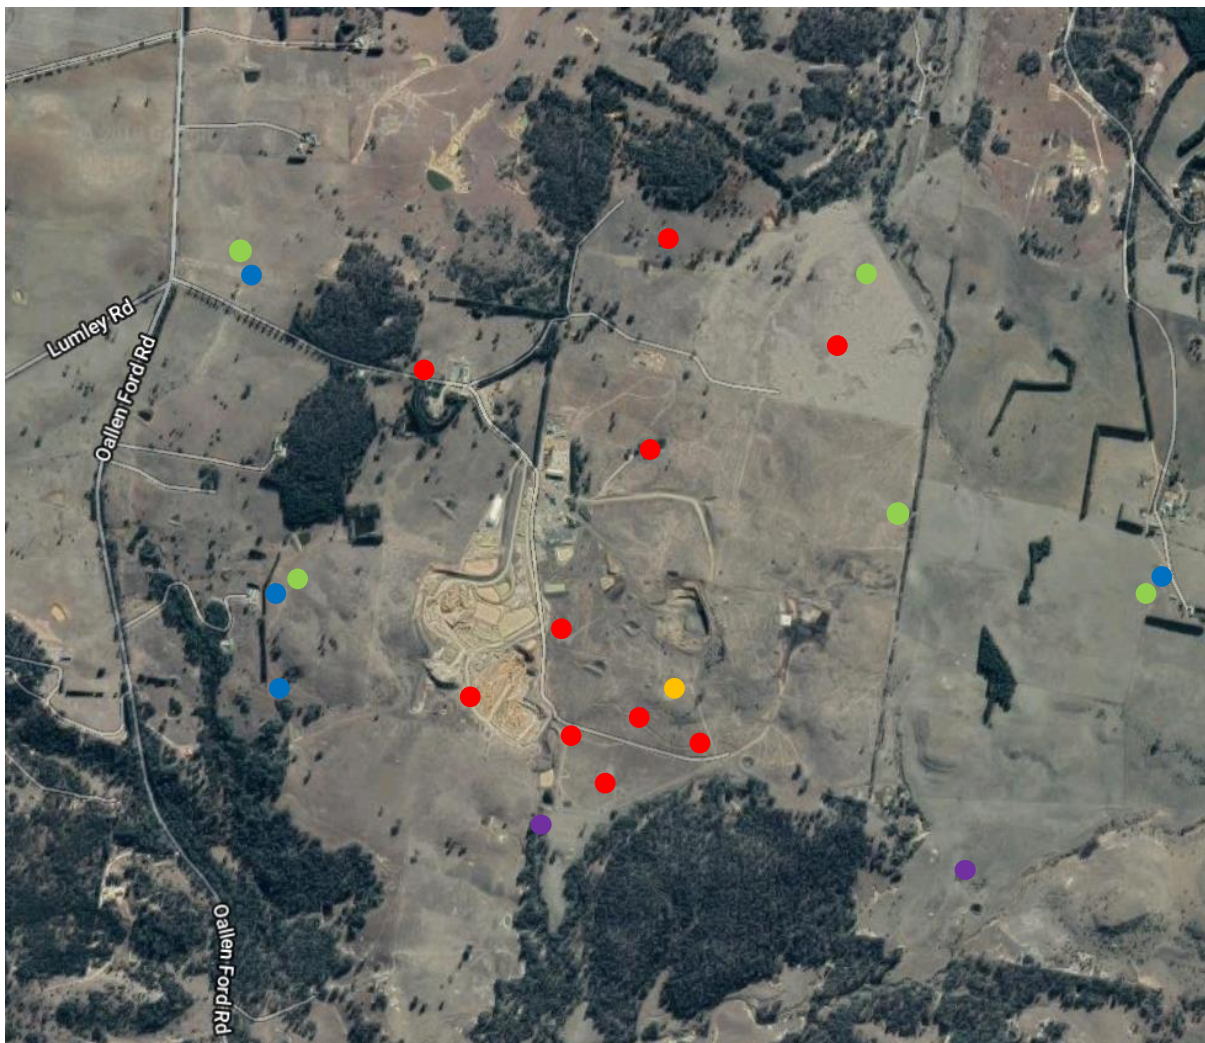
Figure 2 Location of Environmental Monitoring Points

A range of monitoring points both within and surrounding the extraction area are used to assess environmental performance. In total there are four air quality monitoring points, ten monitoring bores and two springs. The locations of each monitoring point are shown in figure 2. A key to figure 2 is included in table 6.

Colour	Type
Red	Monitoring Bore
Purple	Flowing Spring System
Yellow	Meteorological Station
Blue	Dust Deposition
Green	Noise Assessment Location, noise assessments were also undertaken on Oallen Ford and Jerrara Road.

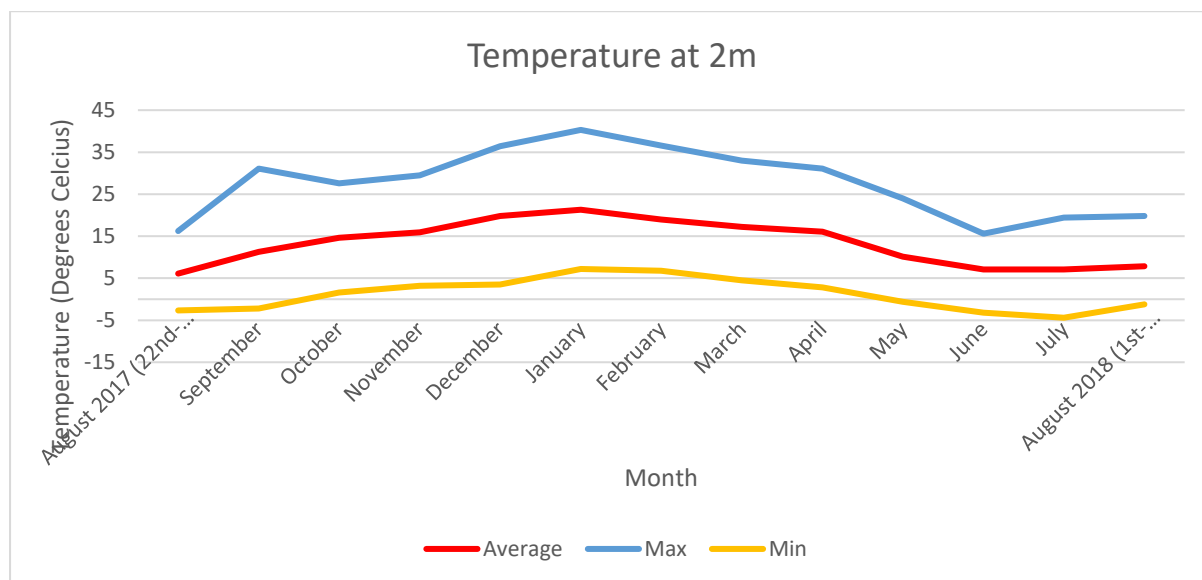
Figure 3 Temperature Ardmore Park

The maximum, minimum and average temperature for each month is presented in figure 3. Average temperatures varied from 20°C in summer to 8°C in winter.

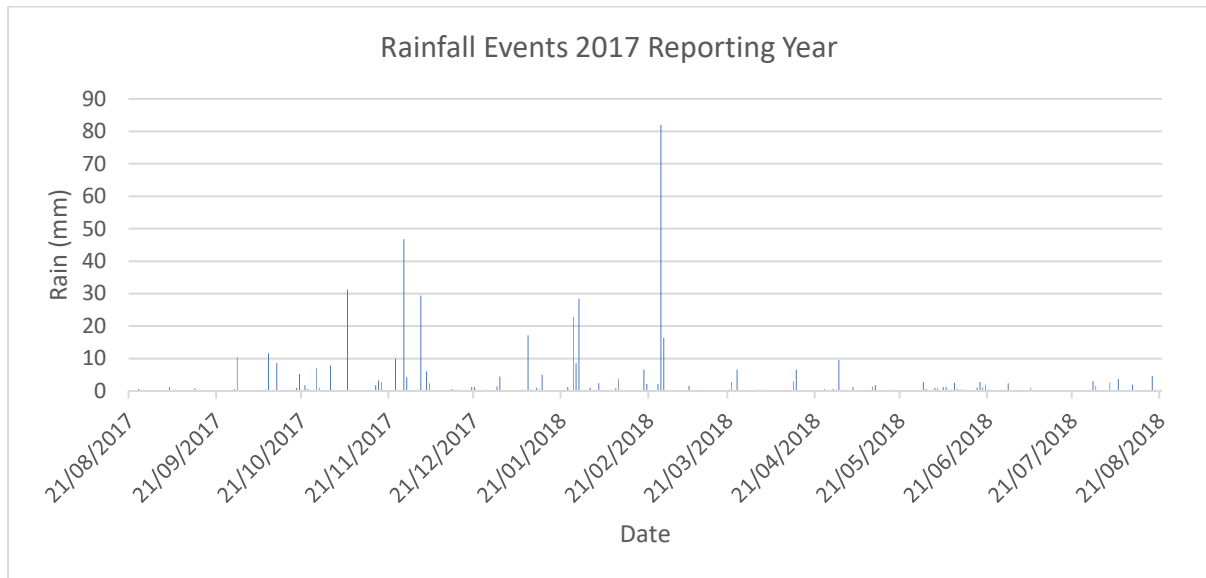
Figure 4. Weather Station Rain Events

A depiction of the individual rain totals for each day has been shown in figure 4. This effectively summarises the distribution of rain events and their relative magnitude throughout the reporting year. Rainfall was more consistent during spring and summer, with February being the wettest month of the year. The wettest day of the year received 82mm and occurred in February, while a total of 22 days saw more than 5mm.

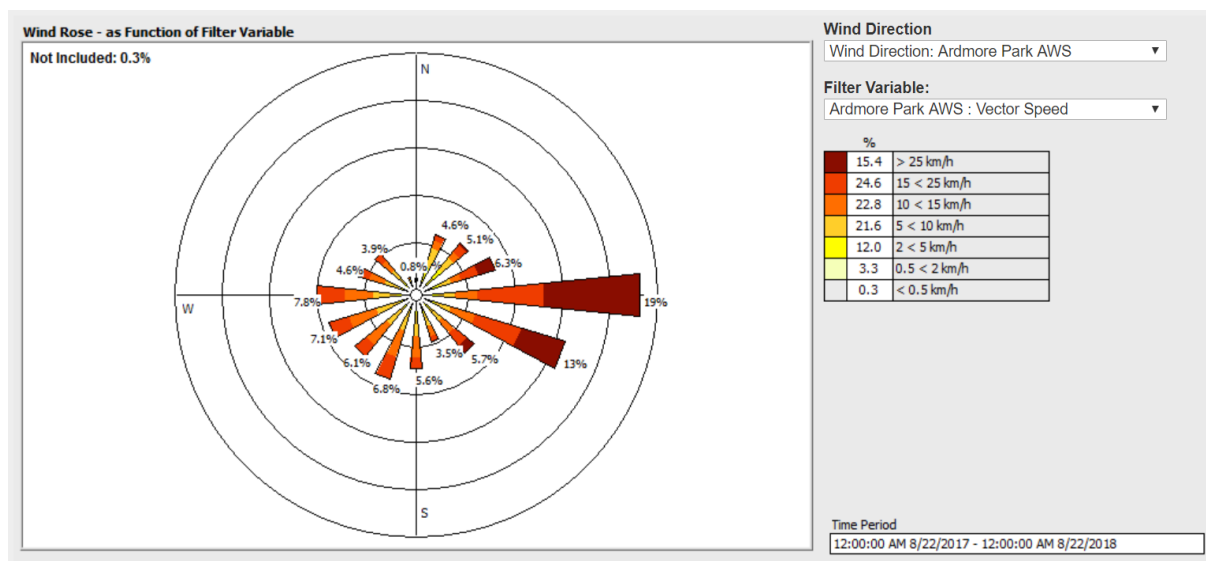
Figure 5. Directional Wind Rose

A directional wind rose is shown in figure 5. Winds on site predominantly blow are westerly, with the strongest winds, westerlies and north-westerlies.

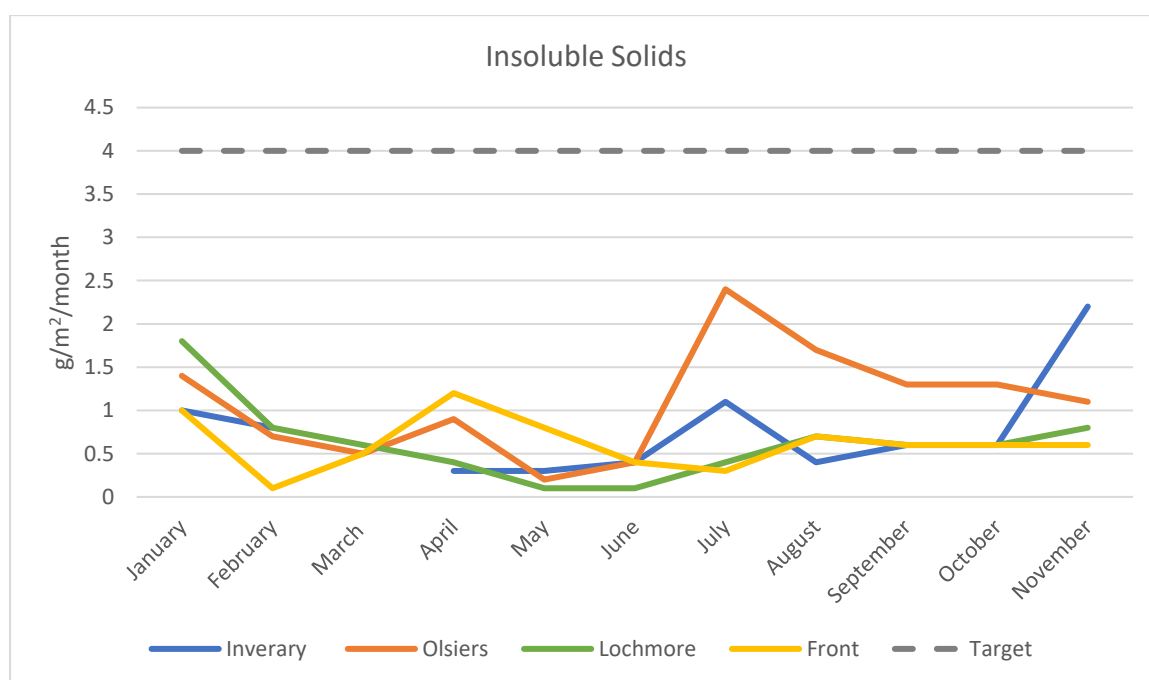
Figure 6. Soluble Solids Dust Deposition

The results for each individual month are shown in figure 6.

There were no instances of an exceedance of the monitoring criteria in any dust deposition gauge in any month of the reporting year.

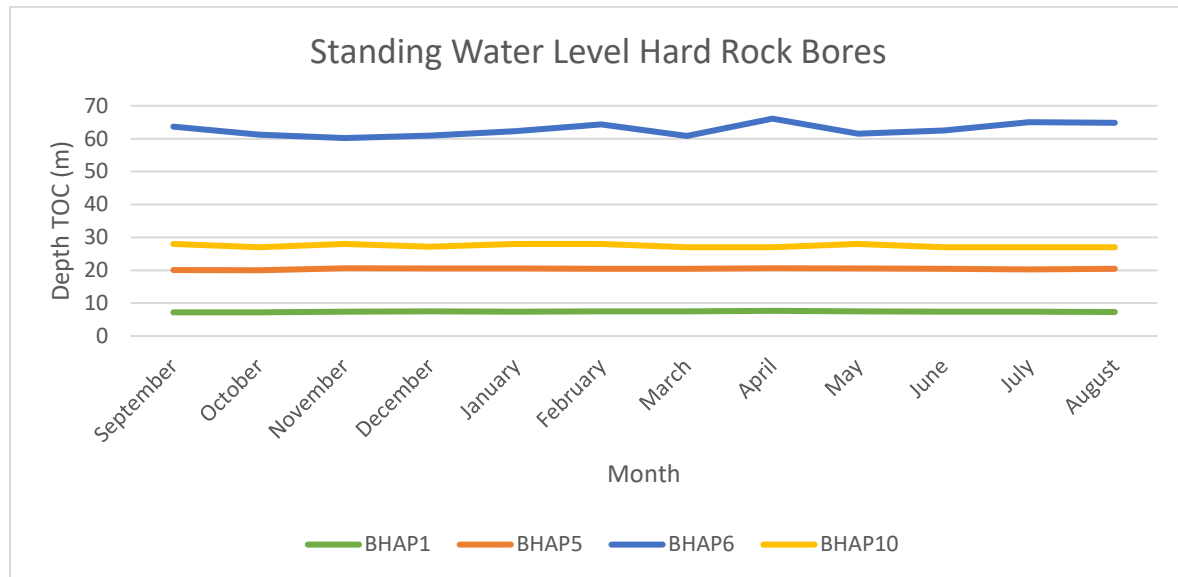
Figure 7 Hard Rock Monitoring Bore Standing Water Levels

The depth of the standing water level in the hard rock bores is shown in figure 7.

None of the depths recorded in the shallow sand bores have passed the trigger points described in the Water Management Plan (RW Corkery and Co, 2017) of a 15% change in standing water level (SWL) attributable to the project. Water levels can be observed to fluctuate over time but the overall trend in each monitoring bore is considered stable.

Higher fluctuations of the SWL within BHAP6, the production bore, are inferred to be caused by variations in recharge levels following pumping from the fractured rock aquifer. As noted in the original groundwater impact assessment to the quarry, the time taken for the SWL to return to its final level after pumping can take over 24 hours (Larry Cook and Associates, 2008). Depending on the time that the production bore is “dipped” it may therefore still be in the process of recharging. It is anticipated that long term data collection however will yield more reliable trends analysis, although data from this reporting period suggest the SWL remains stable.

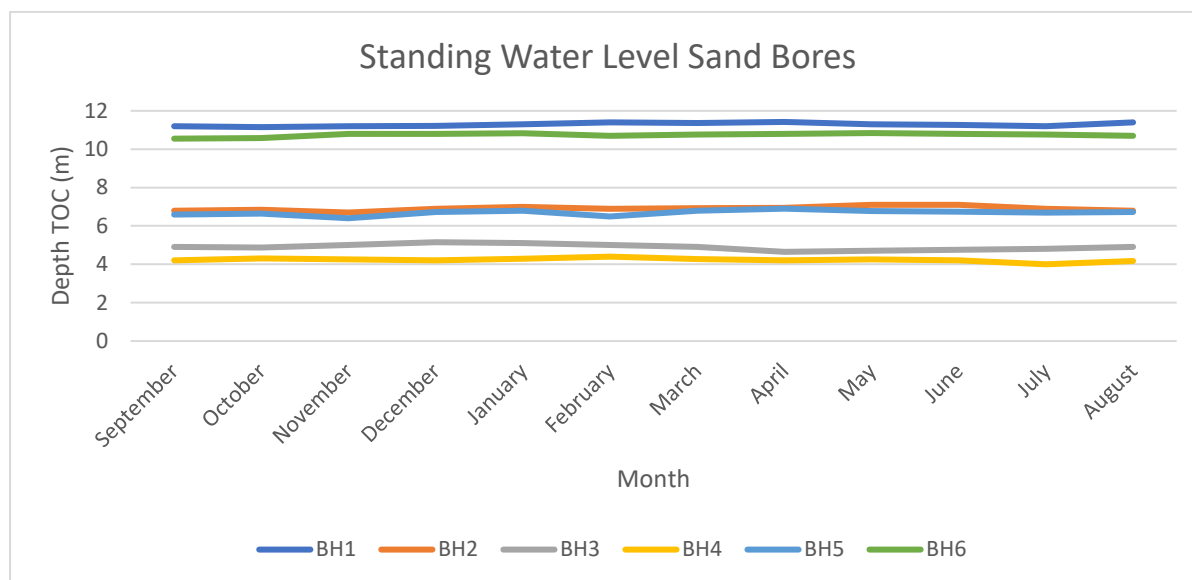
Figure 8 Sand Monitoring Bore Standing Water Levels

The depth of the standing water level in each sand monitoring bore is shown in figure 8.

None of the depths recorded in the shallow sand bores have passed “trigger points” described in the Water Management Plan (RW Corkery and Co, 2017) of a 15% change in standing water level attributable to the project. The data collected in the reporting period indicate no significant change in SWL over time.

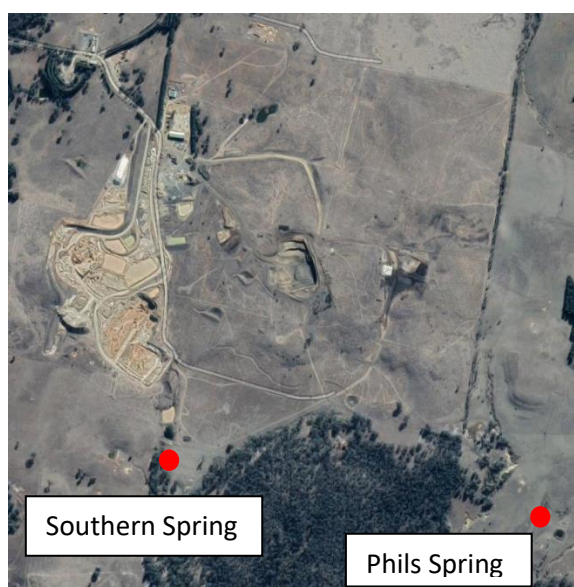
Figure 9 Location of Phils Spring and Southern Spring

The location of the two springs sampled during the monitoring period are shown in figure 9.

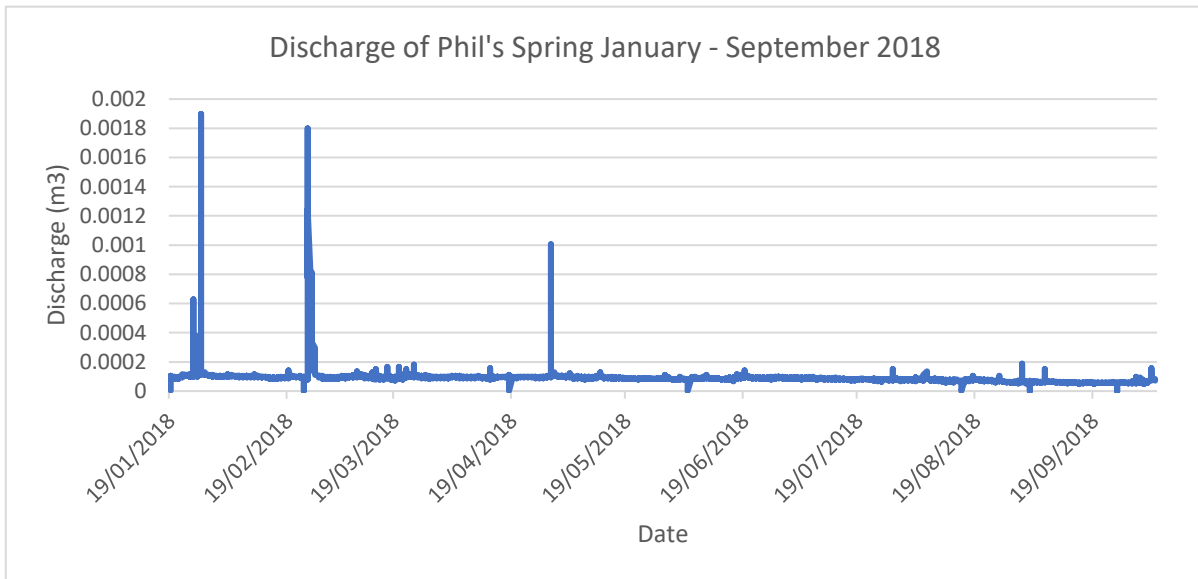
Figure 10 Discharge of Phil's Spring January – September 2018

Analysis of the Phil's Springs discharge shows an overall trend of decline, albeit with highly variable discharge during periods of significant rainfall (as much as nine times the standard rate of discharge of 0.1L/sec). The data collected from the v-notch weir over the reporting period is shown in figure 10.

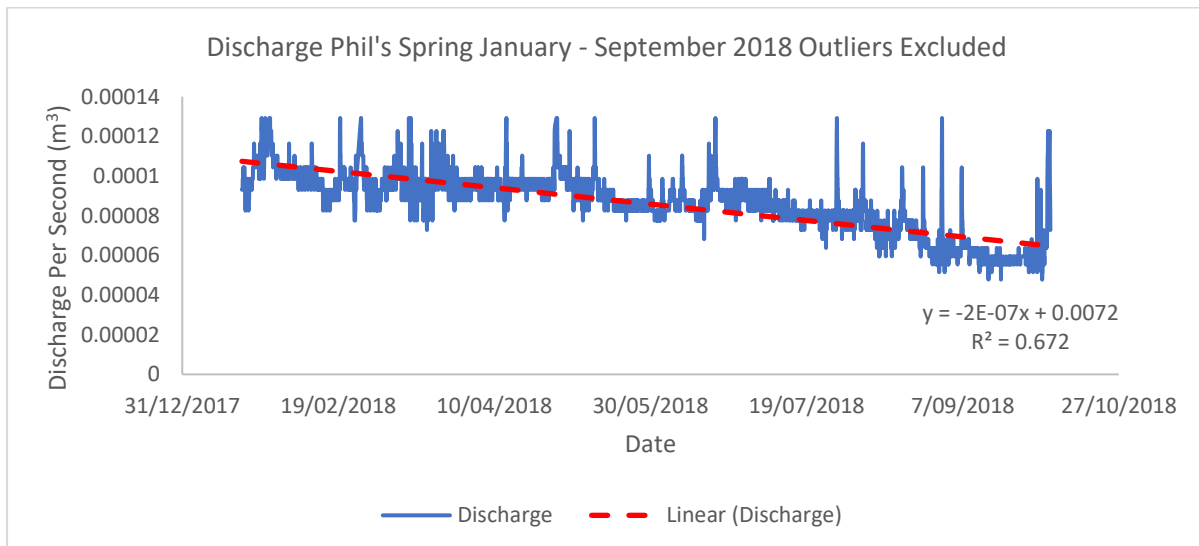
Figure 11 Discharge of Phil's Spring Excluding Outliers

Statistical analysis of the available flow data, excluding outliers, shows a clearer trend of decline throughout the year. Figure 11 shows this trend, as well as a fitted, linear trend line.

In the reporting year, the flow rate of Phil's Spring past the trigger point of 0.1 L/sec flow rate considered to be a "significant decline" as described in Ardmore Park's Water Management Plan (RW Corkery and Co, 2017). Additional flow data provided to Multiquip by the owners of Inverary Park shows that the observed decline during the reporting period is part of a longer-term consistent decline in flow, from peak flow rates of as high as 28,000 L/day (equivalent to 0.0003m³/sec or 0.3L/sec) in 2004. In response to passing the trigger level as well as claims that use of groundwater at Ardmore Park, had since 2004, contributed in part to the decline in spring flow, Multiquip

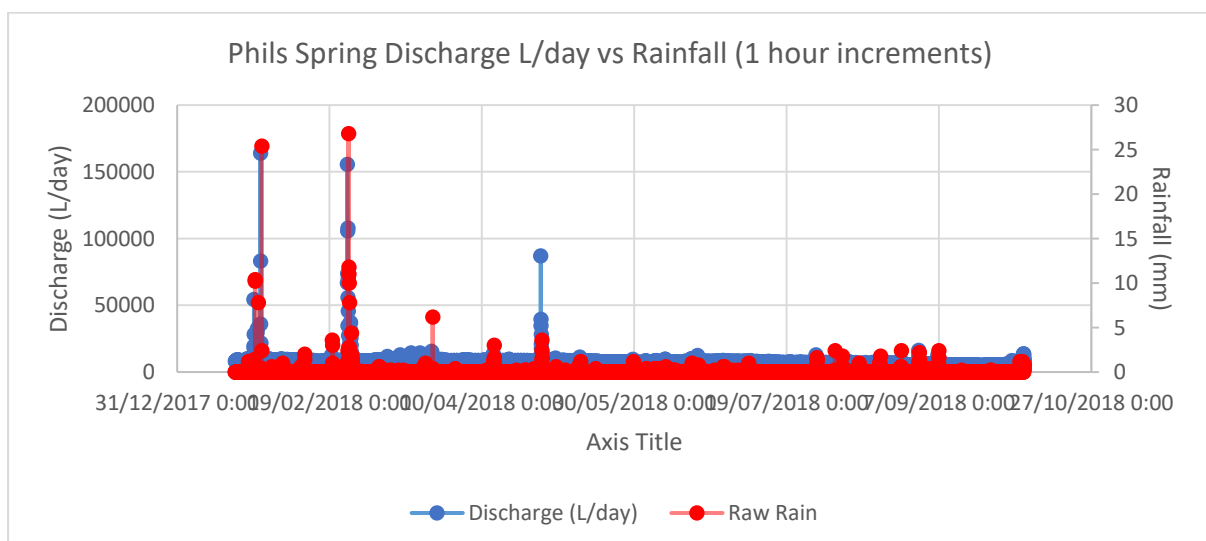
Figure 12 Comparison of Hourly Flow Rate of Phil’s Spring to Hourly Rainfall at Ardmore Park

The report further noted that much of NSW is being affected by a period of significant drought and that such conditions can contribute to declines in both spring recharge and flow (Larry Cook and Associates, 2018). Comparison between the Ardmore Park’s hourly rainfall and the flow in Phil’s Spring suggests a high degree of correlation. A plot of these two data sets since the installation of the v-notch weir is shown in figure 12.

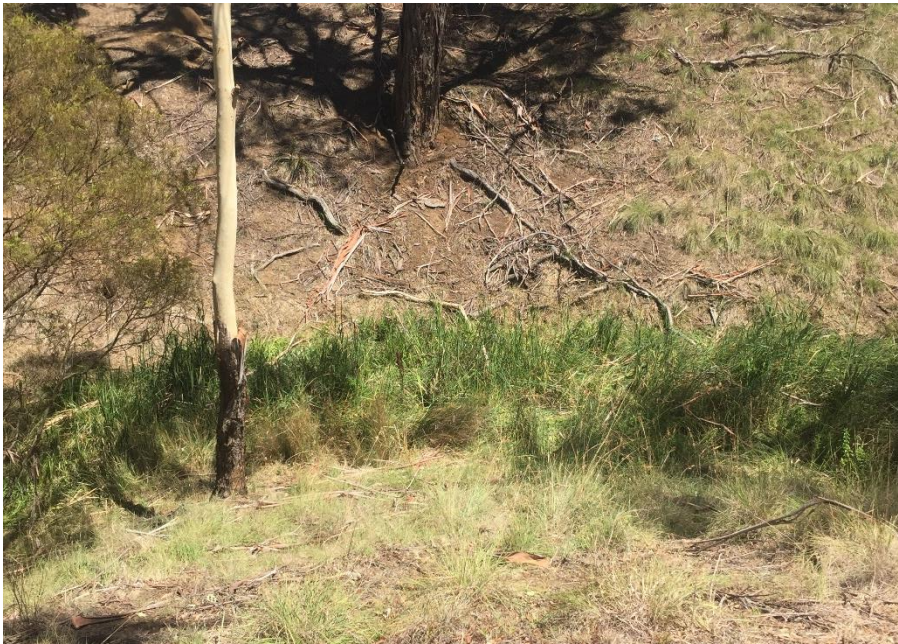
Figure 13 Proposed Location of Southern Spring V-notch Weir

It is anticipated that during the following reporting year that a second v-notch weir will be installed in the Southern Spring, allowing for further remote data collection and analysis. A site approximately 50m downstream of the spring's origin has been identified as a suitable location to install the weir due to its narrow width, which would minimise the amount of work required to build a weir pool which would effectively channel all flowing water through the weir. The proposed site is shown in figure 13.

The broad, braided and highly vegetated path that water discharged from the Southern Spring flows into and through, makes accurate assessments of total flow difficult (refer to figure 13). Field measurements and observations suggest that the Southern Spring has experienced no significant change in flow rate. No change in vegetation has been observed, during any monthly inspection, nor has there been any noticeable changes to channel depth due to erosion nor evidence of pollution discharged from the quarry site.

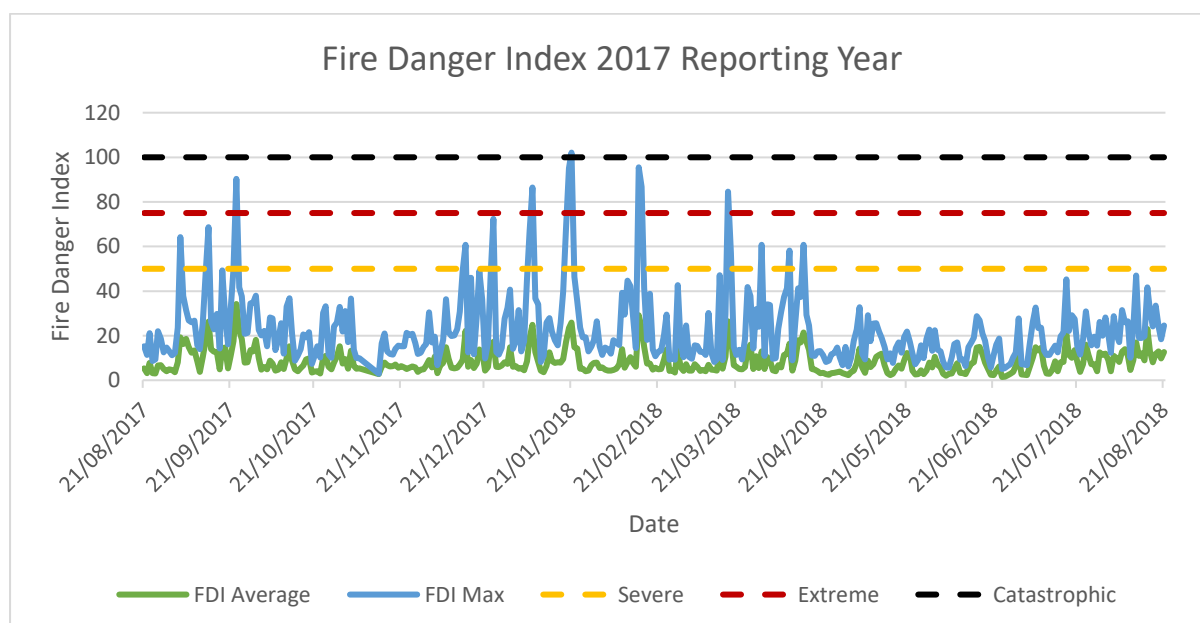
Figure 14 Daily Fire Danger Index 2017 Reporting Year

The Ardmore Park weather station is equipped to calculate the McArthur Forest Fire Danger Index as a function of relative humidity, temperature and windspeed. This information is assessed by site management on days when the fire risk is elevated. The daily maximum and average fire danger index scores for the 2017 reporting year are shown in figure 13.

A total of seven days reached “severe” conditions, while four days could be categorised as “extreme” and one day, the 21st January, as “catastrophic”. The yearly plot of the danger index clearly delineates between the cooler winter period in which the index rarely averages above twenty, and the Bushfire Danger Period which occurs between October and March (NSW Rural Fire Service, 2018). Notably the fire risk was elevated in throughout late winter and spring period in 2017.

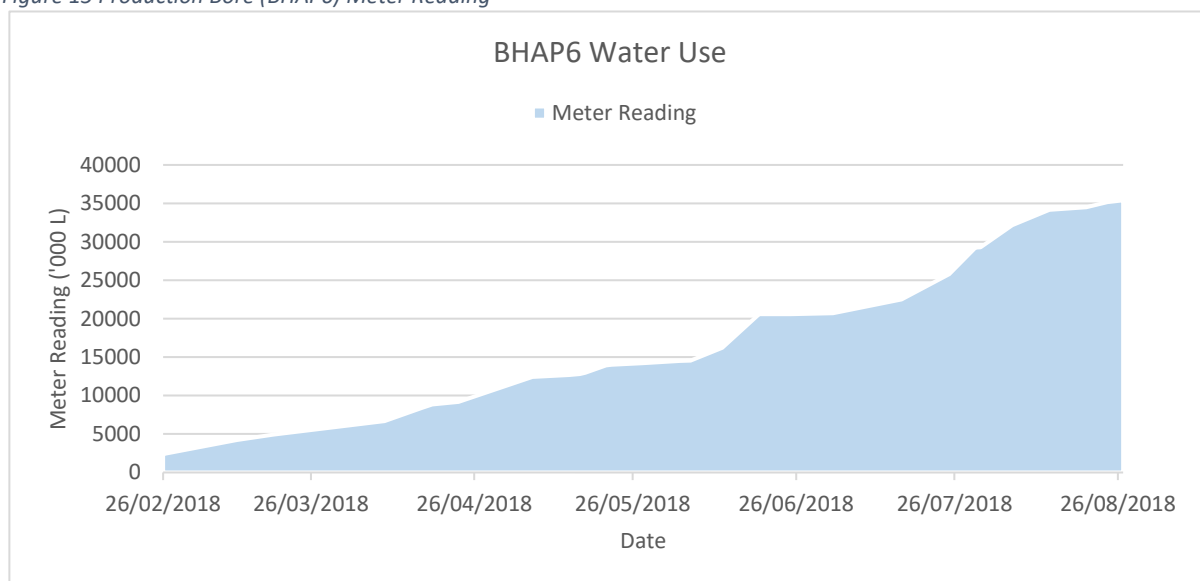
Figure 15 Production Bore (BHAP6) Meter Reading

A plot of the water usage from BHAP6 during this reporting period is displayed in figure 14.
