Ardmore Park Quarry – Modification 3
Engineering Assessment of
the Culverts and Bridges on
the Product Delivery Route

Bridge Designs Pty Ltd

B1833-R-01

Bungonia Culverts - Engineering Assessment

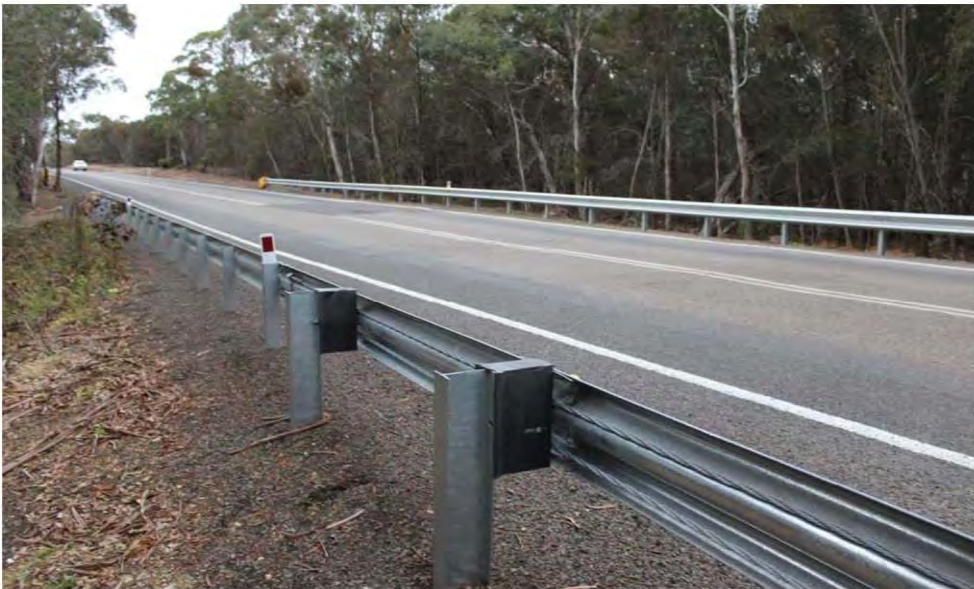
Road level

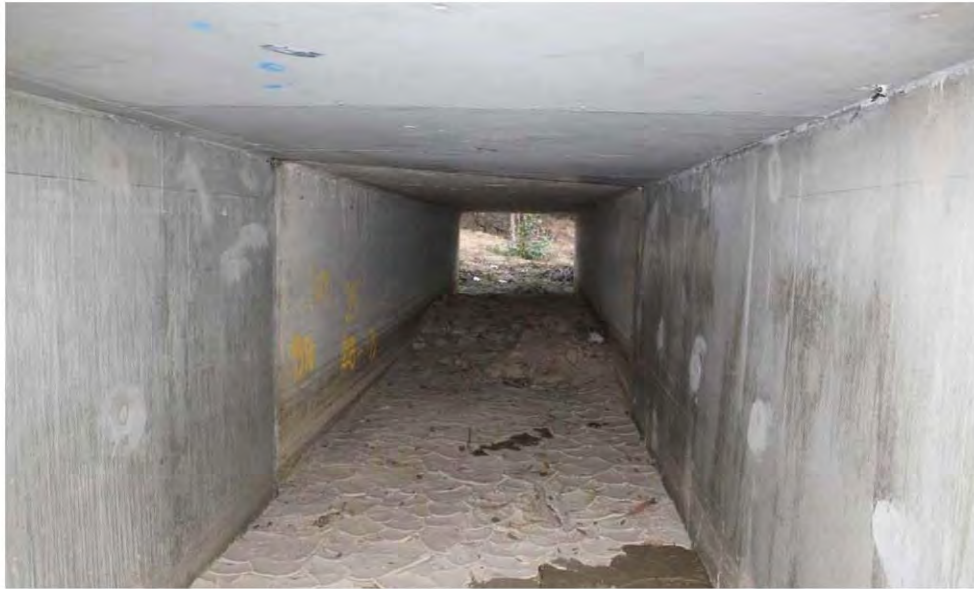
Cell 1 from west

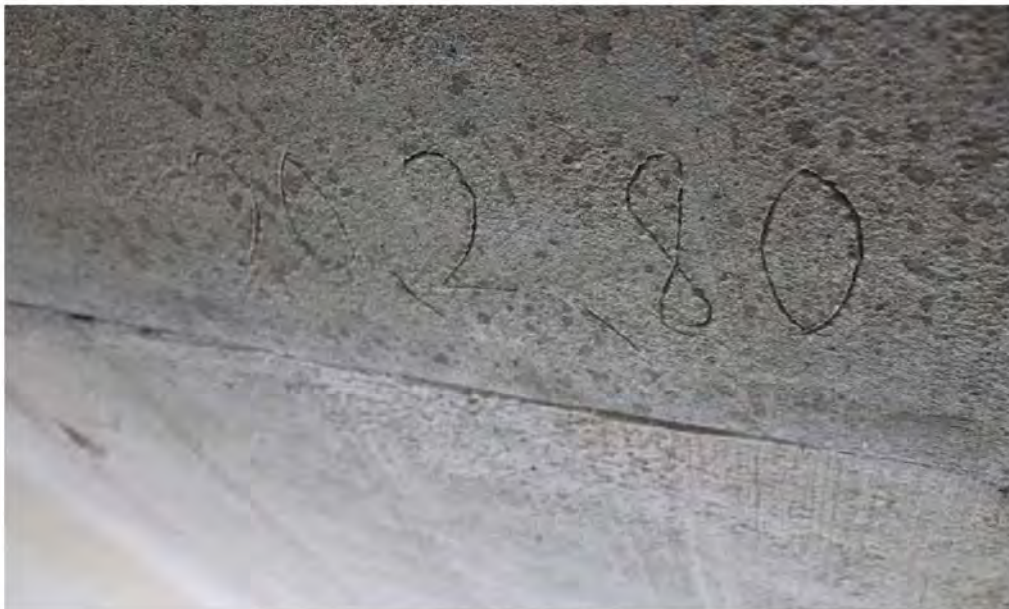
Construction date

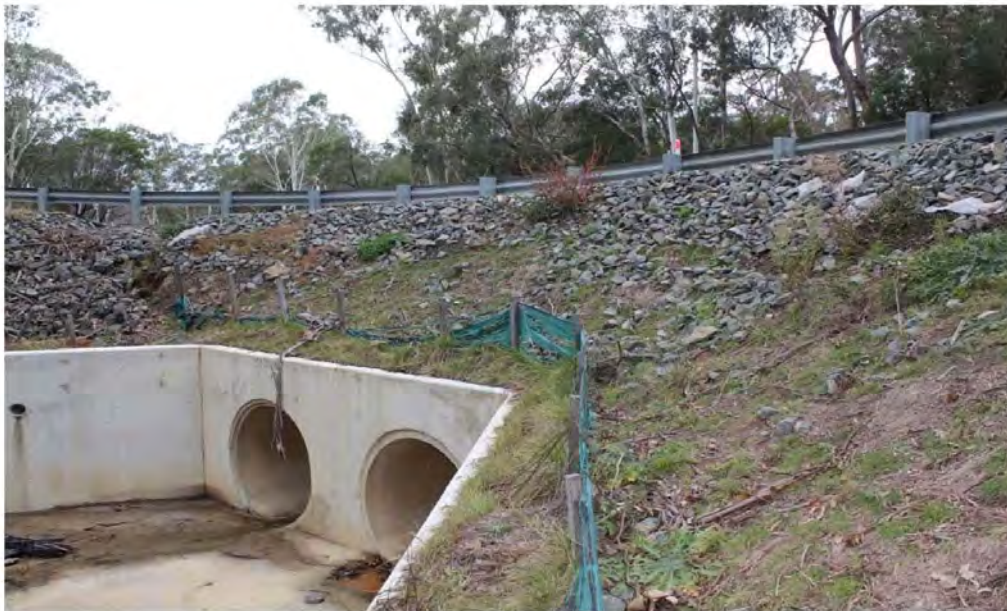
Northern (new) side

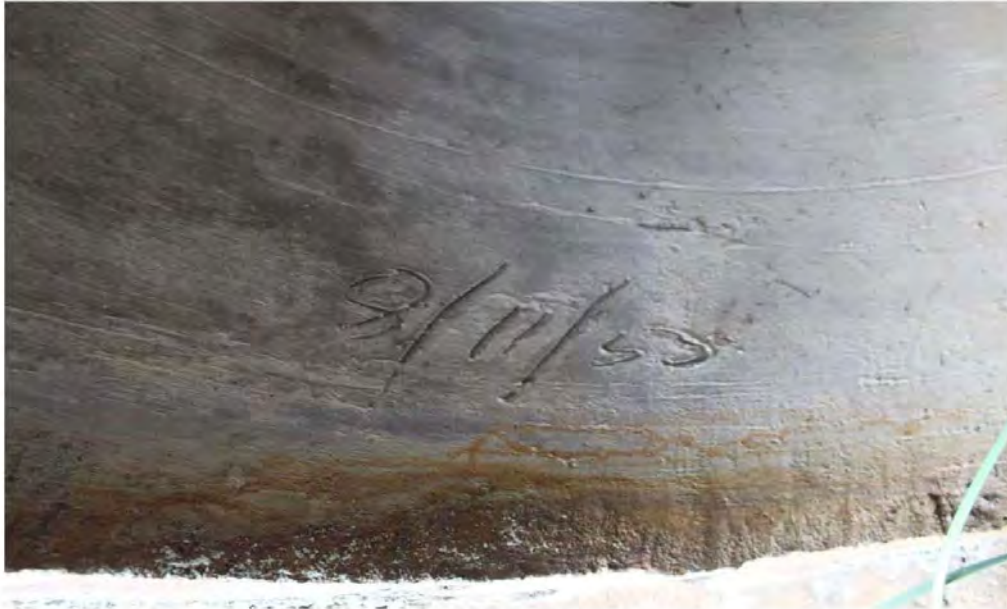
Construction date

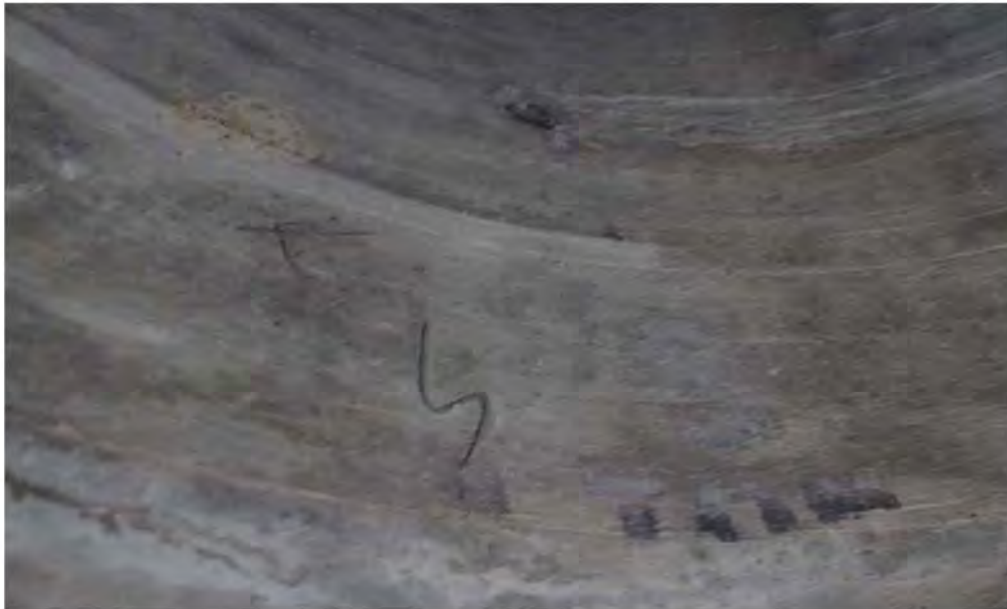
Pipe class noted as S and Y

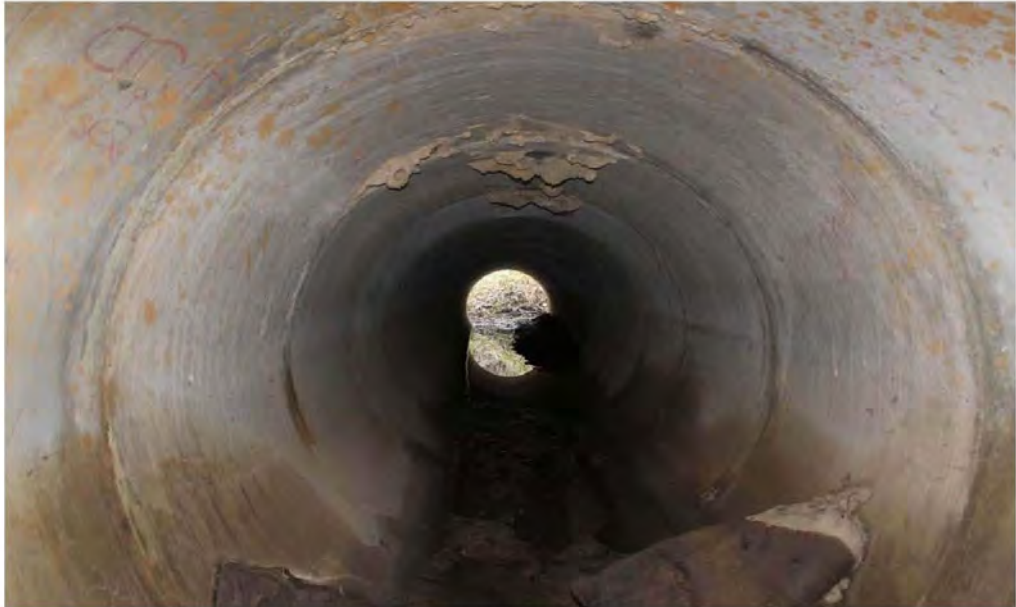
Original pipes

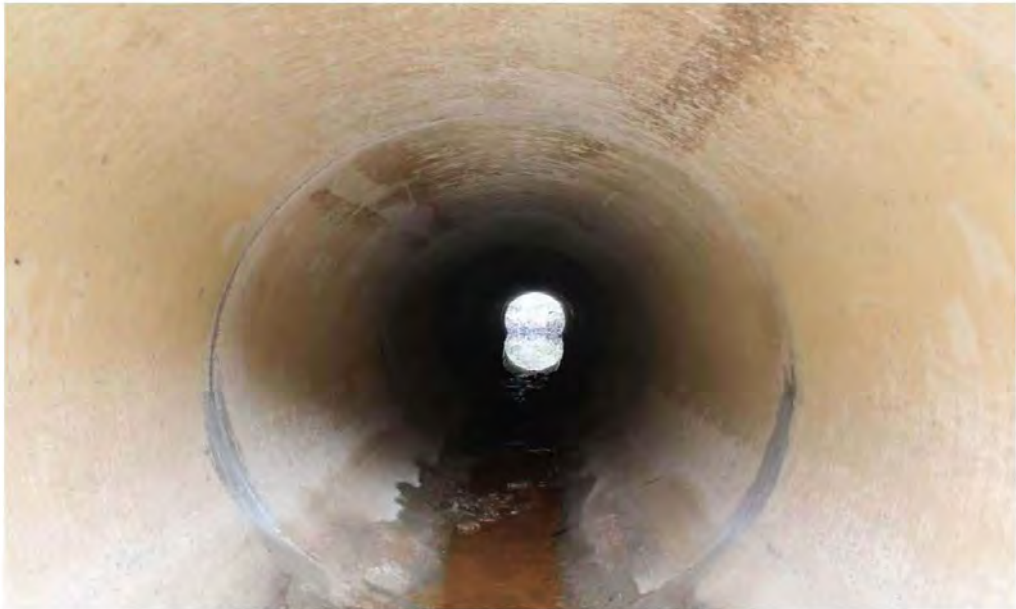
Cell 2 looking south

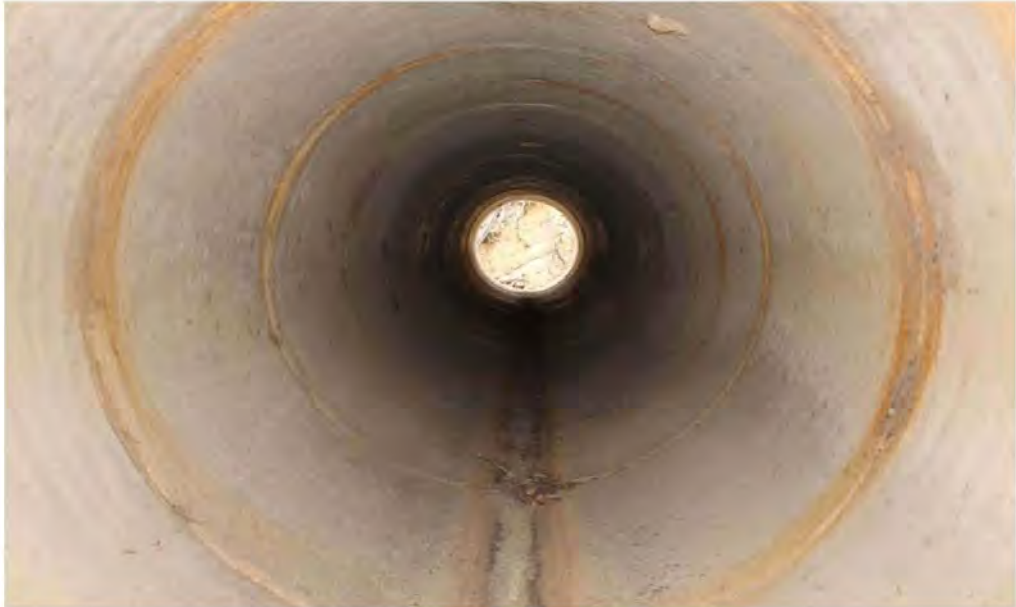
Inside pipe

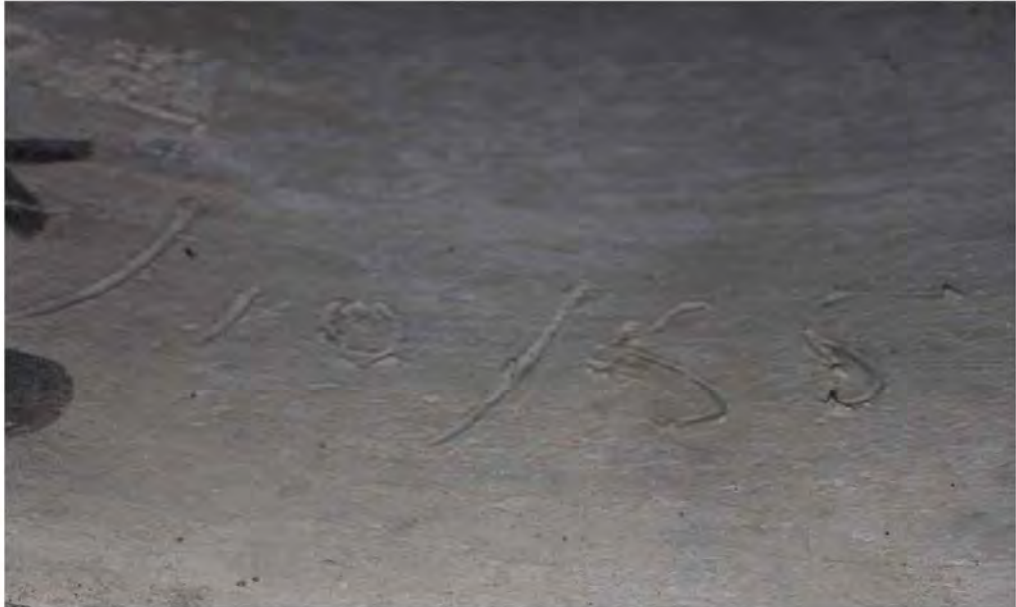
Construction date

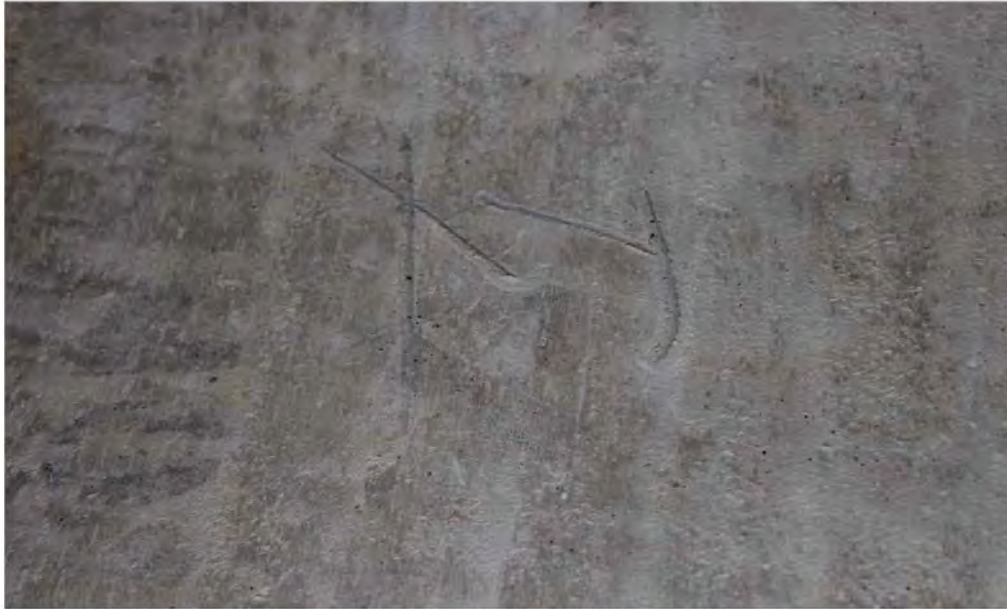
Pipe class 'XY'

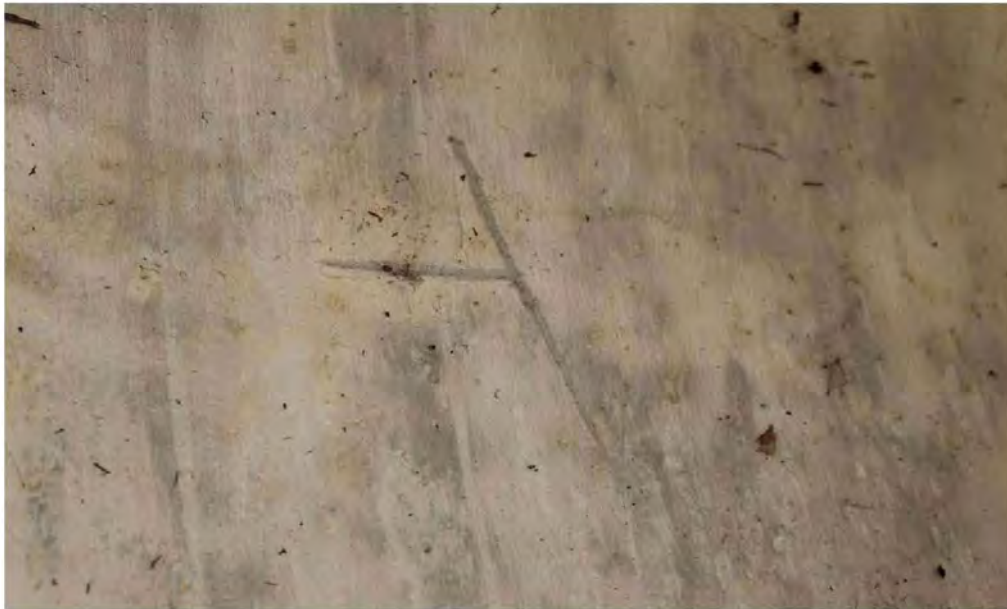
Pipe class 'Y'
